PERFORMANCE ANALYSIS OF CIGS THIN-FILM PHOTOVOLTAIC SYSTEM AFTER 10 YEARS IN THE HOT AND HUMID CLIMATE OF FLORIDA

Eric Schneller, Narendra Shiradkar and Neelkanth G. Dhere

Florida Solar Energy Center, 1679 Clearlake Road, Cocoa, FL 32922-5703 USA

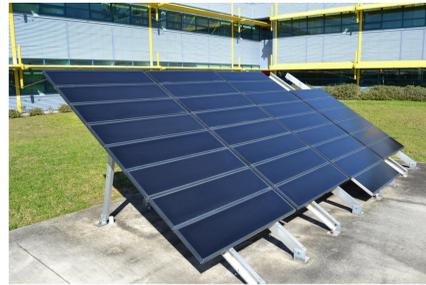
A CIGS thin-film photovoltaic array has been deployed at the Florida Solar Energy Center for almost 12 years. This array consisted of 8 strings in parallel, each with of 4 modules. The open circuit voltage of the system was just under 100 V with an operating voltage of 60 V. Analysis of the array was performed including illuminated and dark I-V measurements, electroluminescence and infrared imaging, and visual inspection.
