Current status of TG5 region Japan

Mitsui Chemicals, Inc.

Delamination

A 20y-field-aged PV module with delamination failure and induced corrosion

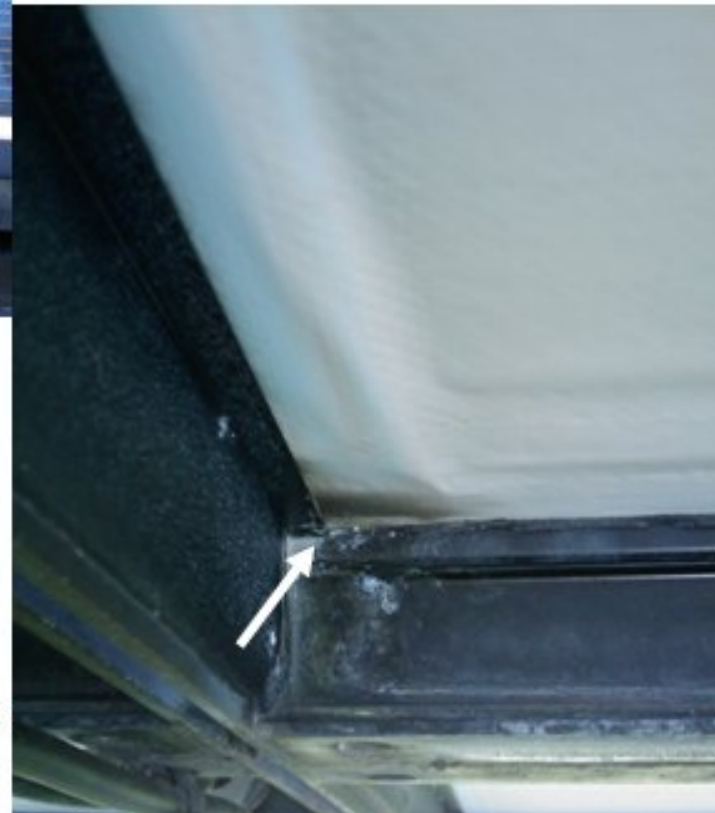
(A), (B)

✓ Adhesion strength among inner layers of the backsheet "TAT" was extremely low.

Delamination at inner-layer or inter-layer of backsheet and penetration of water into front side of cell

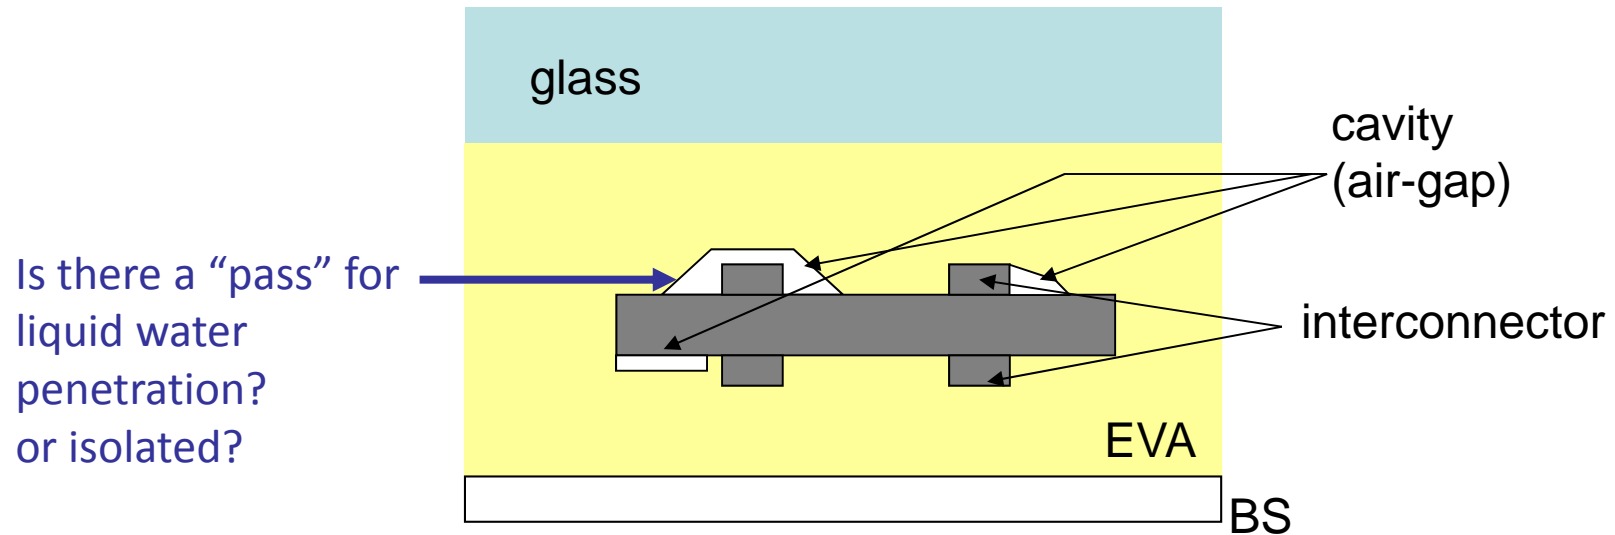
Category (A) Delamination at interface between EVA and cell / interconnector

This is considered to be **isolated** from liquid water penetration.

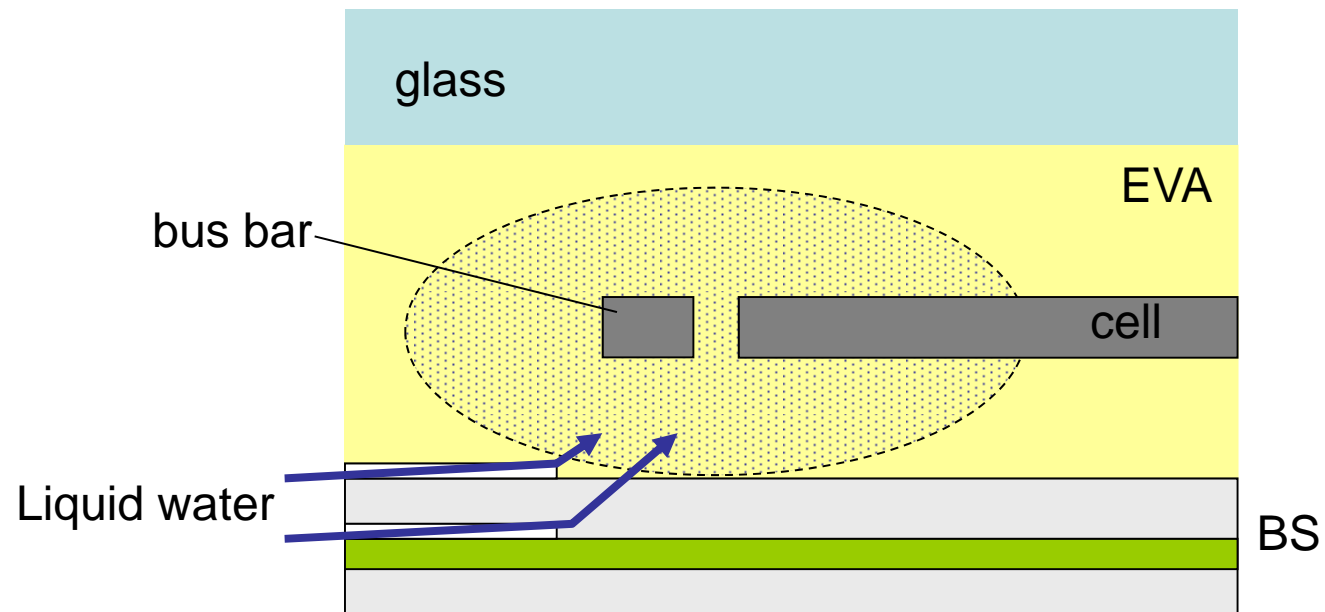
Category (B) Delamination at interface of inner-layer of BS / BS and EVA

Liquid water induces corrosion and delamination which leads to corrosion.

Thus we will focus on delamination failure which leads to corrosion, in terms of severity.

This failure is typically observed at corners of a PV module and lower side for deployment in field.

Adhesion of the interface between inner layers and BS/EVA would be important.

New test, such as dipping hot water, may be necessary for duplicate this delamination, instead of or after typical chamber tests such as UV, DH, TC and these sequence... We need some ideas and data. Of course, we still collect field failure information concerning delamination.

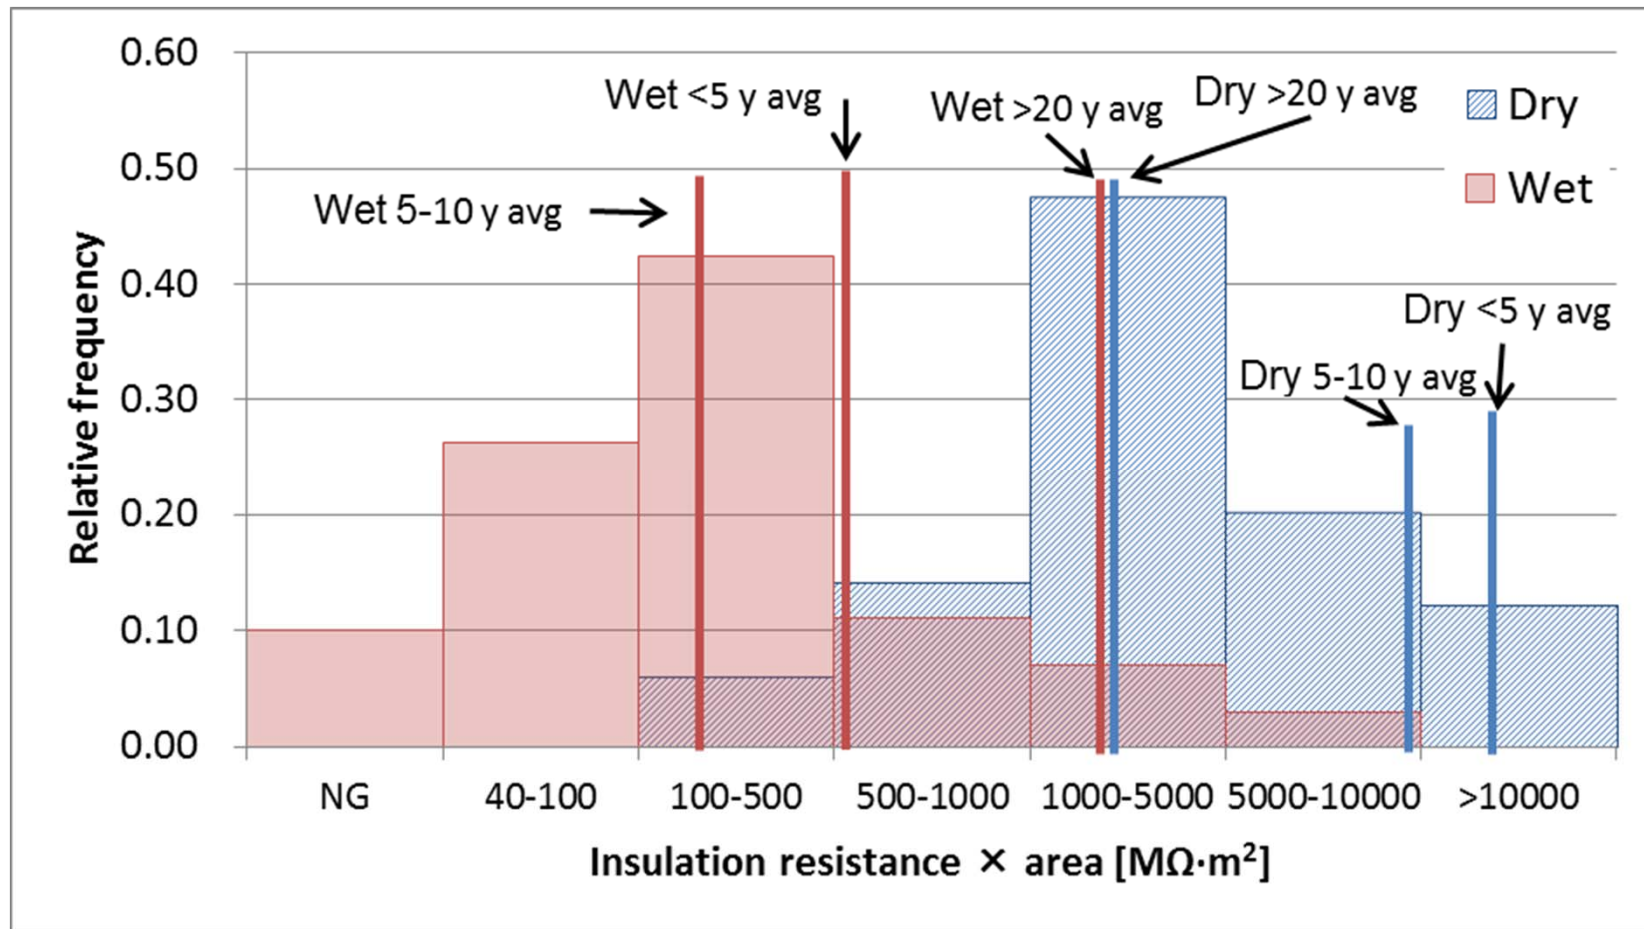
Histogram of insulation performances of field-aged PV modules with no visible failure modes (delamination, cracks) and deployed in Japan

Applied bias voltage was 500V for both measurements.
Total number of evaluated modules are roughly 100.

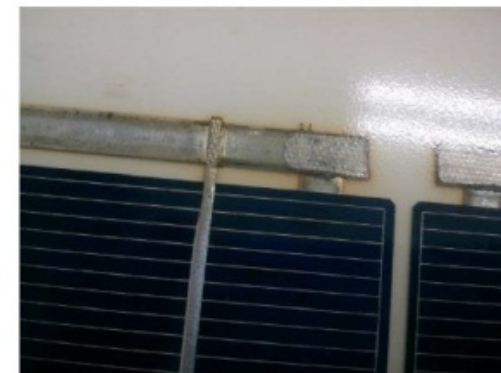
120410-02 UV+DH+TC

After 2nd DH500, TC100, Pmax, FF was dramatically reduced.

Insulation performances of tested modules were still high.
