June 2002 • NREL/TP-500-31666

Wind Turbine Generator System Safety and Function Test Report for the Southwest Windpower H40 Wind Turbine

J. van Dam, H. Link, M. Meadors and J. Bianchi

National Renewable Energy Laboratory

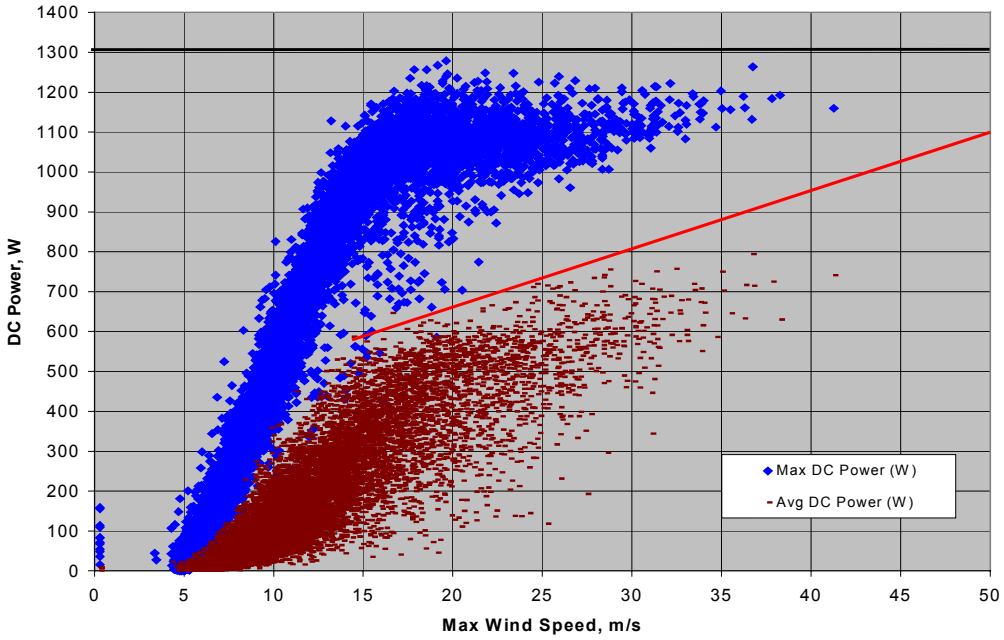
Figure 3. Whisper H40 power response to wind speed.

DC current and voltage were measured throughout the duration test and the data used to determine the maximum observed and the maximum expected power in winds below 50 m/s (112 mph). Maximum DC power is calculated from the maximum 1-sec measurement of DC current multiplied by the maximum, 1-sec measurement of DC voltage for each 10-minute period. There is some error in this method because maximum current and voltage may have occurred at different times during the 10-minute period. However, DC voltage was maintained very closely by the inverter so errors are expected to be low. Figure 3 shows a plot of average and maximum 1-sec DC power versus the maximum 1-sec wind speed. The figure indicates that maximum 1-sec power would be limited to less than 1,300 W in winds less than 50 m/s (112 mph).

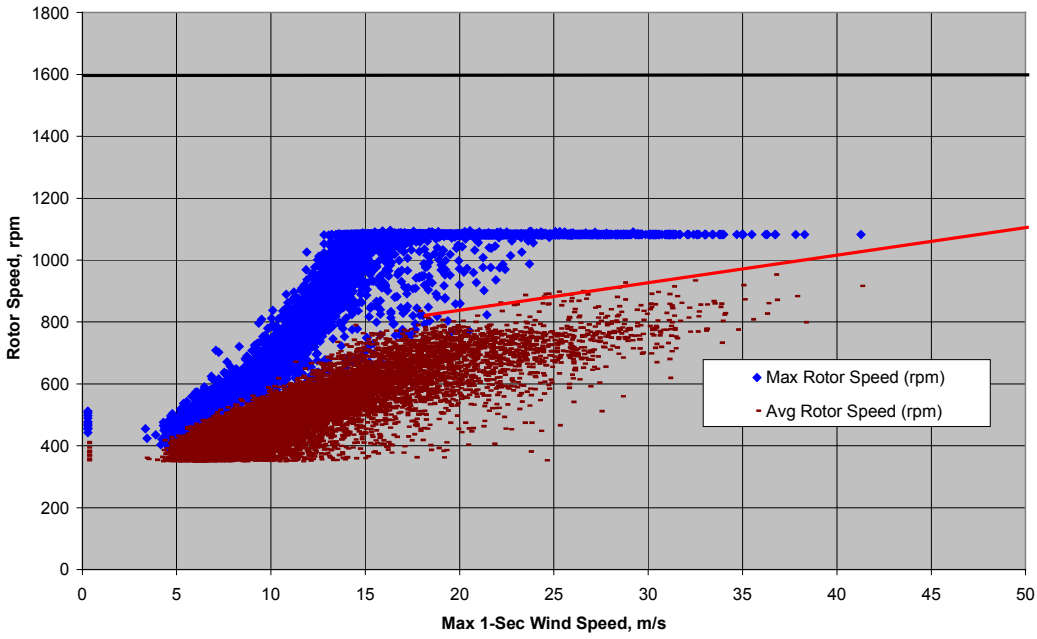
Figure 4. Whisper H40 rotor speed response to wind speed.

Rotor speed was measured throughout the duration test. However, toward the end of the test, NREL noted that a frequency to voltage transducer used in the measurement system was improperly set. This resulted in the rotor speed signal being clipped at 1,100 rpm as shown in Figure 4. Thus it was not possible to directly determine whether rotor speed is properly limited by the furling mechanism. However, rotor speed is well correlated with DC power over the range of operation in which the signal was not distorted, as shown in Figure 5. Using this correlation and extrapolating this to the highest measured instantaneous power level of approximately 1,300 W, NREL estimates that rotor speed does not exceed 1,600 rpm in winds below 50 m/s (112 mph). Because of the uncertainty in the correlation of power and rotor speed outside of the observed range of operation, this estimate may not be conservative.
