Spray Foam Exterior Insulation with Stand-Off Furring

Anastasia Herk, Richard Baker, and
Duncan Prahl
IBACOS, Inc.

March 2014

On behalf of the U.S. Department of Energy's Building America Program

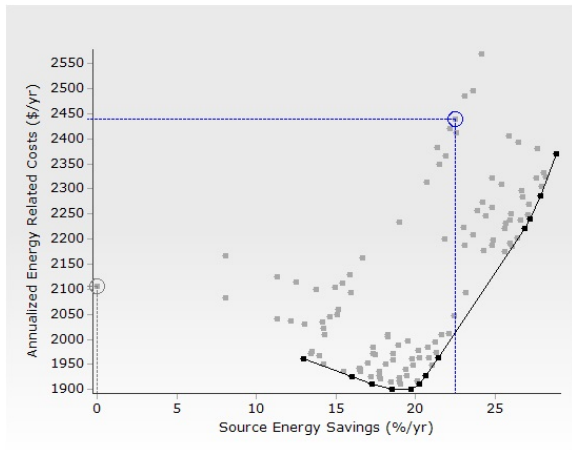
IBACOS used Building Energy Optimization (BEopt™) software Version 2.0.0.4 (BEopt 2013) to model the current conditions of a single-story house located in the area of Syracuse, New York, and an optimization of reasonable retrofit options, including the exterior insulation system with costs as found by the research team. Figure 1 shows the BEopt model with no rebates or financing options, assuming a 7% loan for 5 years to finance the costs. Figure 2 shows BEopt results when the rebates available through NYSERDA (approximately 10% of the cost of qualifying measures, up to \$3,000 and ~4% 15-year loan) were included. Note that the actual house as built included a heat recovery ventilation system that significantly increased costs with little savings. In addition, all of the most cost-effective points do not include ventilation, which is not necessarily a recommended practice when working to aggressively air seal a building. The house had an existing sealed combustion furnace, and a power vent was installed on a relatively new gas tank type water heater. No house combinations achieved more than 20% savings without the inclusion of the exterior insulation system.

Figure 1. BEopt results without rebates and financing

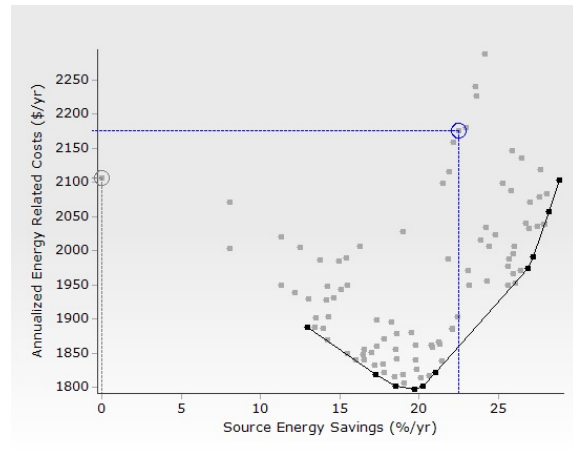
Figure 2. BEopt results with rebates and financing

It is also instructive to look at the impact of rebates and financing of this strategy. BEopt was run with a parametric analysis of financing options and measures, including various interest rates and rebates as shown in Table 1. Figure 3 shows the results of this analysis.

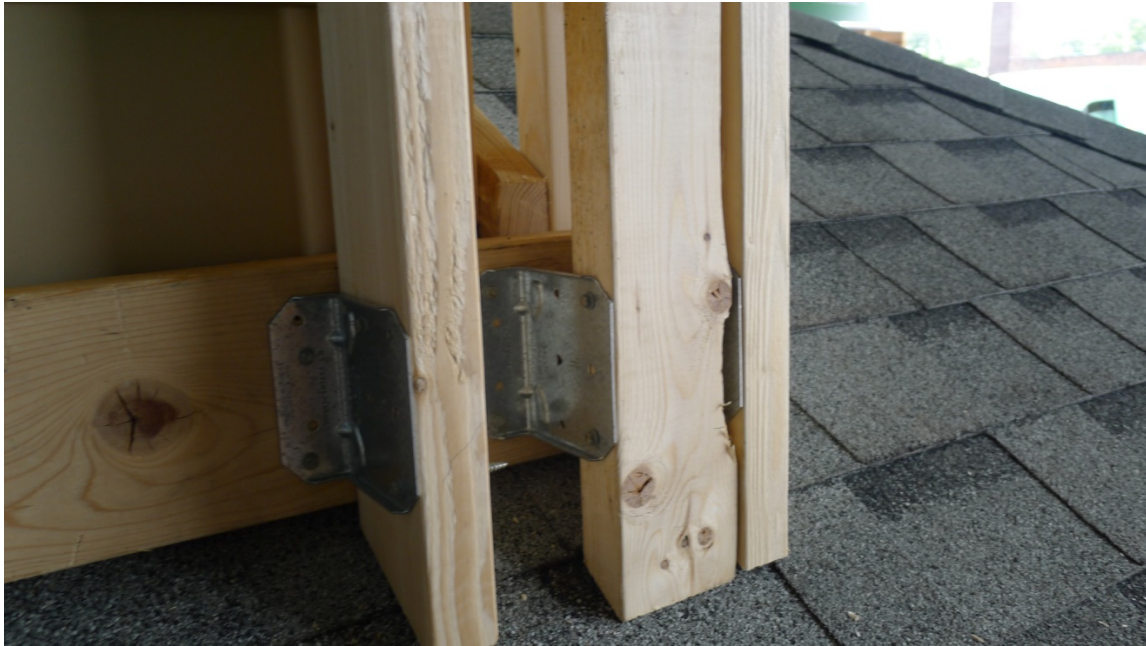
During the detailing phase, IBACOS discussed using a variety of different brackets for the top and bottom of the 2 × 4 that was installed vertically. To satisfy the building official, an engineer’s stamp was needed on the details. For the engineer to stamp the details, technical specifications were needed. Due to the lack of technical information on the structural strength of the adhesion of foam to wood, the clips were needed. The team decided to use a standard “L” bracket product from a national supplier of structural metal clips and hangers. This bracket originally was designed for use on light-commercial, steel-framed curtain wall construction. Figure 7 shows a picture of the Simpson Strong-Tie “L” bracket that was used.

Figure 7. Simpson Strong-Tie “L” bracket

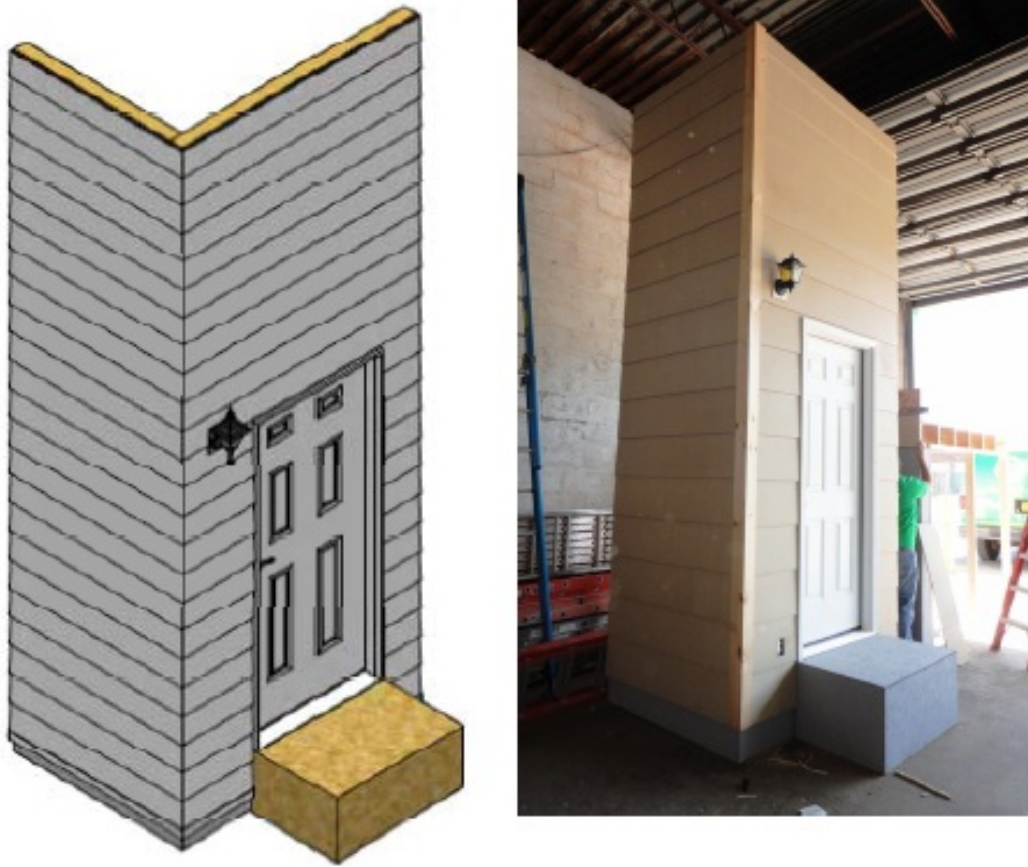
After these full-scale mockups were built, the team was able to troubleshoot specific areas and revise the details before arriving on site at the test house. Figure 9 is representative of the mockup drawings (left) and the corresponding physical mockup (right) built by GHA. Additional mockups are presented in Appendix C.

Figure 9. Detail around exterior door and light fixture

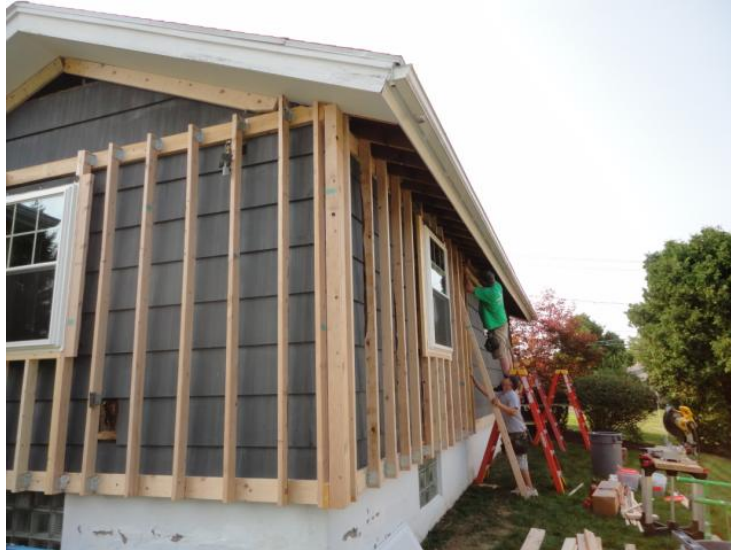
Figure 17 shows the start of framing being installed over the existing siding for the spray foam DER.

Figure 17. Exterior framing

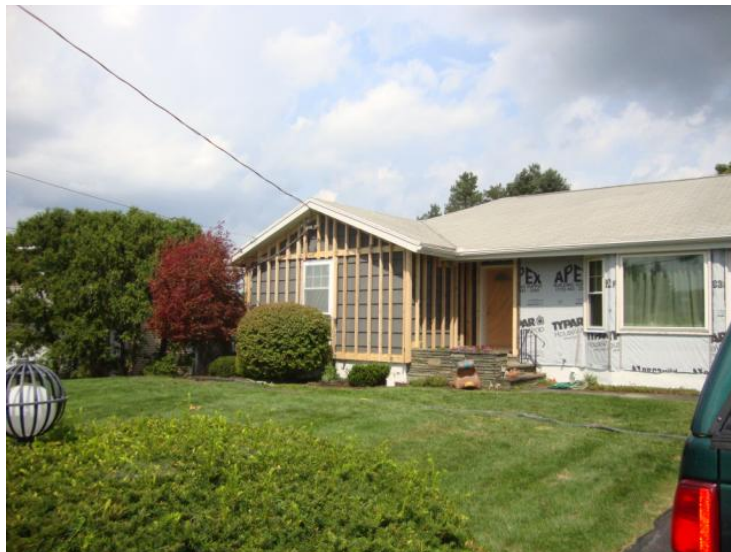
Figure 18 shows the front elevation of the house, with most of the framework installed.

Figure 18. Exterior front framing

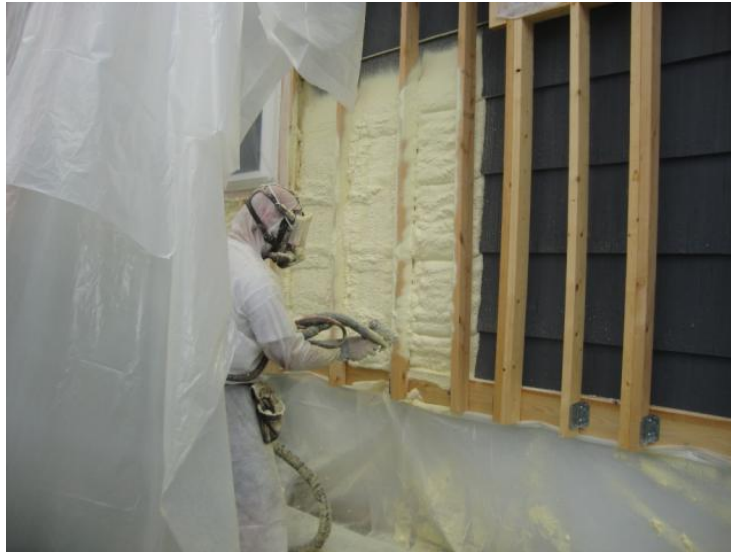
The house then was ready for the application of the spray foam. Figure 19 shows the start of that process.

Figure 19. Installation of spray foam

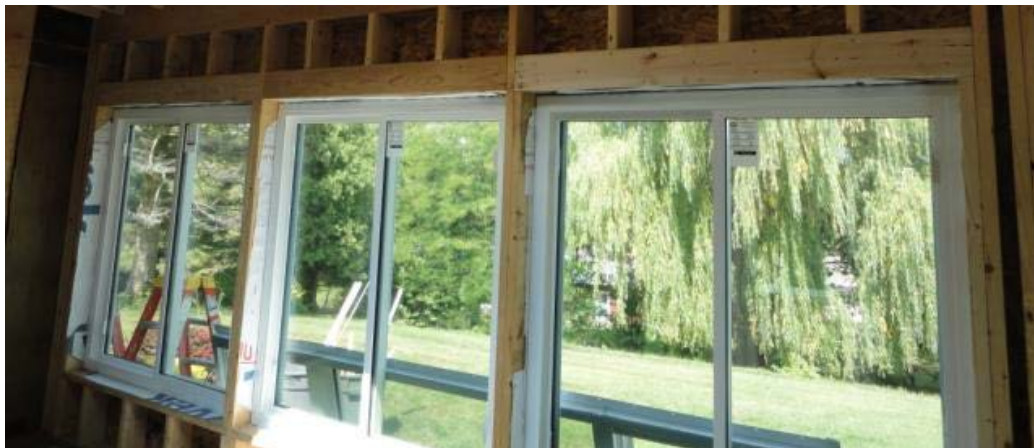
Figure 20 shows the interior unfinished build-out after the new window was installed.

Figure 20. Window detail at built-out box

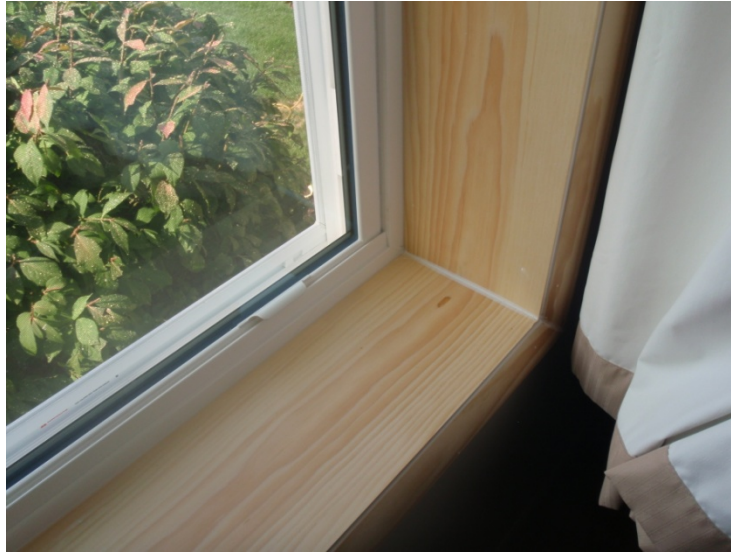
Figure 21 shows the interior finished wall trim after the new window was installed.

Figure 21. Window detail

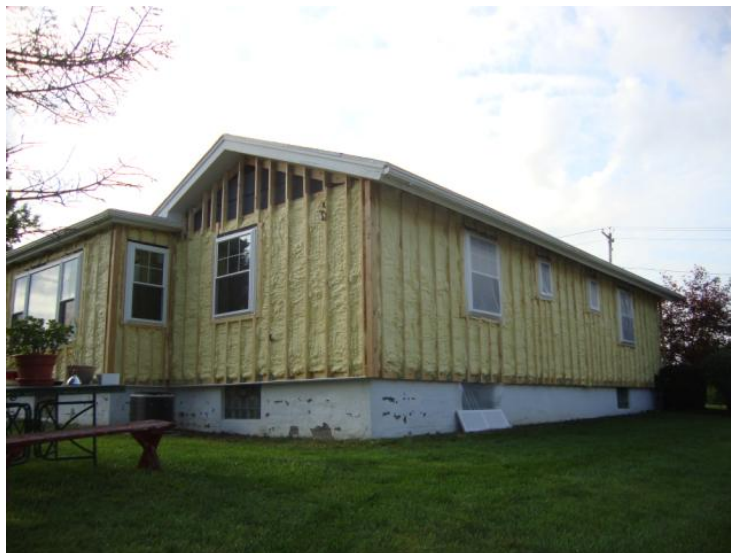
Figure 22 shows the exterior of the test house with the spray foam in place.

Figure 22. Exterior spray overview

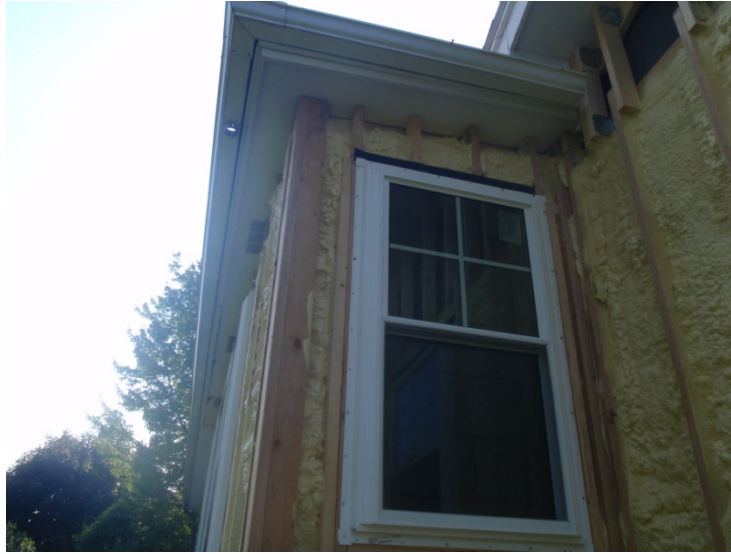
Figure 23 shows the wall system at interior and exterior corners.

Figure 23. DER intersection

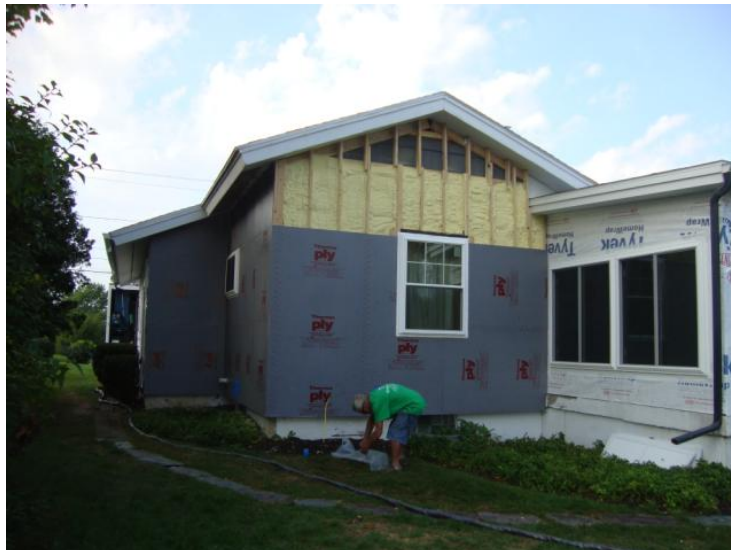
Because this house was to receive new vinyl siding, a sheathing product was needed over the studs, per the vinyl siding manufacturer's recommendation. The team used a thin profile structural sheathing that was extended to the roof line and was installed after the spray foam insulation. Bulk water was handled by the thin profile sheathing, and it was inferred that incidental water past the sheathing would drain over the spray foam. Figure 24 shows the thin profile sheathing being attached.

Figure 24. Exterior thin profile sheathing

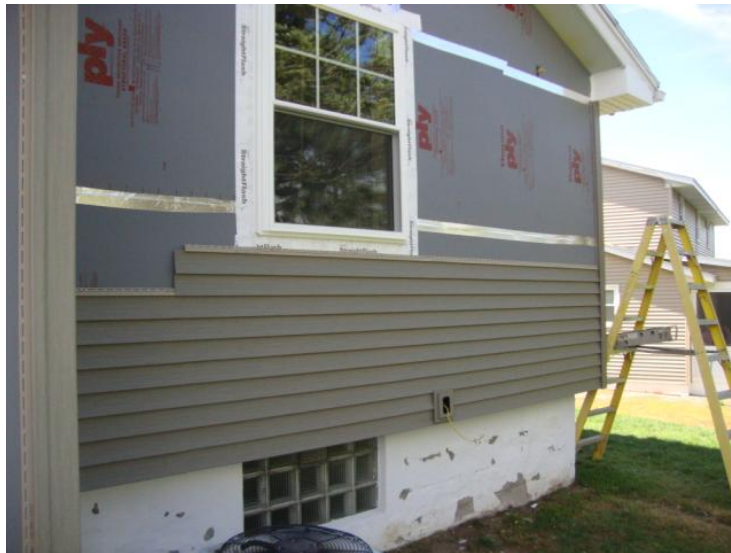
Figure 25 shows the installed thin profile sheathing with the vinyl siding. Note that taping of the windows and seams in the sheathing provides an extra layer of water management in addition to those shown in the step-by-step details described in Appendix A.

Figure 25. Siding Installation

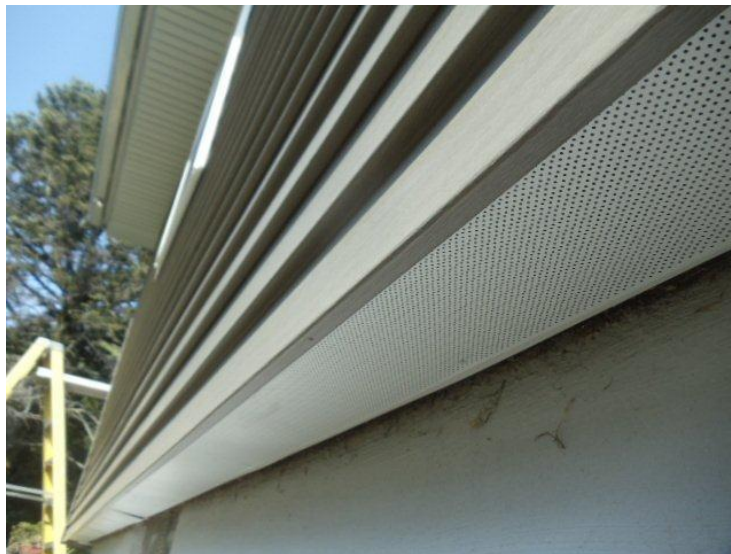
Figure 26 shows the insect screening that was installed at the bottom of the new siding application.

Figure 26. Insect guard and ventilation at the bottom of the wall system

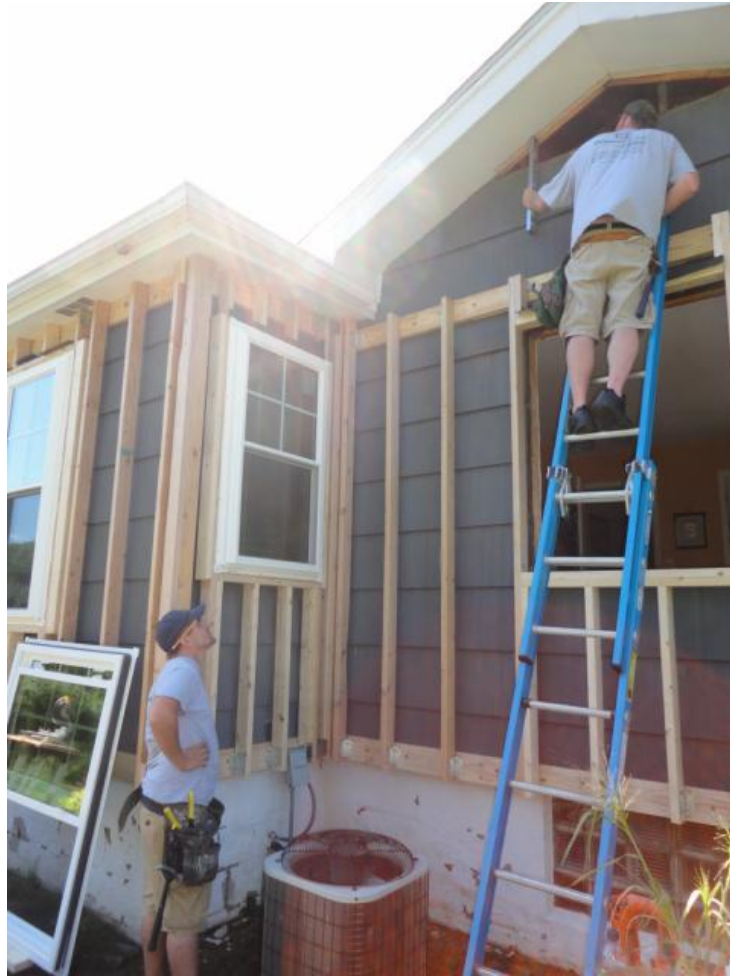
When the ledger boards were installed over existing siding, the inconsistent surface created more layout work. The distance of the ledger boards from the walls varied, depending on where these ledger boards fell. In the case of the test house, the siding was a wide shingle that left significant variation. This led to creating a new wall surface that did not follow the existing wall and rough opening. Figure 28 shows the installers measuring the surface and installing the 2 × 4 boards.

Figure 28. Installation of ledger boards

In the future, this issue could be resolved by planning for the inconsistencies from the beginning and measuring out how far the boards need to be placed from the existing wall, or shimming the ledger to a consistent distance from the existing wall framing.

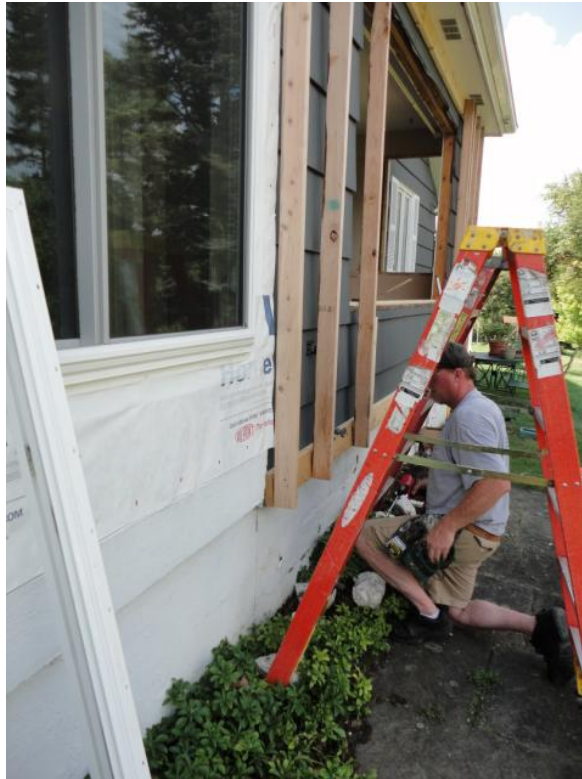
The decision to change the original plan of installing the windows after the exterior wall construction to doing the two installations simultaneously allowed for sections of wall to be completed; however, this change left a gap between the old and new walls that had to be addressed. Instead of a temporary enclosure with tape or oriented strand board to handle foam expansion, it was decided to install the extension jambs along the way as well. This minimized disruptions on the inside as more work was done all at once in a particular area. Figure 30 shows this process.

Figure 30. Window installation

It is recommended that contractors plan for pulling and replacing the windows at the same time as the exterior wall framing is being built.

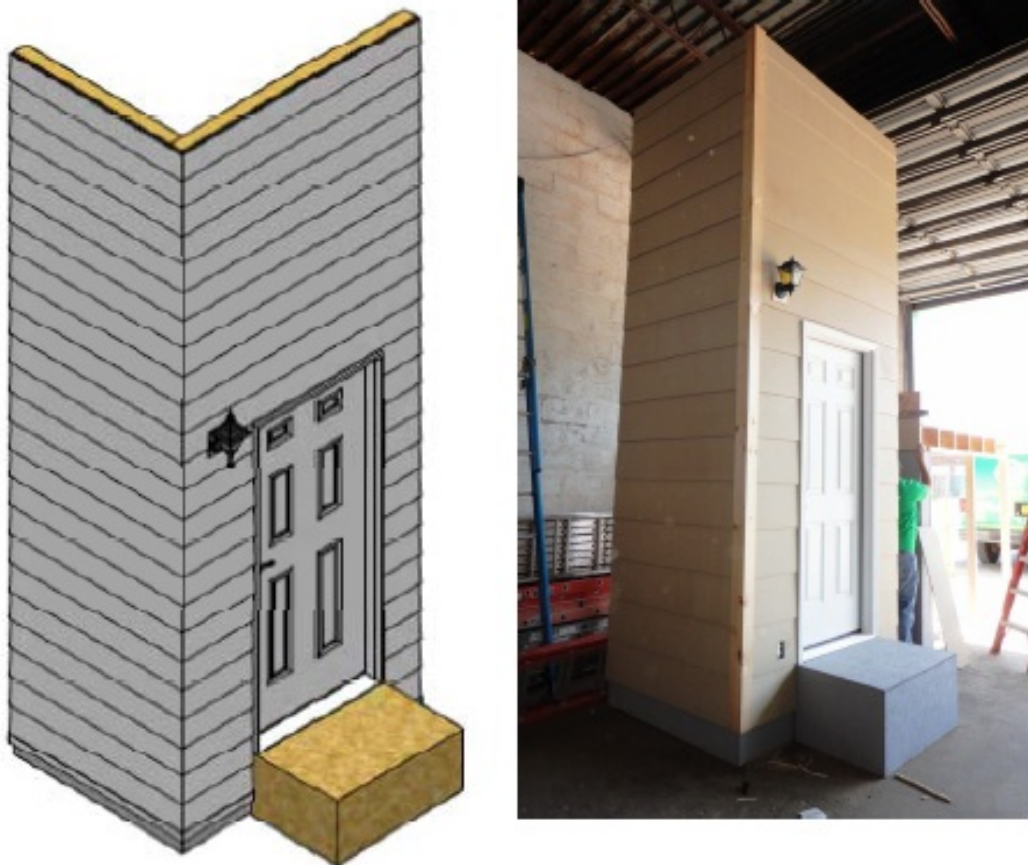
Figure 59. Detail around exterior door and light fixture

Figure 59. Detail around exterior door and light fixture 56

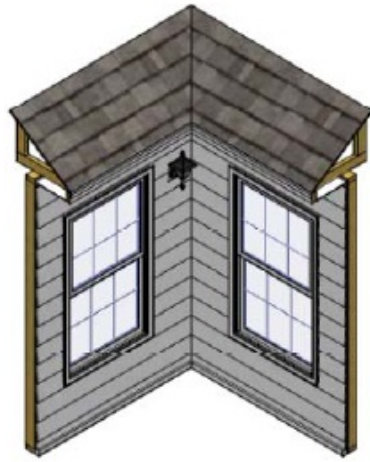
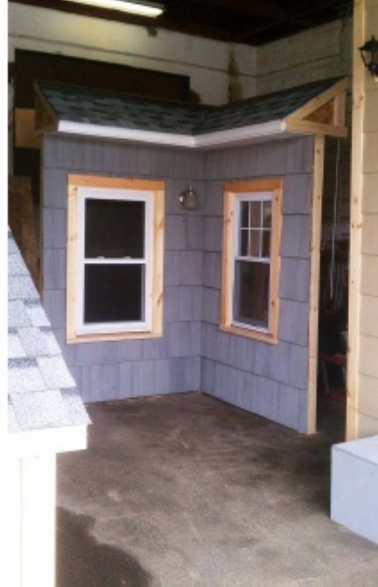
Figure 62. Detail at inverted corner and light fixture

Figure 62. Detail at inverted corner and light fixture 58
