Implementation of a Comprehensive On-Line Closed-Loop Diagnostic System for Roll-to-Roll Amorphous Silicon Solar Cell Production

**Annual Report, Year Two
1 September 2003—31 August 2004**

T. Ellison
*Energy Conversion Devices, Inc.
Troy, Michigan*

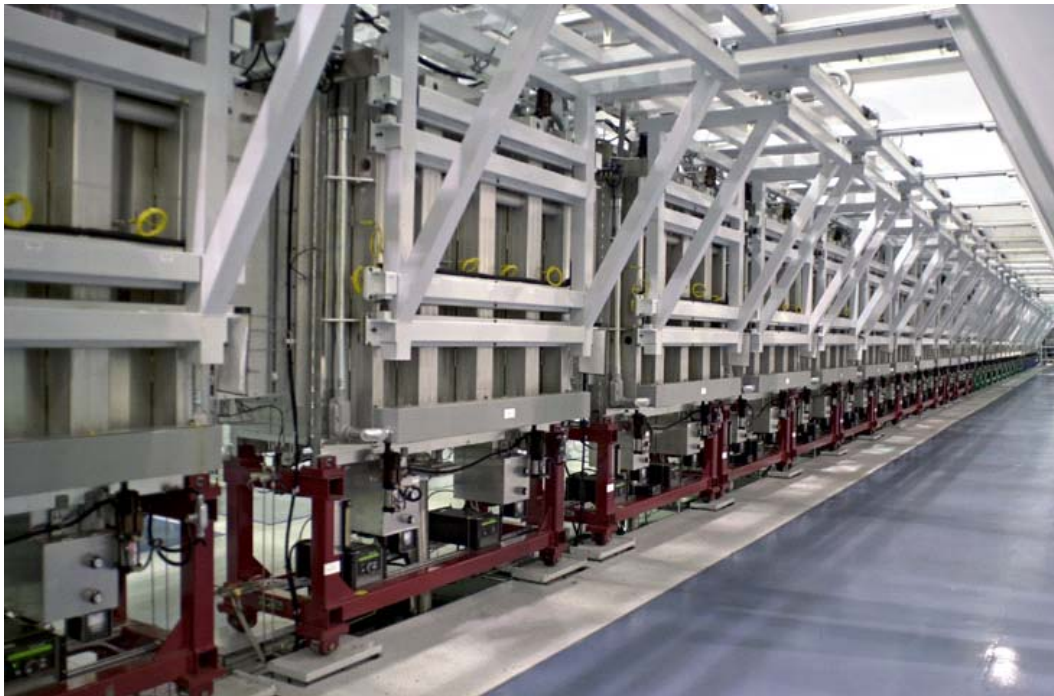
Fig. 2. Side view of the United Solar 30 MW/yr a Si processor.

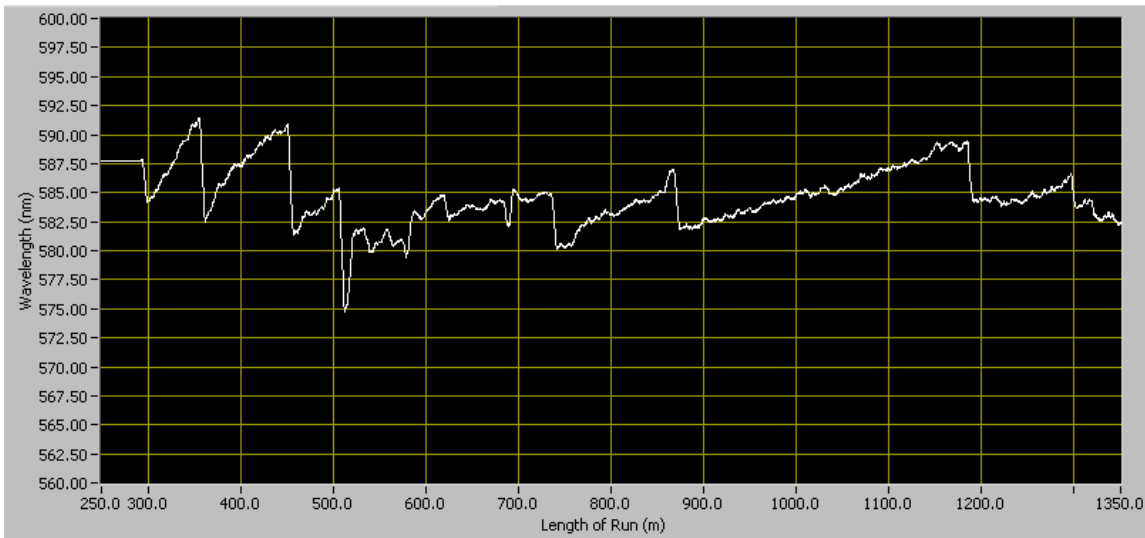
line measurements) to produce uniform deposition. However, while the uniformity remains constant during operation, the overall ZnO thickness varies over time. The change in thickness can be corrected by scaling all six PEMs accordingly. The initial operational mode for the ZnO Machine required the operator to monitor ZnO thickness with the spectrometer and make corrections using the PEMs. Plotted in Fig. 1.1 is the variation in ZnO through such a production run. The saw-tooth pattern is produced as the thickness drifts beyond the established tolerance and the operator makes a corrective PEM change.

Fig. 1.1. Variation in ZnO through a production run prior to closed-loop control operation.

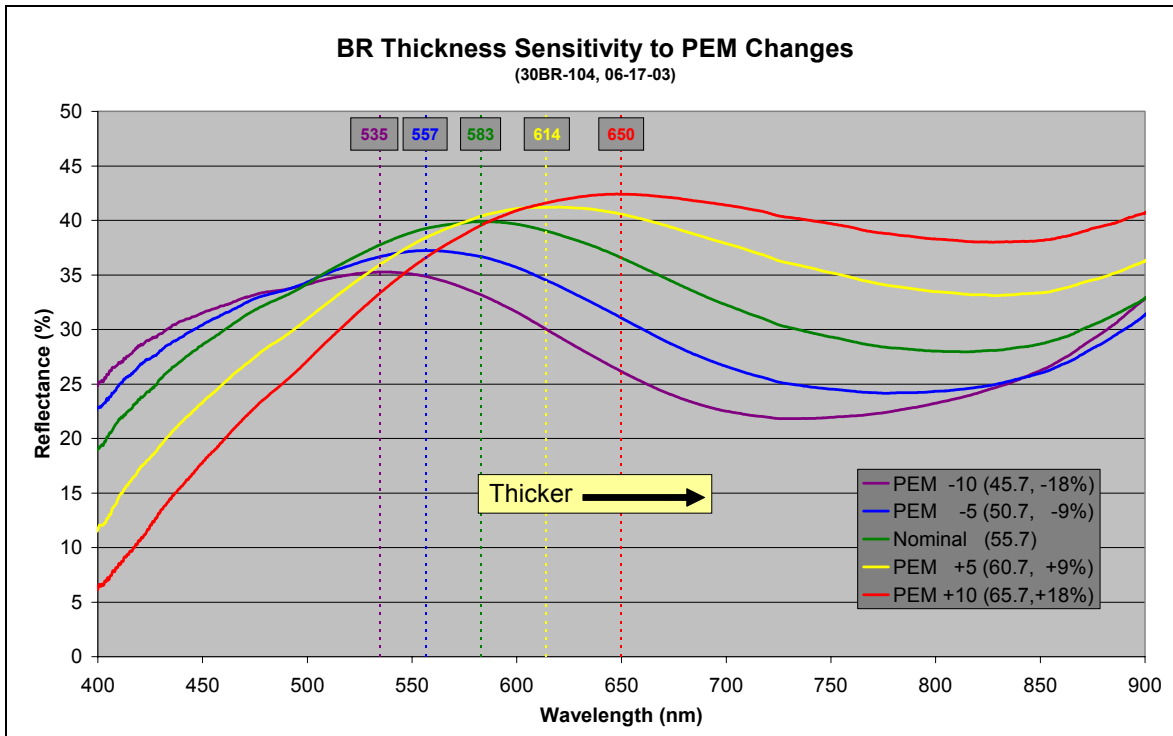
To quantify the change in thickness due to a PEM change, an experiment was performed that stepped the PEM settings to $\pm 9\%$ and $\pm 18\%$ of nominal. The reflection spectra from the spectrometer are plotted in Fig. 1.2 and the resulting shift in the ZnO interference maximum is plotted in Fig. 1.3.

Fig. 1.2. Shift in the reflection spectrum resulting from PEM set-point changes.

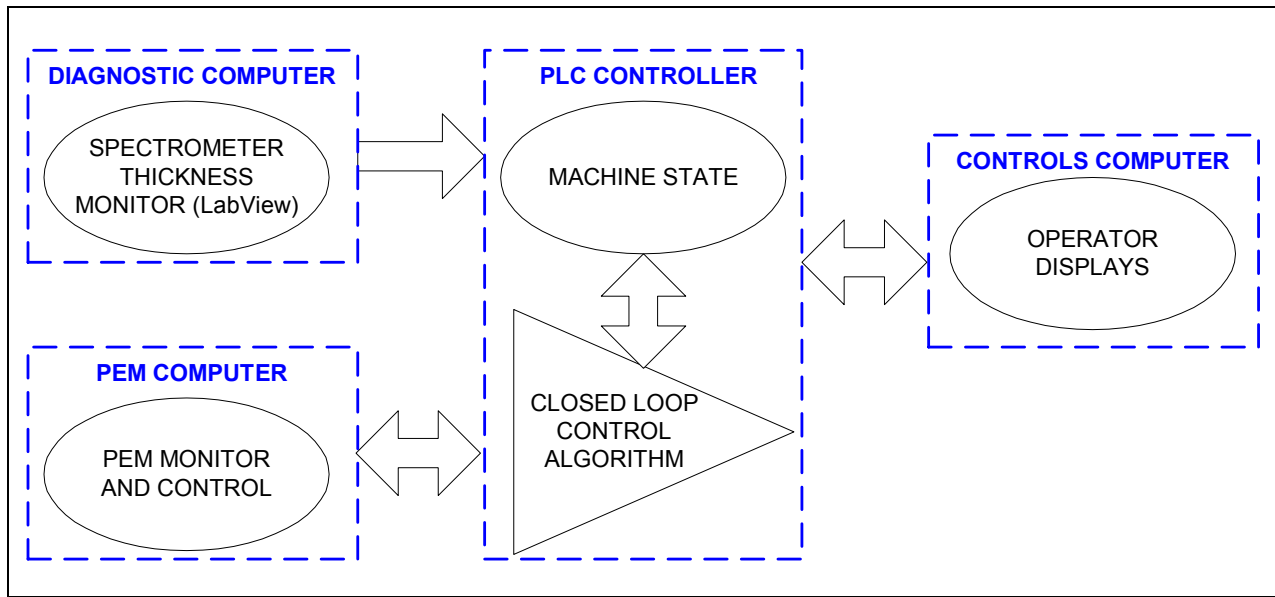
The modular layout of the closed loop software is shown in Fig. 1.4. The feedback algorithm resides on the PLC that runs the ZnO Machine. The algorithm is written in the S7 flowchart language of the Siemens PLC which provides a CPU efficient and robust framework. Communication between the PLC and the Controls Computer, PEM Computer, and Diagnostic Computer is accomplished by a mix of network protocols.

Fig. 1.4. Modular layout of the CLTC software

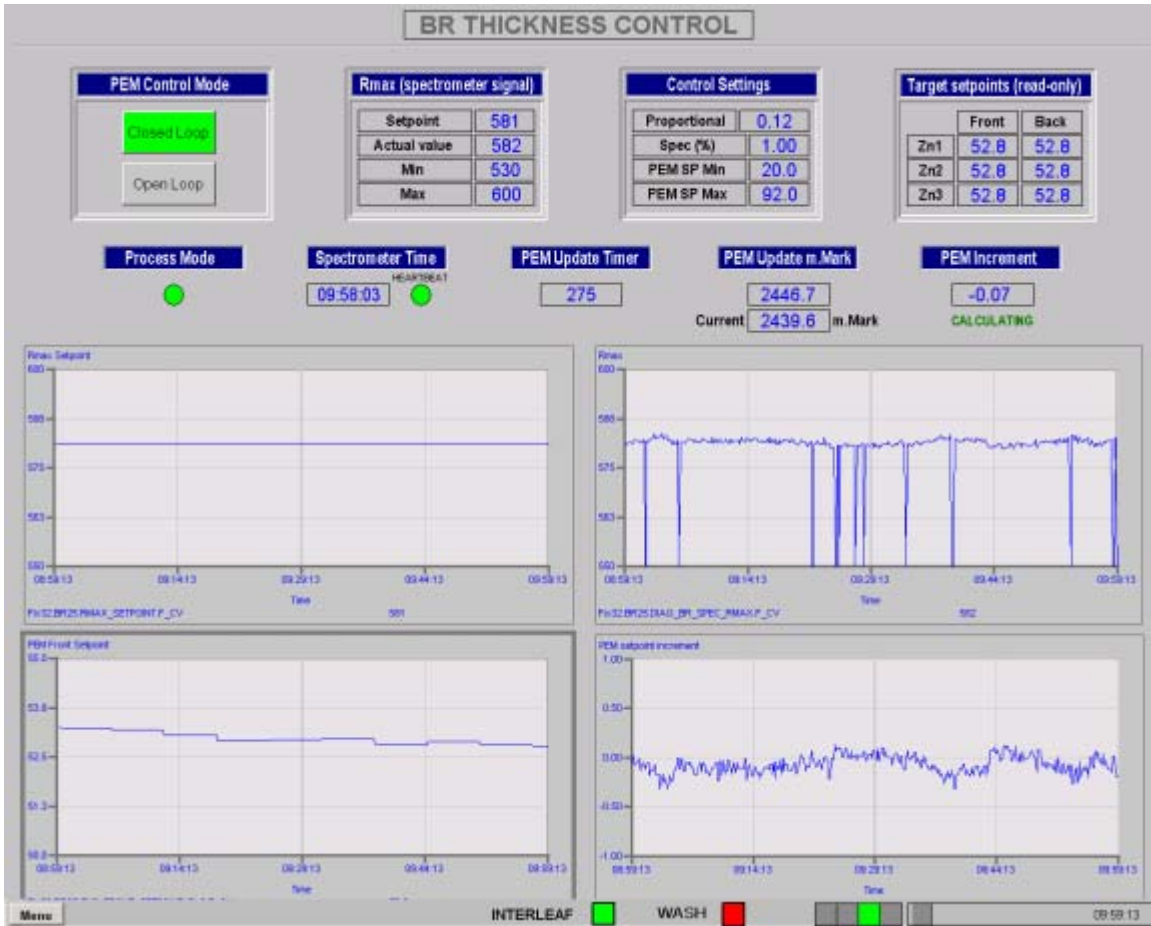
- It is easy to switch between closed-loop and open-loop control modes by just clicking on the button in the PEM Control Modes group. The selected control mode will be turned green for indication purpose.
- The ZnO thickness set-point and measurement values are displayed in the R_{MAX} group. The set-point can be changed but the measurement value is read-only.
- The control settings related to the control algorithm are displayed and adjustable on the interface screen.
- The Process Mode and communication with spectrometer, the two pre-requisite conditions to run the closed-loop control system, are displayed on the screen.
- For the purpose of monitoring the behavior of the CLTC system, historical data for thickness set-point and measurement, PEM set-point as well as PEM set-point increments are plotted.

Fig. 1.5. BR CLTC Interface Screen.

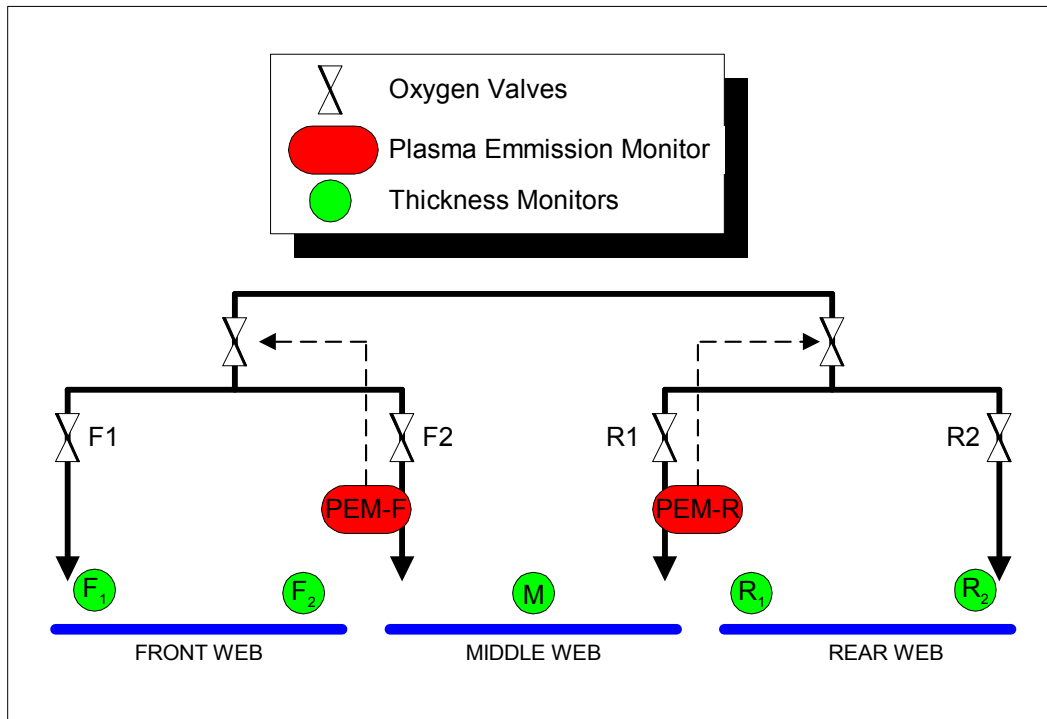
The ITO system is a Multi-Input and Multi-Output (MIMO) system with six inputs and five outputs. The layout of these devices is shown schematically in Fig. 1.7. The five output devices are thickness measuring spectrometers located transversely across the three webs. The six input devices consist of four valves controlling oxygen flow and two plasma emission monitors. The complexity of the system is driven by determining the coupling amongst the input and output variables of the MIMO system.

Fig. 1.7. Schematic layout of the ITO CLTC inputs and outputs

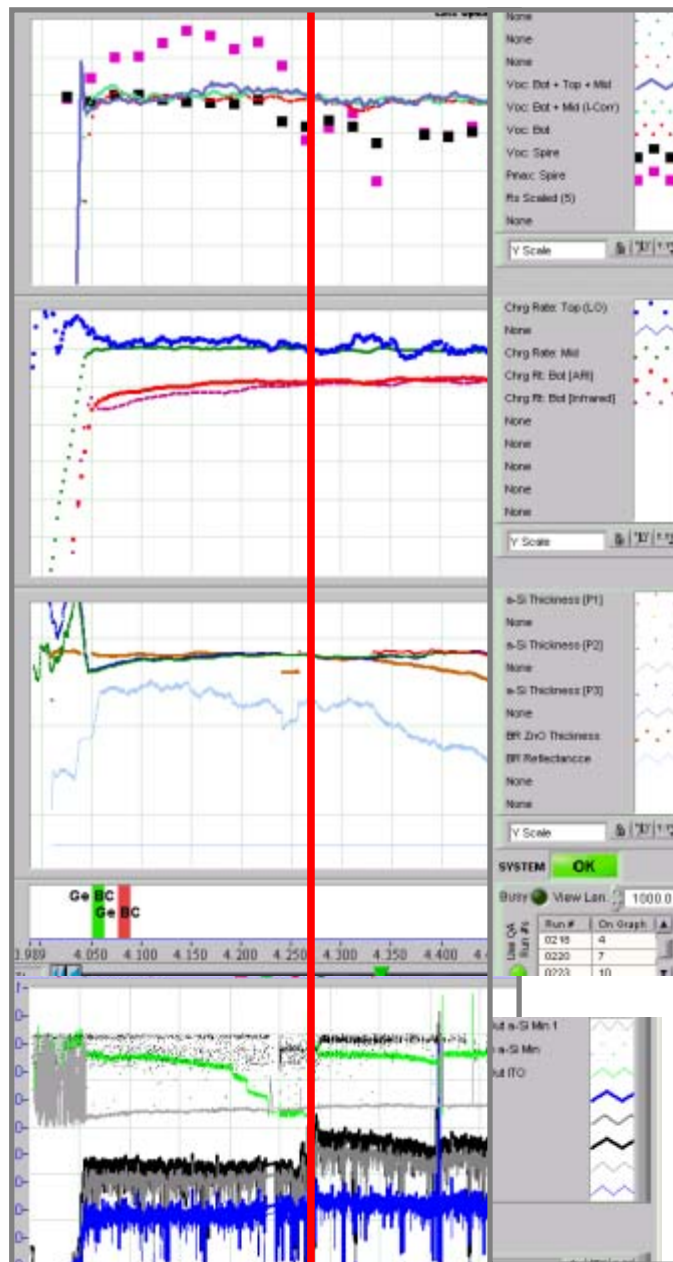
Fig. 1.9. Online data from a-Si and ITO machines along with offline QA/QC data.

- The precision of the systems matches or exceeds the precision of offline measurements;
- They bandwidth of the systems exceeds the bandwidth of offline measurement systems by more than an order of magnitude;
- As shown in Fig. 1.9, there are discrepancies between online (PVCD) measurements and offline measurements of up to a few percent, or an order of magnitude above the online PVCD stability and accuracy, caused by downstream processing (e.g. ITO deposition conditions).

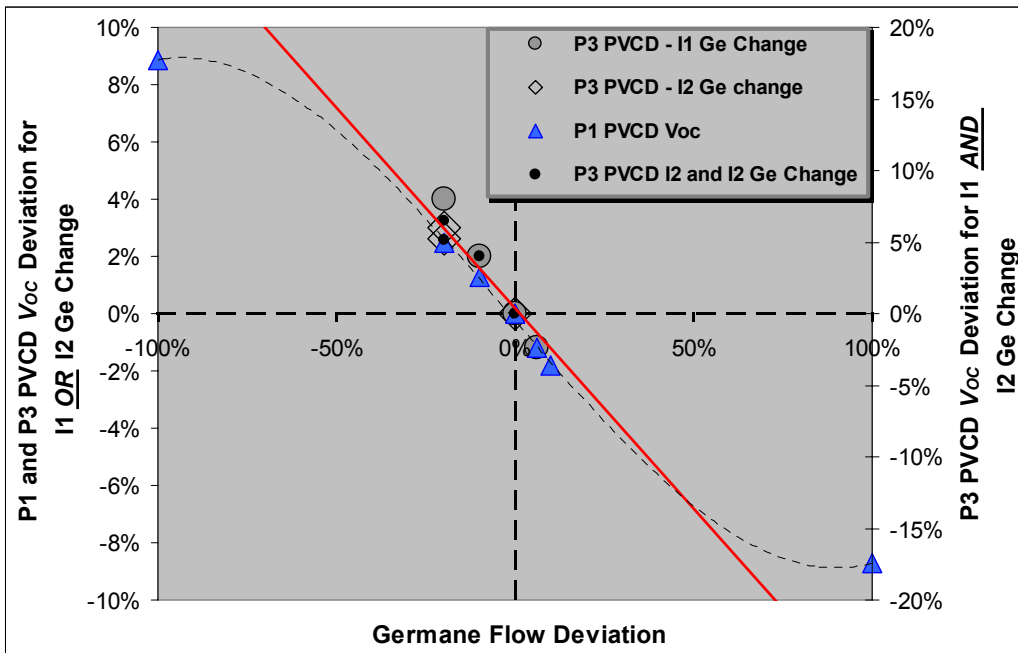
Fig. 2.4. Data from experiments with changes in germane gas flow. Four sets of measurements are displayed: the P1 PVCD can measure changes in the bottom cell V_{OC} ; since the changes pass through the P3 PVCD serially, it can measure changes in the bottom, middle, and bottom + middle layer; this latter change is plotted on the right-hand scale.

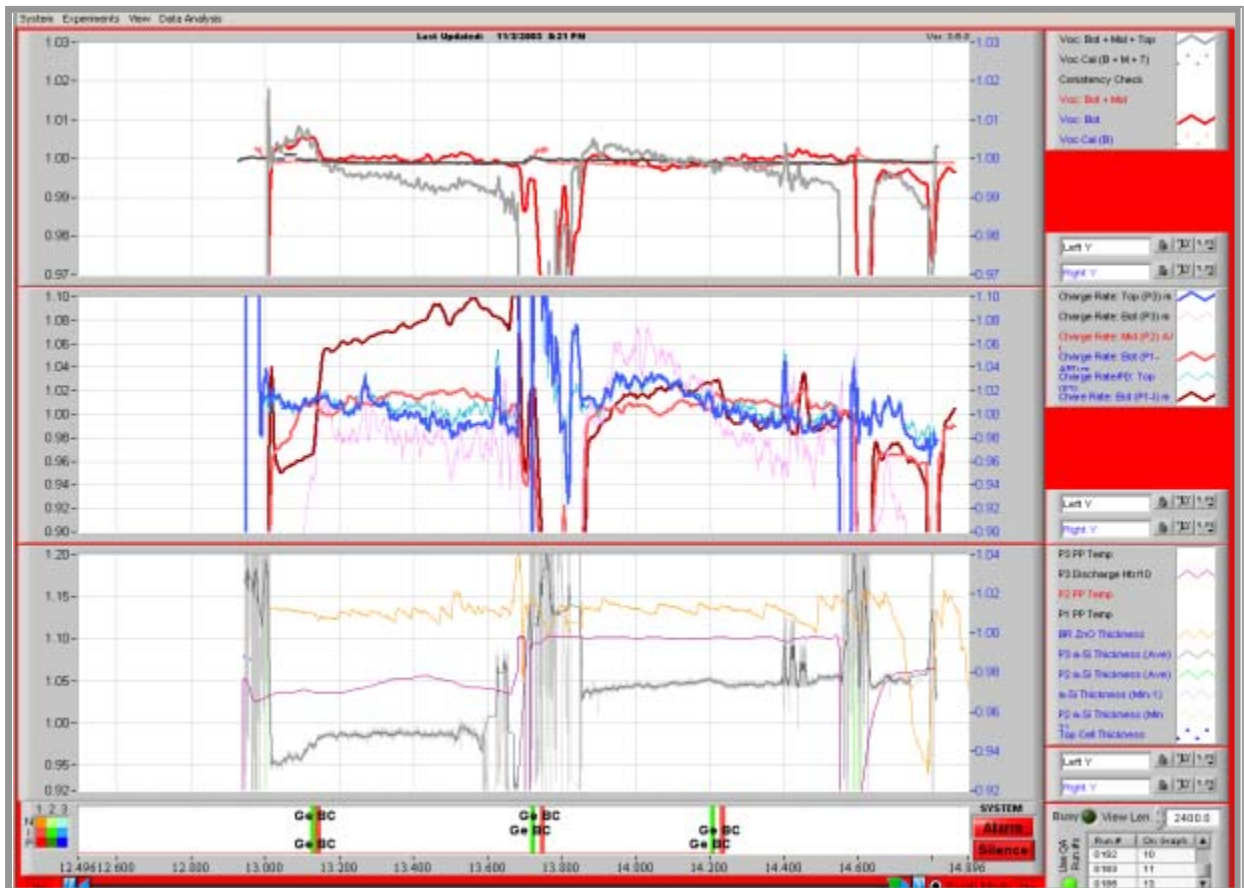
- The bottom plot shows online spectrometer thickness measurements, 2%/div, $\pm 6\%$ full scale. **Gold**: ZnO thickness; **Grey**: total cell thickness – towards the right hand side one observes one of the one-minute burns providing us with deposition rate measurements for each cathode.

In this display we see 3 germane bottle changes. In the first bottle change the germane concentration was increased by about 3%. The sub-percentage decreases in the device V_{OC} can be easily observed in the upper plot. Even clearer, however, is the 9% increase in the new bottom cell infrared charging rate signal.

Fig. 2.5. Online DDD showing three germane bottle changes. See text for explanation.

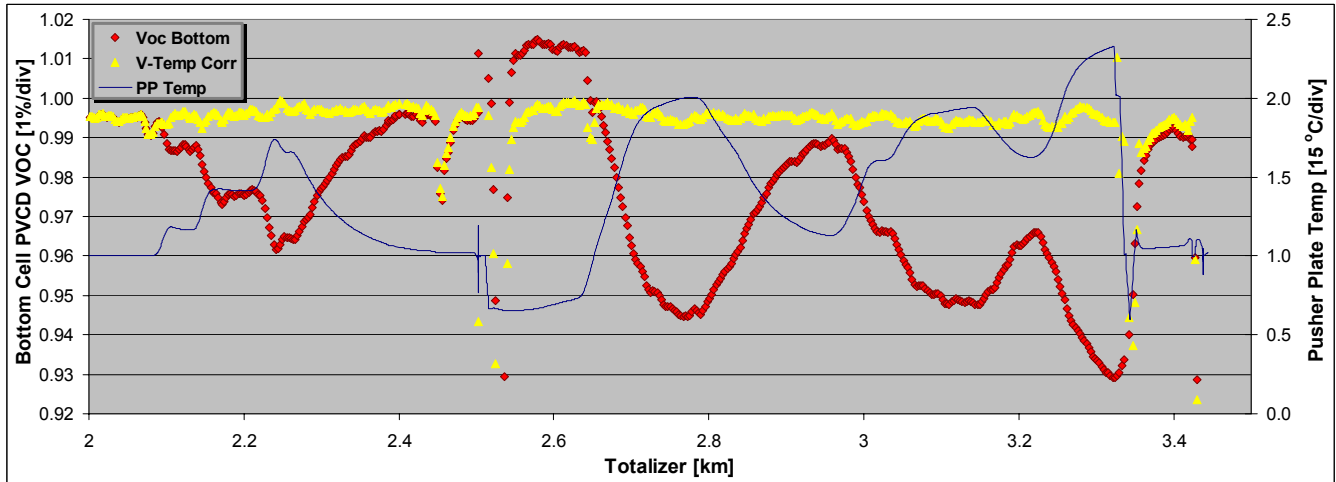
Fig. 2.12. Bottom Component Cell PVCD V_{OC} measurement vs. pusher plate temperature: raw data, and data corrected with the pusher plate temperature and temperature derivative.

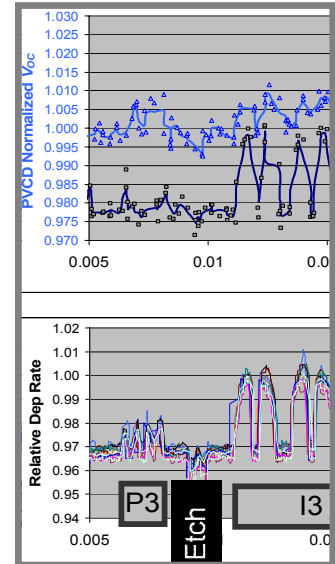
Fig. 2.13. Top: online PVCD V_{OC} [light blue] and charging rate [dark blue] signals vs. change in deposition thickness [bottom plot].

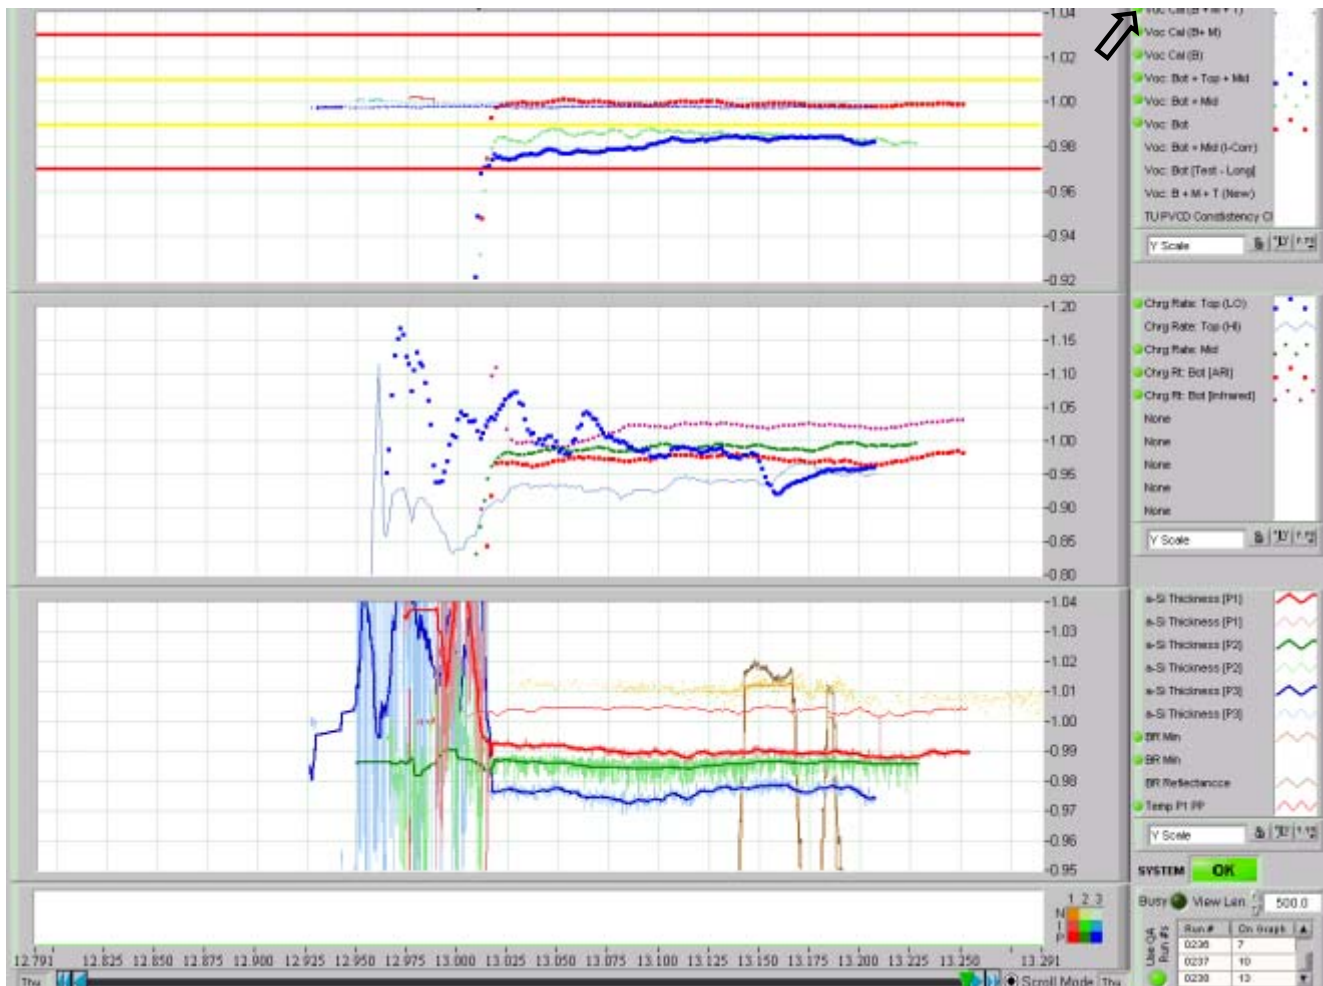
Fig. 2.15. New “Alarm DDD” display. The system is operating in the mode.

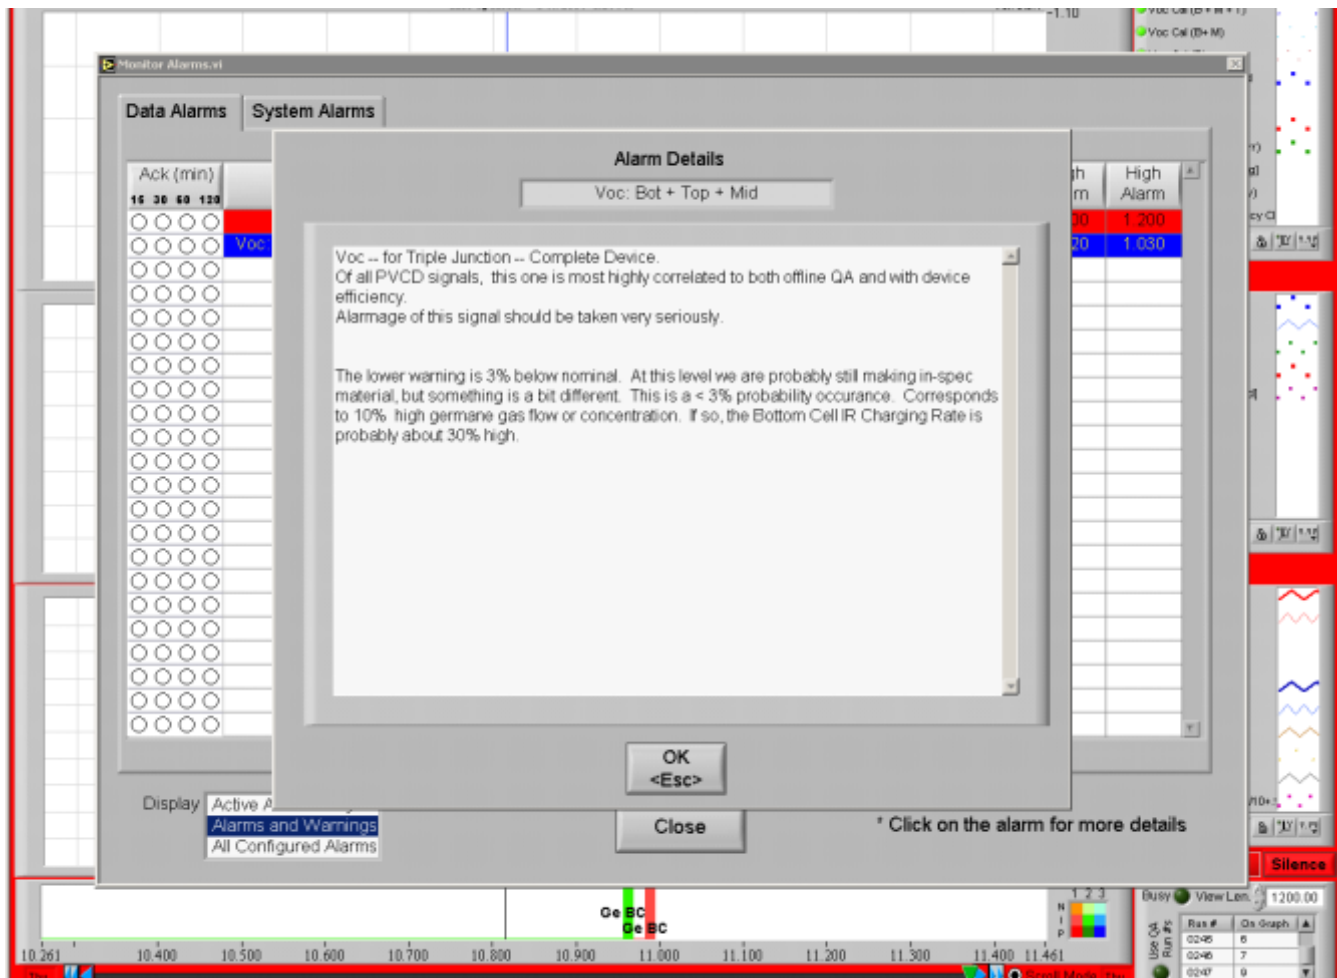
Fig. 2.16. Example of a warning explanation associated with a system warning.

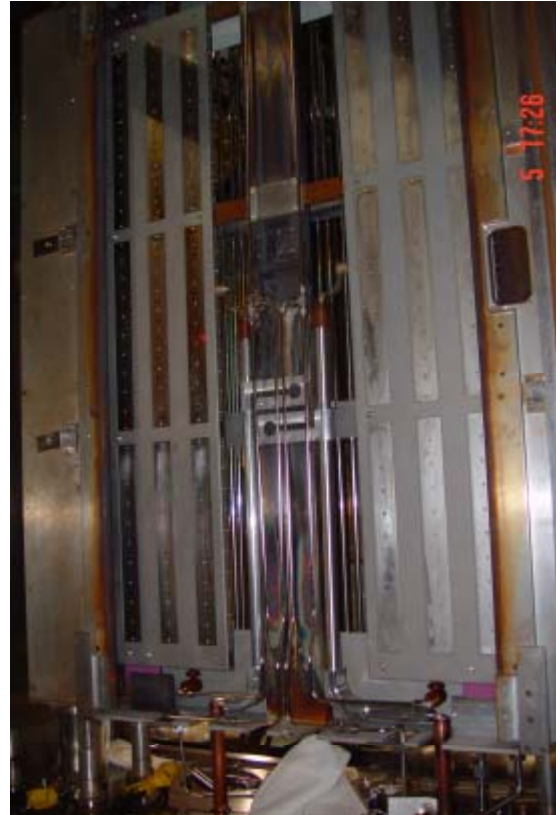
Fig. 3.1. Photograph of the test chamber showing the newly-installed p-type cathodes and gas lines.

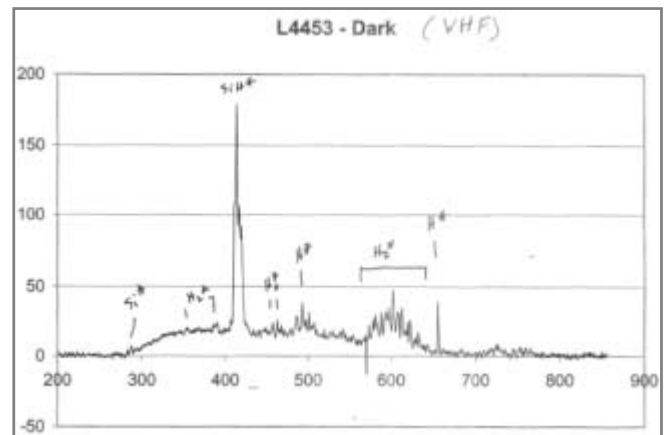
Fig. 3.7. Emission spectrum from a VHF plasma.

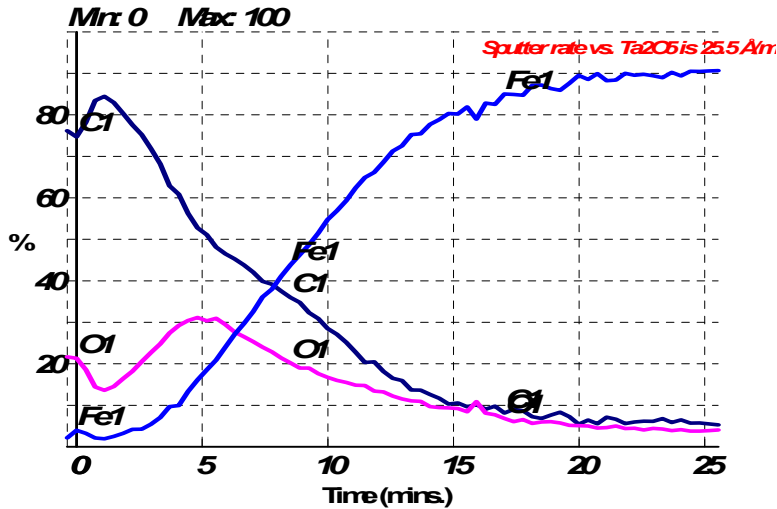
Fig. 4.2. Profile of oil contaminant before sputter cleaning.

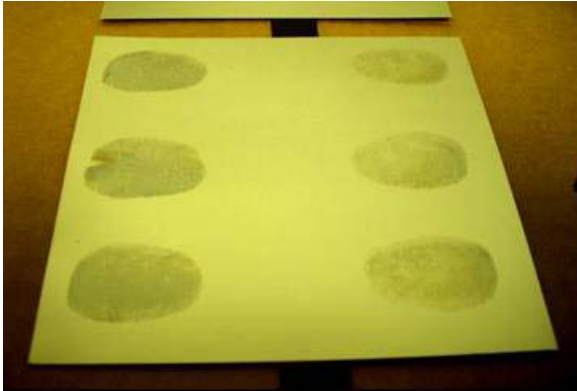
Fig. 4.5 – Ar plasma, 5 seconds

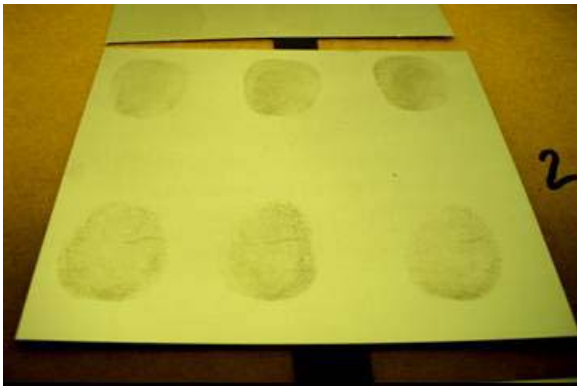
Fig. 4.6 – Ar plasma, 15 seconds

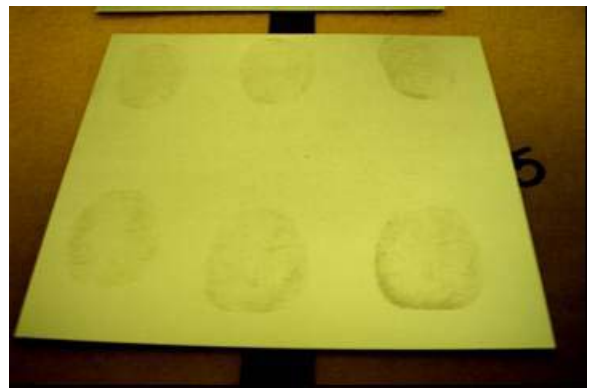
Fig. 4.9 – Ar+O₂ plasma, 15 seconds

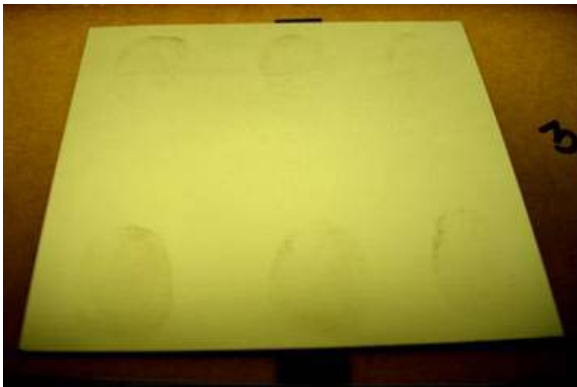
Fig. 4.7 – Ar plasma, 30 seconds

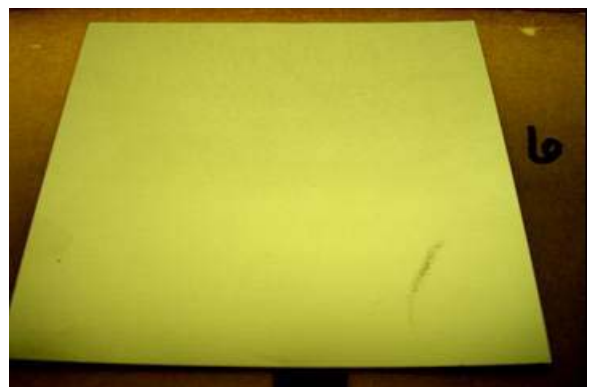
Fig. 4.10 – Ar+O₂ plasma, 30 second

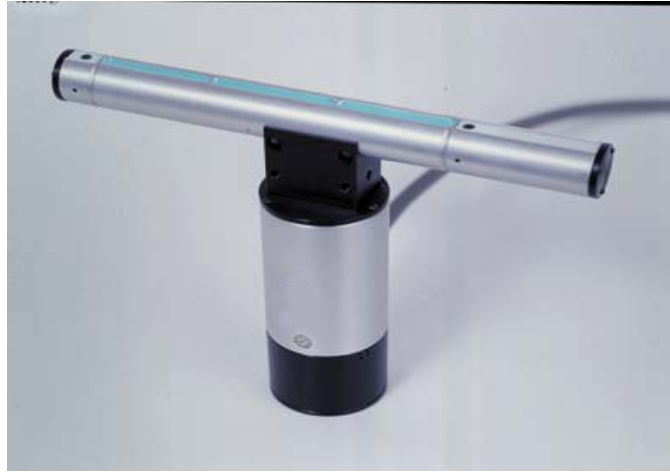
Fig. 4.11. The PET 6-in wide OSEE sensor head used in the Pay-Off and Take-Up chambers of the 30 MW Washing Machine.

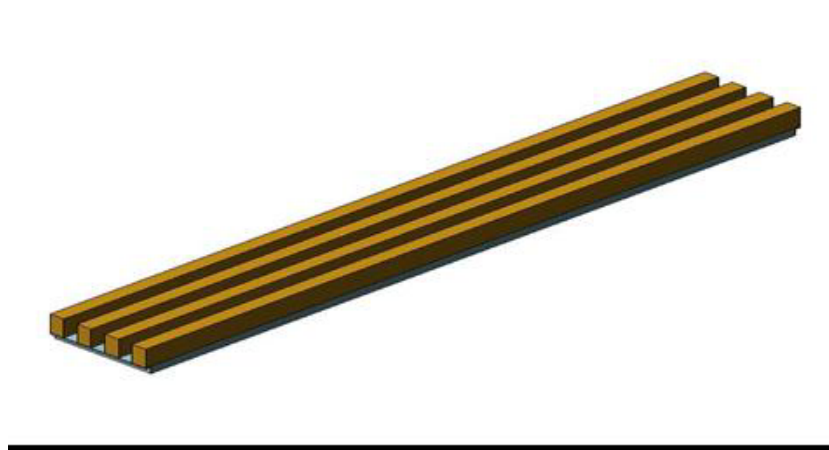
Fig. 4.16. Ribbed anode assembly

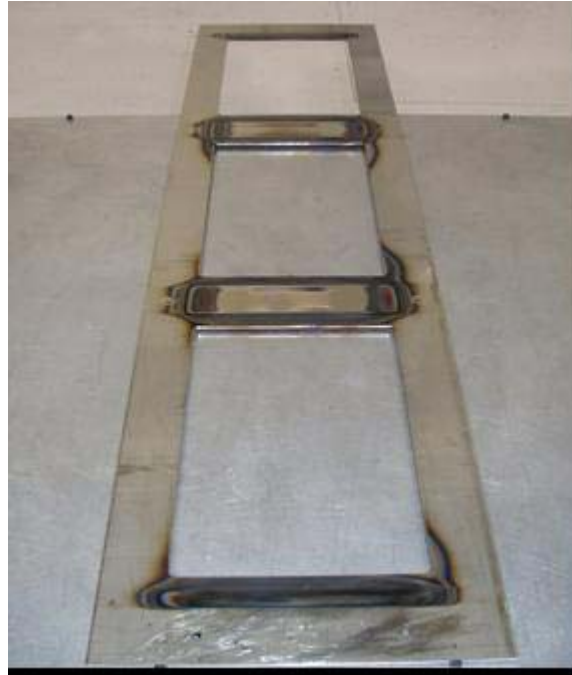
Fig. 4.17. Inner surface of the confining mask

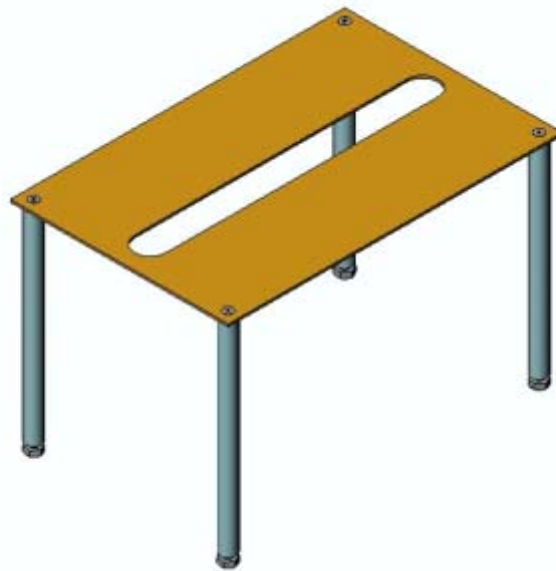
Fig. 4.20. OSEE sensor sample table.
