Test-to-Failure of Crystalline Silicon Modules

Peter Hacke, Kent Terwilliger, Steven Glick,
David Trudell, Nick Bosco, Steve Johnston,
and Sarah Kurtz

National Renewable Energy Laboratory

Conference Paper
NREL/CP-5200-47755
October 2010

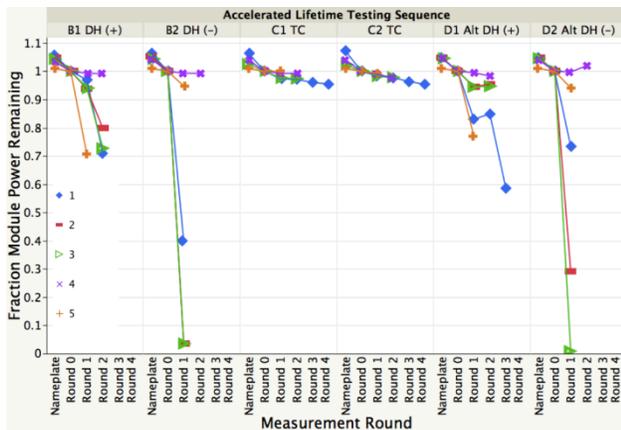
Figure 1. Table of results. Fraction module power remaining vs. measurement round by accelerated lifetime testing sequence. Module models 1-5 are indicated in the legend.

The normalized module maximum power results are given in Fig. 1. With the exception of one design (module 5), module nameplate ratings were found to be consistently higher than the power that we measured. Module model 1 completed four rounds; models 2, 3, and 4 completed two rounds; and model 5 completed one round of the protocol at this writing.

The modules subjected to the TC sequence can be seen to degrade slightly with each TC 200 cycle round (Fig. 1). Model 1 retains about 95.5% of the initial power after 800 cycles with an approximately linear degradation rate. The other module designs appear to be tracing this rate as well or performing slightly better. In some cases, crack growth in the cells was observed (Fig. 2). Considering this, the crystalline silicon modules under test are exhibiting good resilience to thermomechanical fatigue.

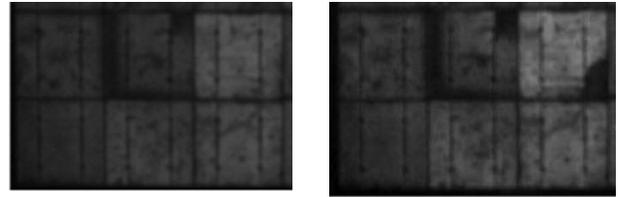
Figure 2. Development of a crack in a cell in thermal cycling imaged by electroluminescence in model 1 at the upper right cell. Left, initial; and right, after 200 cycles. This stress sequence has not caused significant power loss.

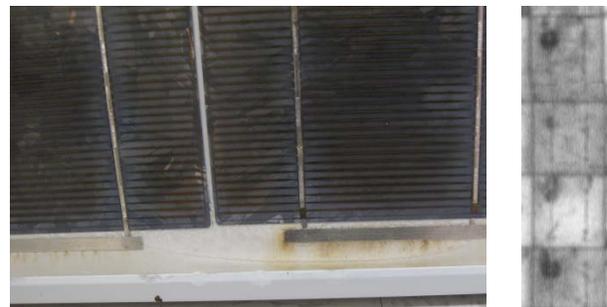
Figure 3. Left, image of a module after 2000 hrs. in damp heat with + 600 V applied to the active layer with respect to the grounded module frame. There is evidence of grid finger and aluminum frame corrosion, metal ionic transport from the bus strap, and occasional delamination. Right, electroluminescence image of a four-cell region of this module, indicating darkening and degradation at positions around the rear bondpads.

An image taken for failure analysis of model 1 stressed in DH(+) configuration after 2000 h is shown in Fig. 3. The following is observed:

- Silver grid finger corrosion
- Silicon nitride thinning, relatively uniformly
- Ionic transport from bus-straps to module edge
- Formation of bubbles in encapsulant
- Rear contact metallization degradation
- Corrosion of the aluminum frame
- Backsheet cracked (after 2000 h)
- Reduced electroluminescence efficiency around cell edges (significant after 2000 h)

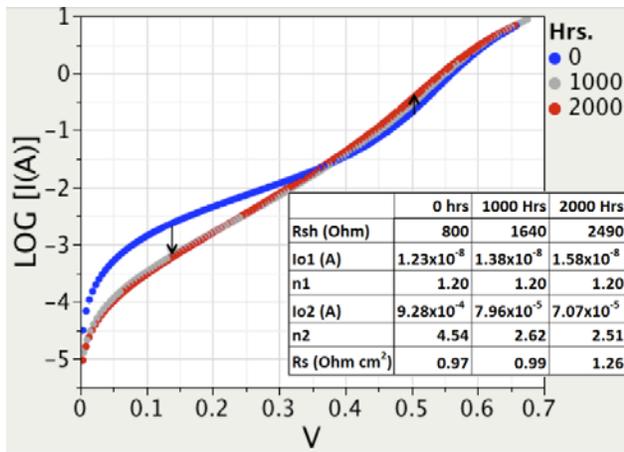
Figure 4. Dark I-V curves normalized with respect to the number of cells in the module, for module model 1 undergoing damp heat with +600 V bias measured initially, and after two rounds of 1000 h of stress testing. Results of the two-diode model fitting parameters are shown in the inset, including saturation currents (I_d), ideality factors, and series (R_s) and shunt resistance (R_{sh}). R_{sh} and the parameters associated with junction quality (I_{d2} , n_2) improve with stressing, but R_s increases. The arrows indicate motion of the two regions of the curves over the stress intervals.

Dark I-V curves were obtained for the modules over the course of stress tests. Curve fitting of the results using a two-diode model is shown for model 1 in the DH (+) configuration (Fig. 4). Interestingly, the 2nd diode properties that were estimated, including the shunt resistance (R_{sh}), the second diode saturation current I_{o2} and the ideality factor n_2 improve with the DH(+) stress. These improvements suggest a reduction in the leakage paths and carrier recombination across the p-n junction of the device because the second diode represents the junction properties [17]. Series resistance (R_s) degrades in each successive round. The R_s increase is likely associated in part with the observed metallization corrosion. Around 0.5 V, the measured saturation current increases with the increase in the first diode saturation current I_{o1} , which would affect the maximum power point. The reduction in short-circuit current measured in the LIV tests is associated with the degradation in the AR coating and is most responsible for the power loss in model 1 (Fig. 5). For other models, loss of fill factor due to series resistance associated with metallization degradation was the greater contributor to power loss under DH(+) stress.

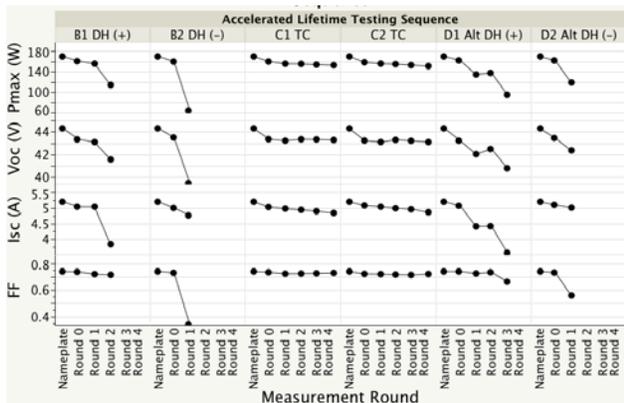
Figure 5. Maximum power, open-circuit voltage, short-circuit current and fill factor for the six modules of model 1 in each round undergoing the TTF protocol.

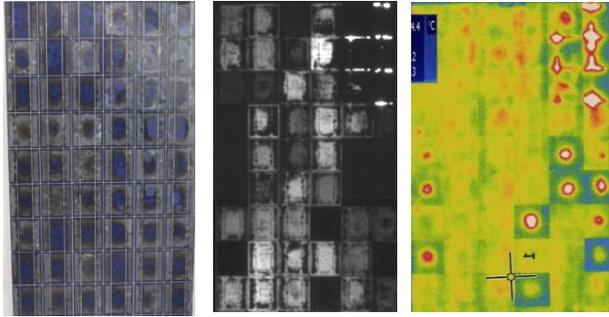
Figure 6. Model 1 after round 1 of DH(-) stress; left, optical image indicating silicon nitride degradation; middle, electroluminescence; and right, thermal imaging indicating severe shunting often in cell centers (white).

Depending on the extent of water ingress, the silicon nitride coating is degraded, but in a more localized manner than in the DH(+) modules (Fig. 6). The silicon nitride is least degraded in the middle of the cell, presumably because it is more difficult for the water reactant to diffuse there, unless delamination has occurred, in which case the silicon nitride is more extensively degraded. As with modules stressed in the DH(+) configuration, the silicon nitride degradation appears to be accelerated electrolytically.

electroluminescence imaging indicate shunting with patterns that depend on the module design. Model 1, which uses glass with AR coating, exhibits localized hot spots in many cases, with those cells having significantly reduced electroluminescence, as is characteristic of shunted cells. The shunting was also confirmed by characterizing the cells by shading them individually in light I-V tests [18]. Modules without AR-coated glass that we tested exhibited greater and more uniform shunting in the DH(-) stress test.

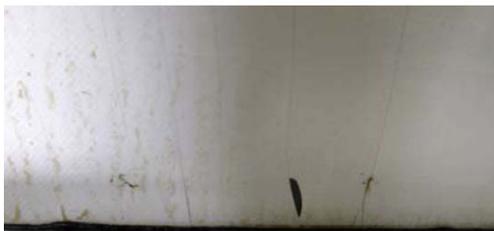
Figure 7. Hydrolytically degraded, embrittled, and cracked backsheet of model 1 after round 3 of the alternating DH+/TC sequence.

In this test sequence, modules were cycled through damp heat with bias followed by TC, and then returned to the start of the cycle. Based on the tests carried out to date, we have not found that module power is significantly reduced after round 2, the thermal cycling round. After the third round in DH(+), the polyester (PET) backsheet in model 1 is hydrolytically degraded, embrittled, and cracked, leading to failure of both the wet insulation resistance test and a power loss >20% (Fig. 7). While such failure modes occurred after 2000 h in the DH(+) sequence discussed above, there were more cracks in the backsheet and greater power degradation after 3 rounds in the alternating sequence for this model. Other models
