Gearbox Reliability Collaborative Project Report: Findings from Phase 1 and Phase 2 Testing

Technical Report
NREL/TP-5000-51885
June 2011

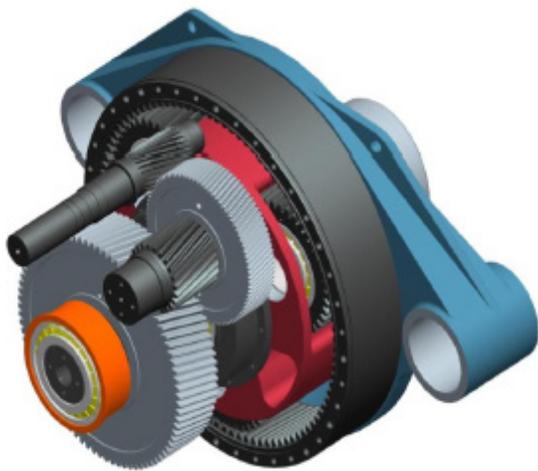
Figure 2. The GRC gearbox has a low-speed planetary stage and two parallel stages.

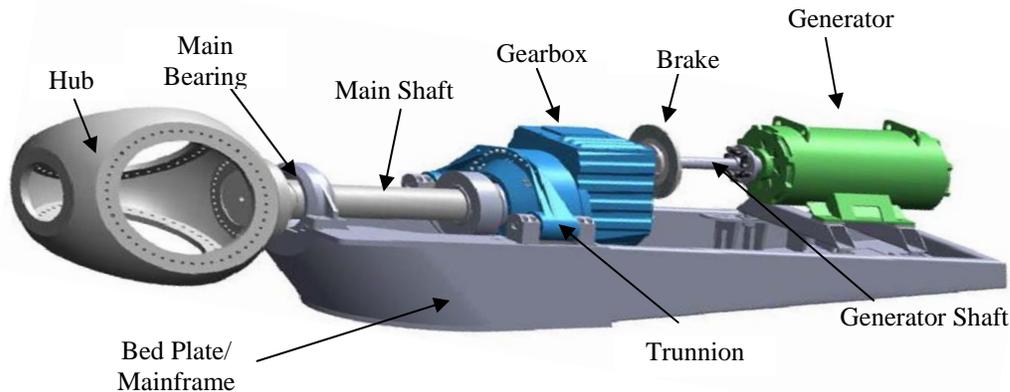
Figure 3. The GRC three-point suspension drivetrain, typical in wind industry

The selected gearbox is from a 3-point suspension drivetrain, which is a typical configuration for MW class turbines. The main shaft is supported by the main bearing, and two elastomeric trunnions at the torque arms, as shown in Figure 3.

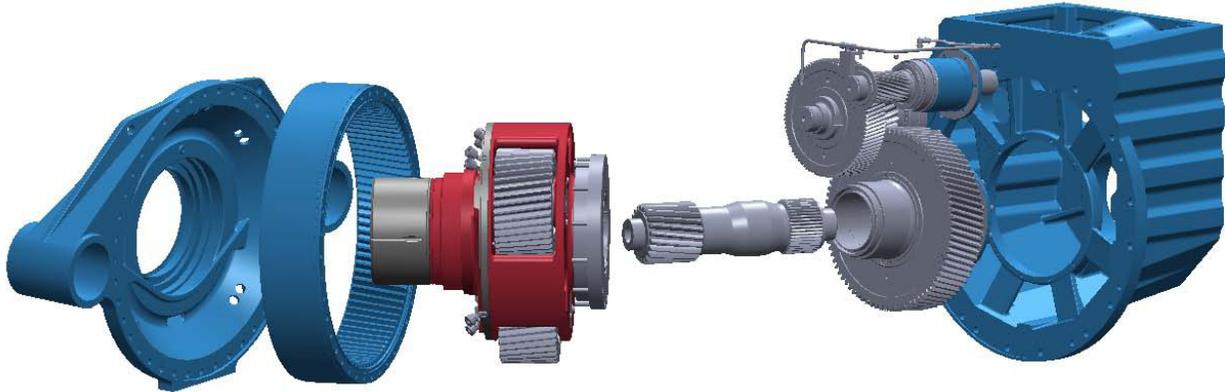
Figure 4. Exploded view of the GRC gearbox

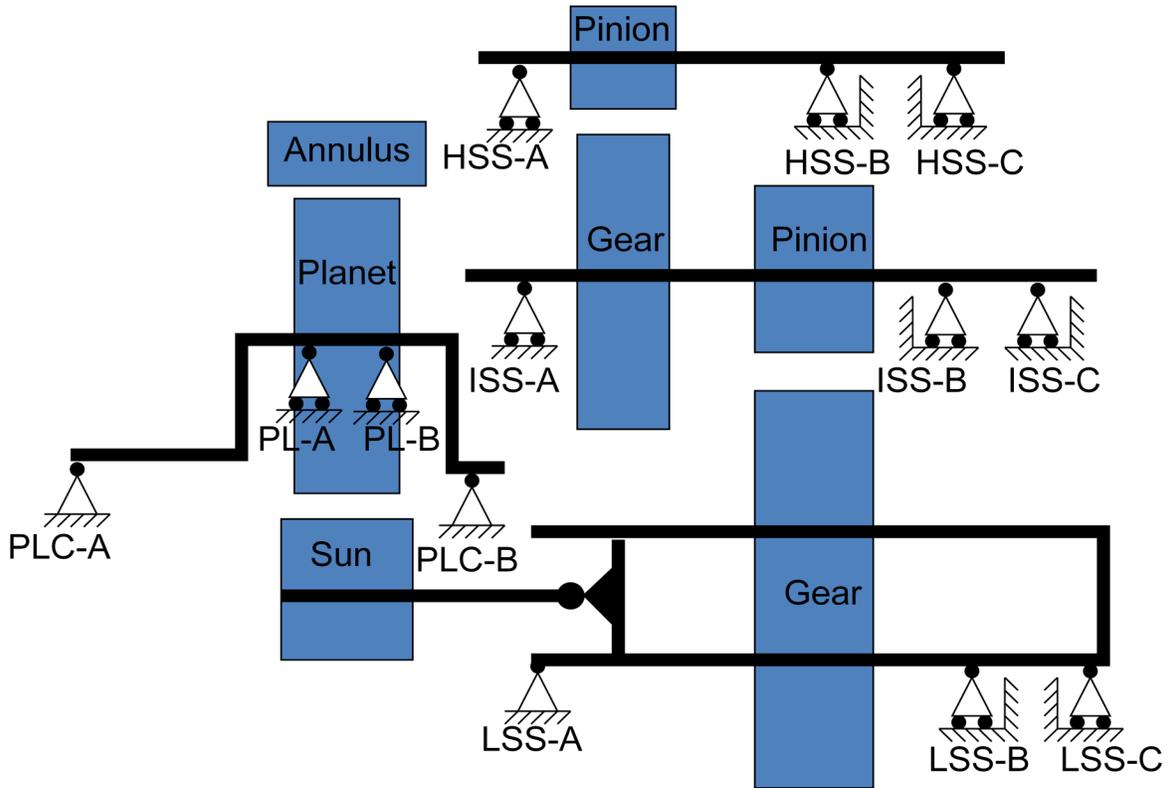
Figure 5. GRC gearbox layout and bearing nomenclature.

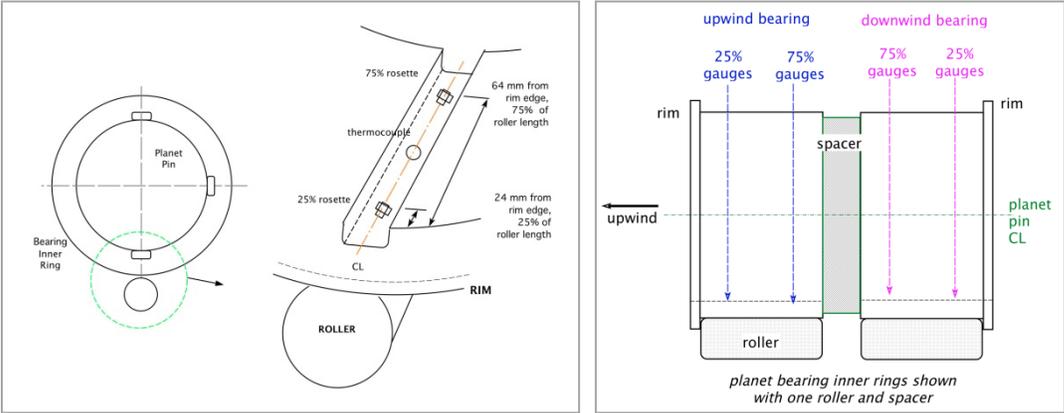
Figure 6. Gauges in machined slots in planet-bearing inner rings

For the planet bearings, strain gauges were applied to three axial slots machined into the inner diameter of the inner ring of all six planet CRB bearings as shown on the left graphic in Figure 6. The slots were located at different locations in the bearing load zone for each planet, but they all had slots 90° from the sun-planet axis (referred to here as top dead center or TDC). Two gauge sets in each slot and two bearings on each planet provided an axial distribution of radial loads along each planet pin (right graphic in Figure 6). These gauges were calibrated to loads applied to the fully assembled planet pins and bearing pairs in a bench top test setup

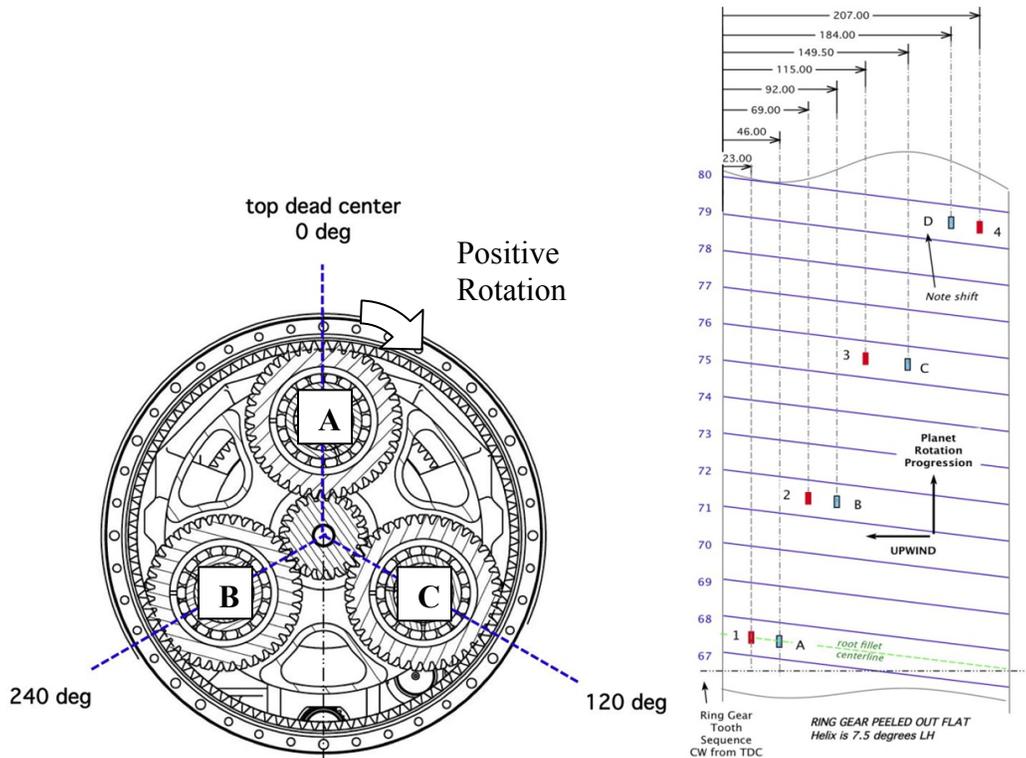
Figure 7. Ring gear load distribution measurement setup and planet labels.

Ring gear load distribution was measured using a cascade of strain gauges placed in the tooth roots at eight axial locations (oriented circumferentially), as shown in Figure 7. Three tooth load distributions at 0°, 120°, and 240° were measured for each rotation of the low-speed shaft from a total of 24 strain gauges. The planets were labeled A, B, and C in counterclockwise fashion with Planet A at TDC when the main shaft azimuth angle equaled 0 degrees.

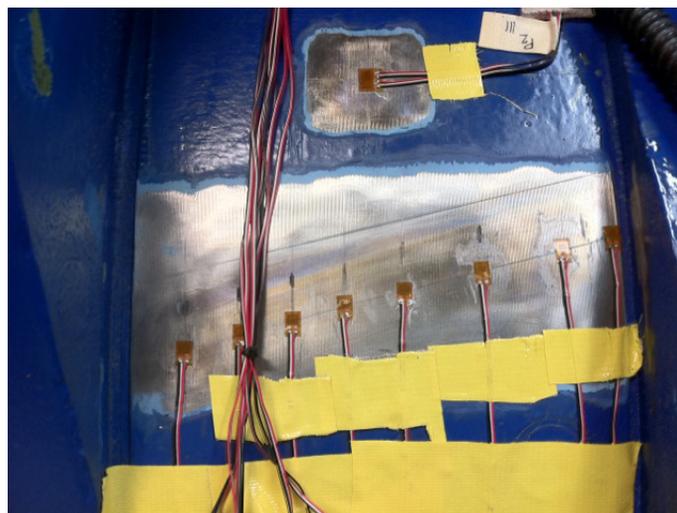
Figure 8. Strain gages on exterior of ring gear on GRC gearbox (NREL PIX/19221)

In Phase 2, an array of external strain gages was added to the ring gear of Gearbox 2 as shown in Figure 8. The first set of gages was placed to quantify the ring gear load distribution. This set consisted of eight gages placed along a tooth root. Ultrasonic equipment was used to locate the root between two gear teeth, which are on the inside of the ring gear, on the outside of the ring gear for strain gage placement. A second set of gages was placed at four azimuth locations (45°, 135°, 225°, and 315° from TDC) on the outside of the ring gear to measure hoop strain.

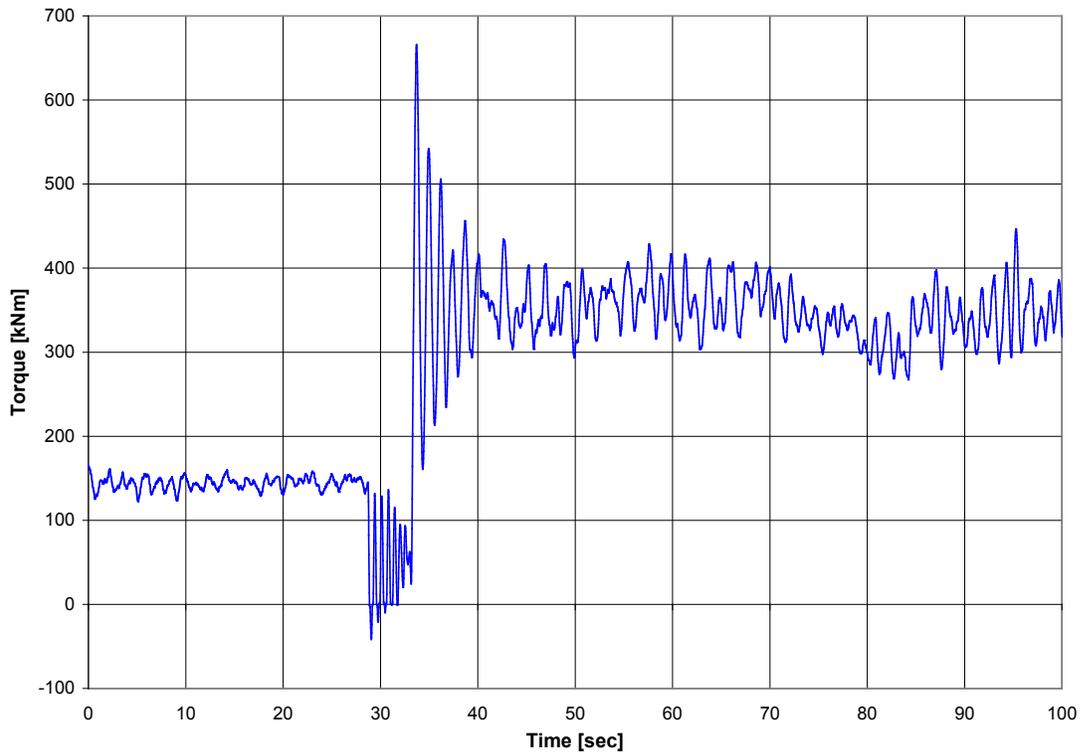
Figure 11. Highest measure torque event from first Ponnequin test campaign

A measurement campaign was conducted from August to October, 2007 (van Dam J. 2007) to verify whether predictions of maximum main shaft torque loads were accurate. The main shaft on turbine 29 at Xcel Energy’s Ponnequin wind farm was instrumented with a full bridge arrangement of strain gages for torque measurement and a National Instruments cDAQ data acquisition system. Data obtained from this test indicated that maximum torque value was 665 kNm, which is approximately two times rated (350 kNm) torque as shown in Figure 11. This torque was measured from data captured at 50 Hz.

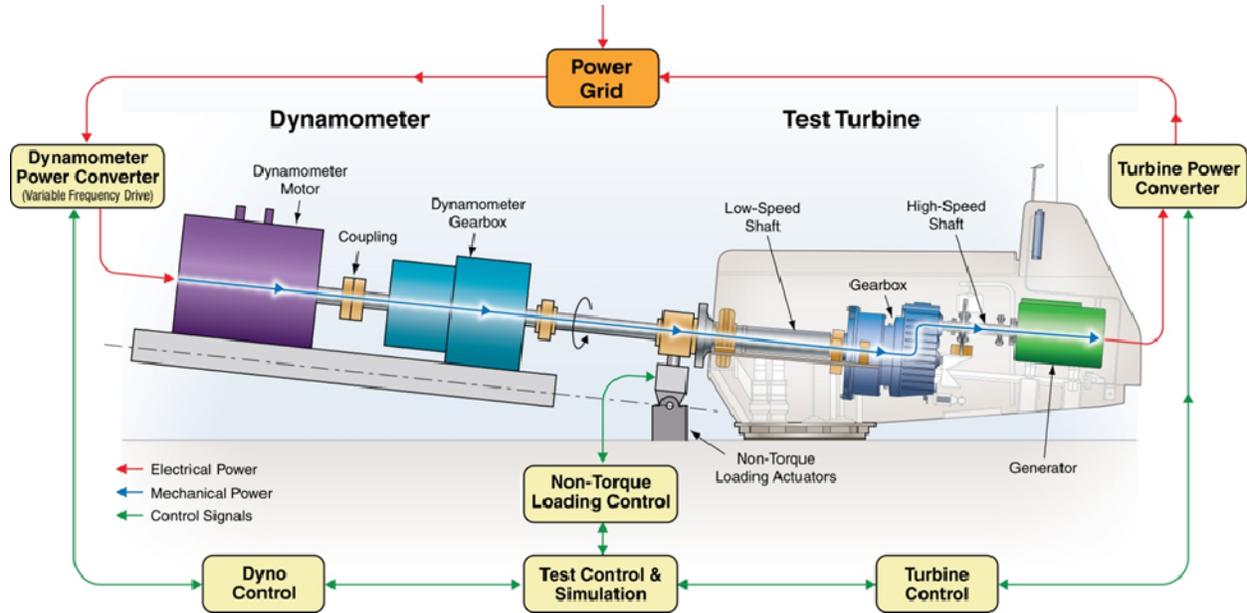
Figure 13. Schematic of NREL 2.5-MW dynamometer test facility and control block diagram

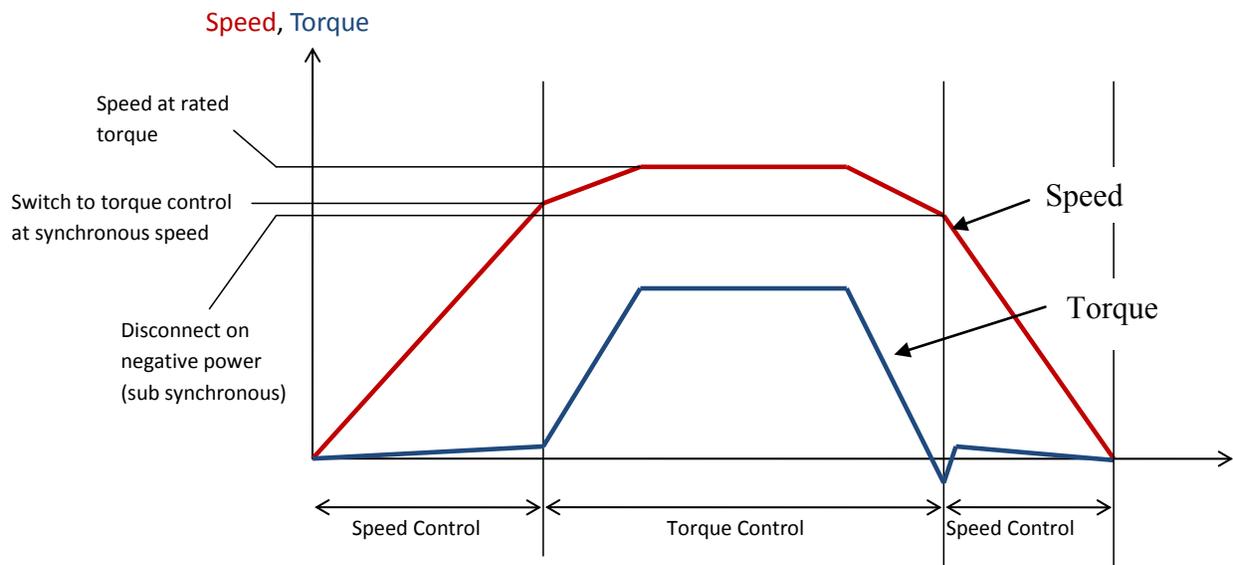
Figure 14. Asynchronous generator control mode

During Phase 2 testing, the dynamometer control was enhanced to provide more precise control of the startup ramp rate and dynamometer behavior during grid connection. In this configuration, the dynamometer was started in speed control mode at a preprogrammed rate of change (ramp-rate). At generator synchronous speed, the torque set point was set to the current torque demand and the dynamometer is switched to torque control mode. Once in torque control mode, the dynamometer ramps at a specified rate to a predetermined torque value. Details of the asynchronous generator control mode are shown in Figure 14.

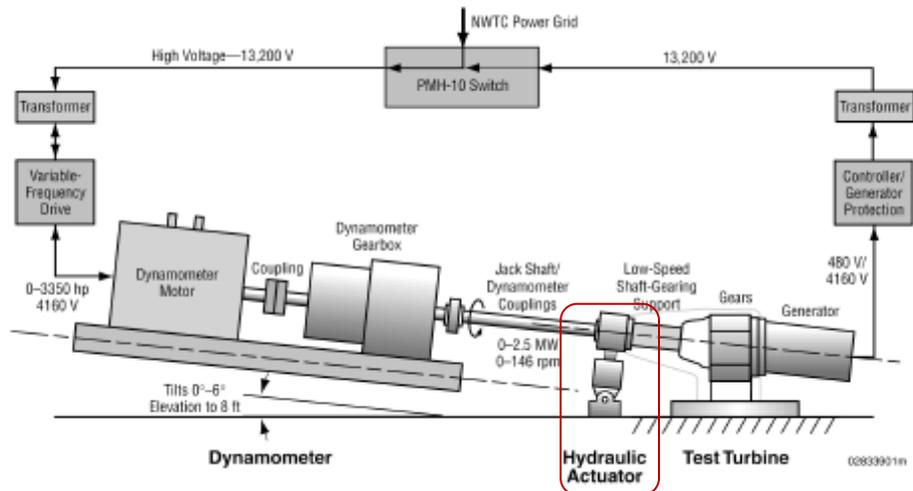
Figure 15. NREL 2.5-MW dynamometer, original NTL configuration shown highlighted in red

The NREL 2.5-MW dynamometer was originally configured to provide a limited capability to apply radial loads to the jackshaft, which connects the dynamometer gearbox to the test article's main shaft. Figure 15 shows a single, 110 kip, hydraulic actuator that was purchased for that purpose. However, in the first 10 years of operation of the dynamometer, this non-torque loading (NTL) capability was used only once.

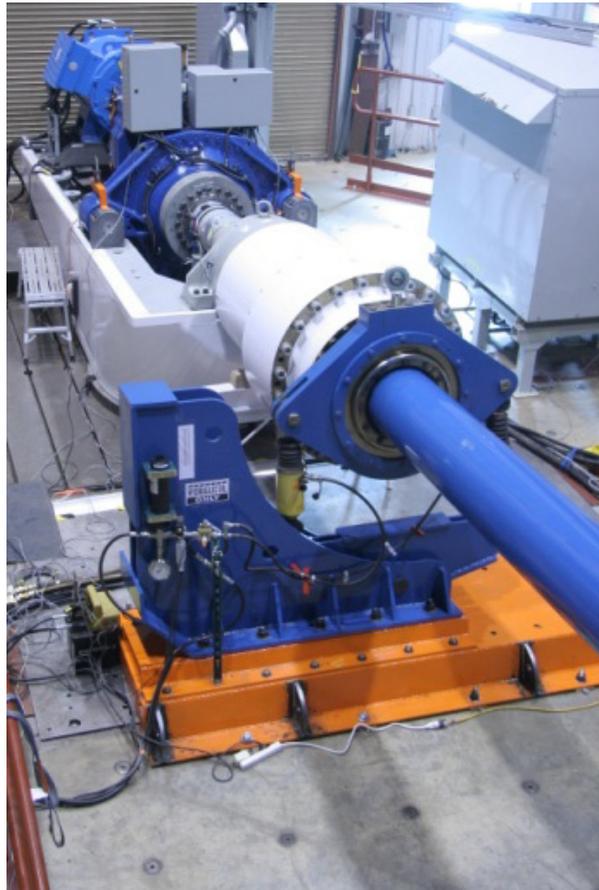
Figure 16. GRC static non-torque loading arrangement (NREL PIX/19222)

seen in Figure 16. The system was limited to lateral and downward force at five discrete azimuth angles. A pressure transducer on common actuator supply line monitored actuator force. Control was accomplished by modulating pump operation and adjusting a pressure relief valve. A nitrogen accumulator was included in the system to reduce system pressure fluctuations caused by slight eccentricity in the jackshaft yoke.

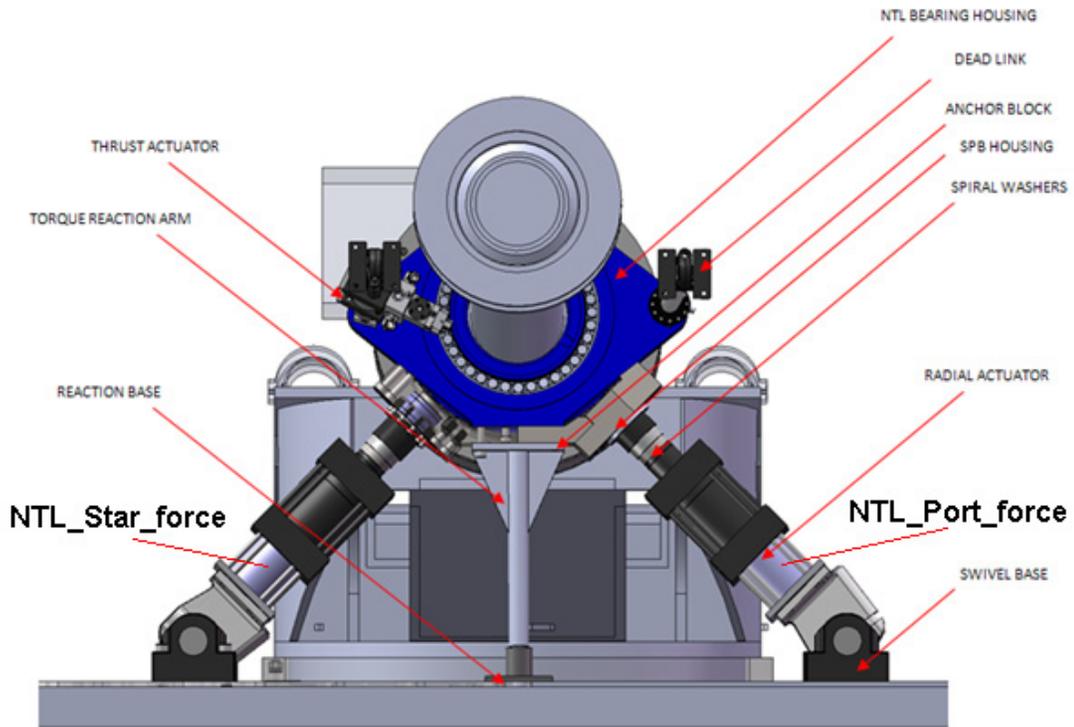
Figure 17. Upwind view of test article and dynamic non-torque loading system components (thrust frame hidden)

Figure 17 and Figure 18 show the components of the Dynamic NTL system.

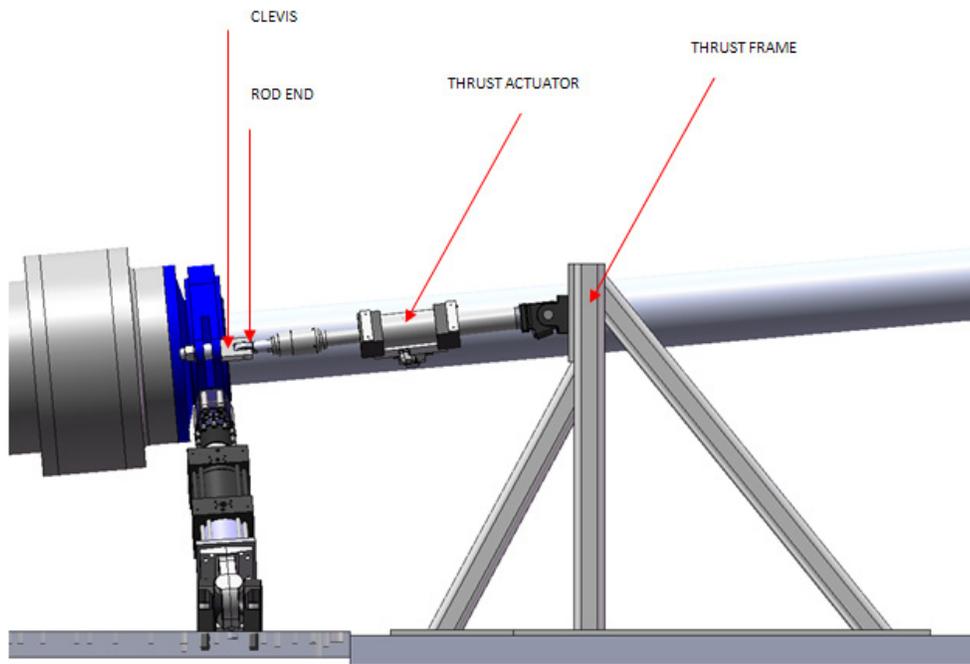
Figure 18. Side view of NTL system showing thrust components

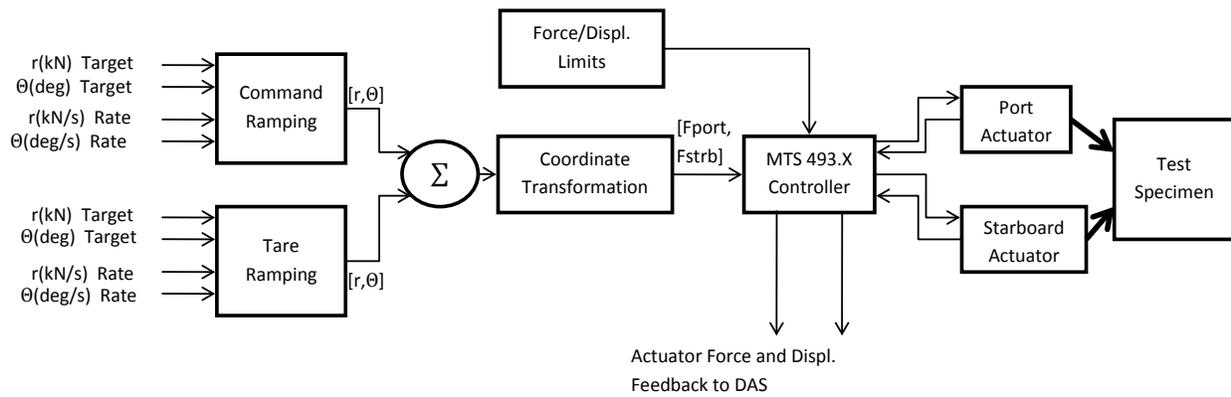
Figure 19. Dynamic non-torque loading control system block diagram

Details for the dynamic non-torque loading control system are shown in Figure 19. An MTS 493 controller is used to close the loop around the servo hydraulic actuators using force and displacement feedback. During testing the system is operated in force control mode. The MTS controller provides programmable force and displacement safety interlocks to shutdown the system in case of unexpected behavior. Measured force and displacement for each actuator are output to the GRC data acquisition system through analog output channels. The dynamometer control system serves as a high-level command generator allowing the operator to enter set points and ramp rates in terms of the system degrees of freedom. Separate ramp generators for command and tare are provided to allow for compensation of extraneous shaft loads. The sum of the ramp generators is transformed into actuator commands and sent to the MTS controlled via analog signals.

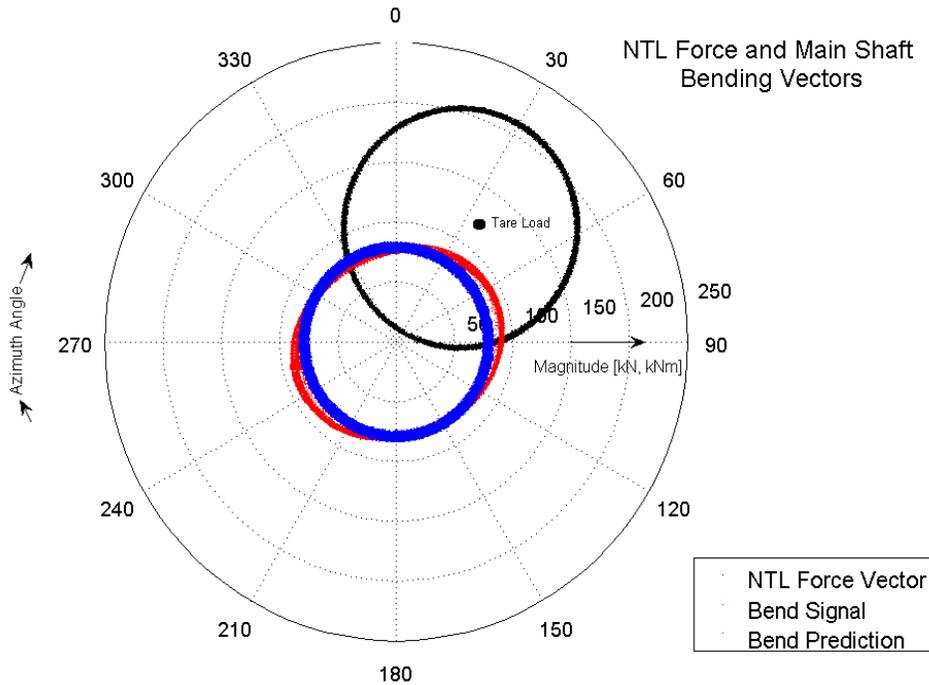
Figure 20. To achieve the desired main shaft bending condition, flexible coupling reaction forces needed to be taken into account in testing and modeling with a tare load

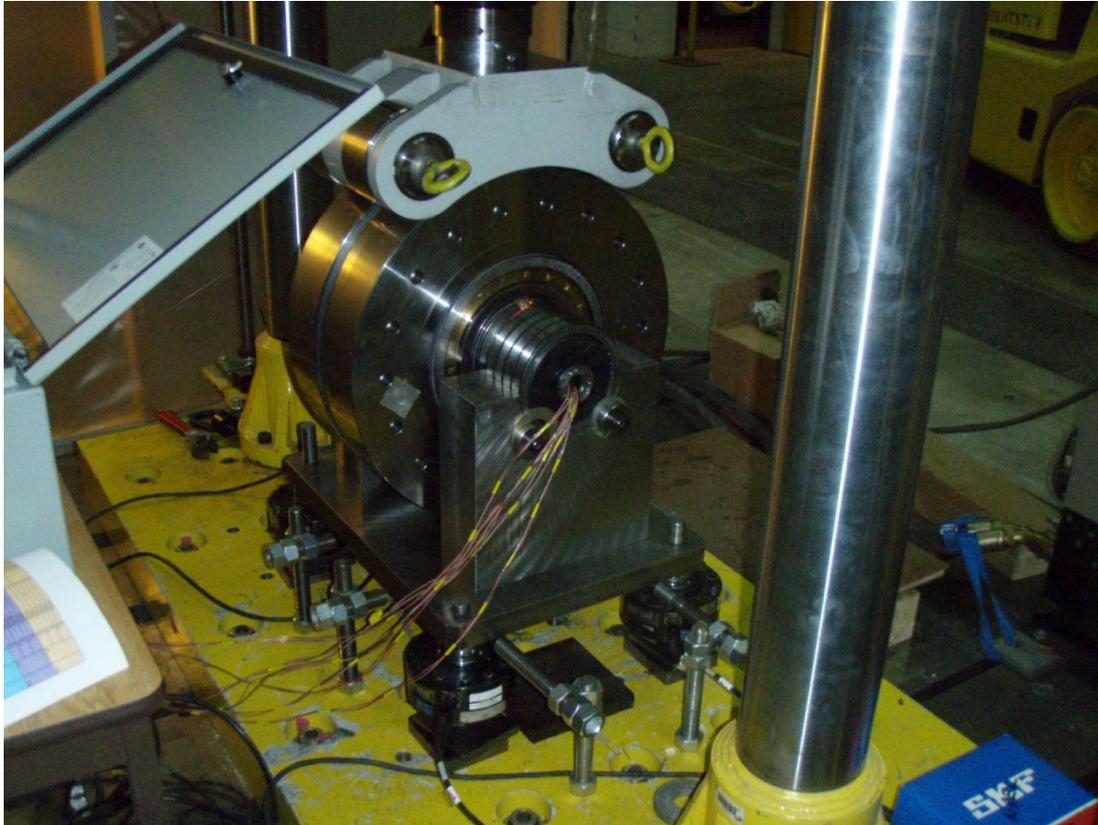
Figure 22. Bearing calibration fixture mounted in the NREL load frame (NREL PIX/19256)

A fixture was designed to provide a means to correlate strain gage response measured in the planet bearings to the forces transmitted through the carrier pins to the planet gears. A complete test program was developed to ensure consistent calibration of all 36 half-bridge signals—a complex task since the loads that are transmitted follow multiple paths through as many as 13 rollers on each of six bearings. The load distribution through the rollers is a complex function of the bearing geometry, the gear and carrier stiffness, and the fit between the bearing inner race and the planet pin. As described in the Gearbox Instrumentation section, grooves were ground into the inner races of each of the six planet bearings. Each groove was fitted with two strain

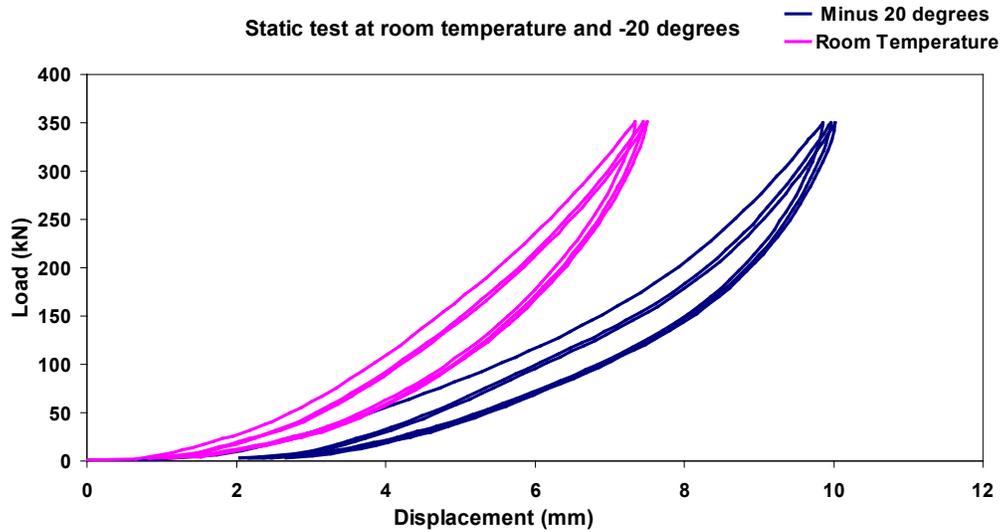
Figure 23. Temperature and load characterization of rubber mount. Larger displacements are seen at low temperature because of separation of the rubber from its casing

The gearbox torque arms are supported in two locations using viscoelastic rubber elements. Gearbox torque and non-torque loads, noise, and structural vibrations travel through these trunnions and into the bedplate. Given the importance of this load path, an investigation of the response of the rubber elements to loading was undertaken. The rubber mounts were removed and tested by Romax at the Tun Abdul Razak research Center (TARRC) (Crowther & Zaidi 2010). Static and dynamic benchtop tests determined that the rubber mount stiffness was nonlinear and temperature, frequency, and preload dependent (see Figure 23). The results were used to organize a collaborative modeling study to accurately model the behavior of the rubber.

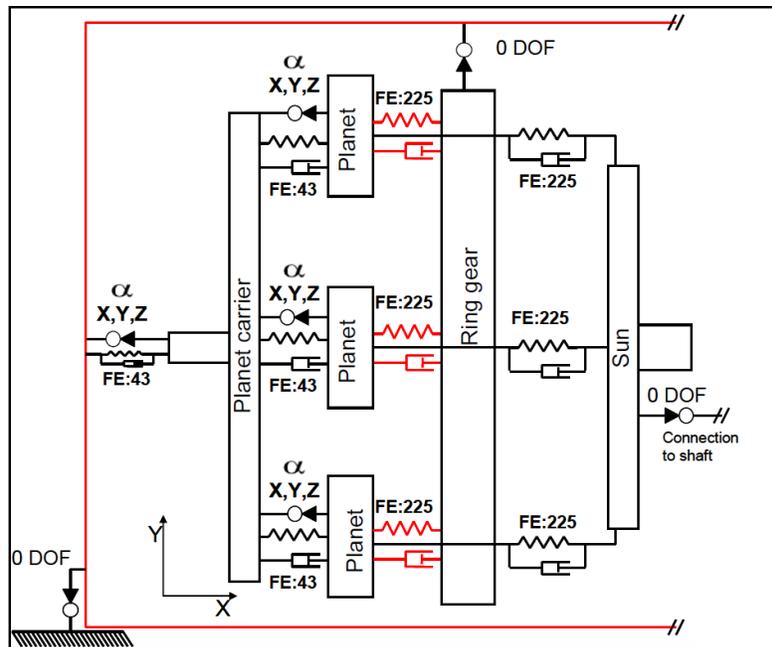
Figure 24. Planetary stage multibody modeling

NREL decided to use the SIMPACK, multi-body simulation software to model the GRC drivetrain. The model was initially constructed as a 2-mass system (rotor and generator) connected by a DOF of freedom, spring/damper joint. It was then tuned to match experimental acceleration data from a field test-braking event (Oyague 2008). The model complexity was incrementally increased to a multiple stage gearbox with contact elements and bearing stiffnesses. The planetary stage topology of the final model is shown in Figure 24.

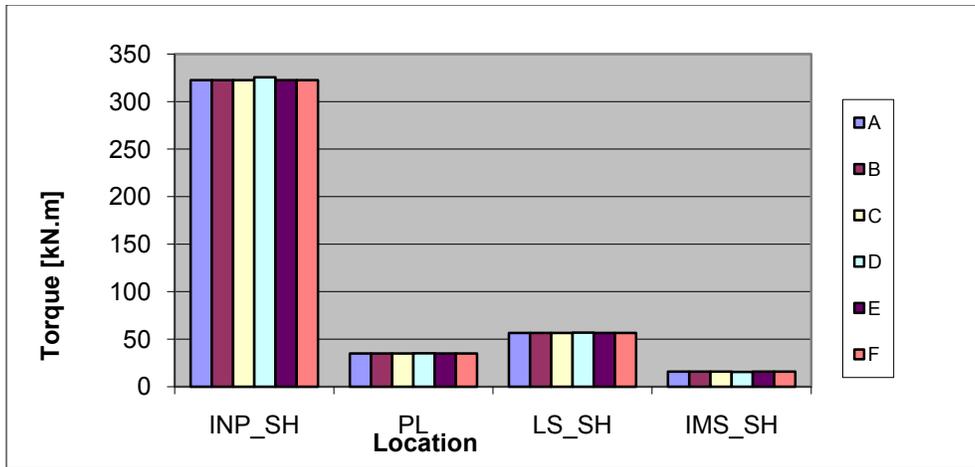
Figure 25. Torque distribution in gearbox shafts.

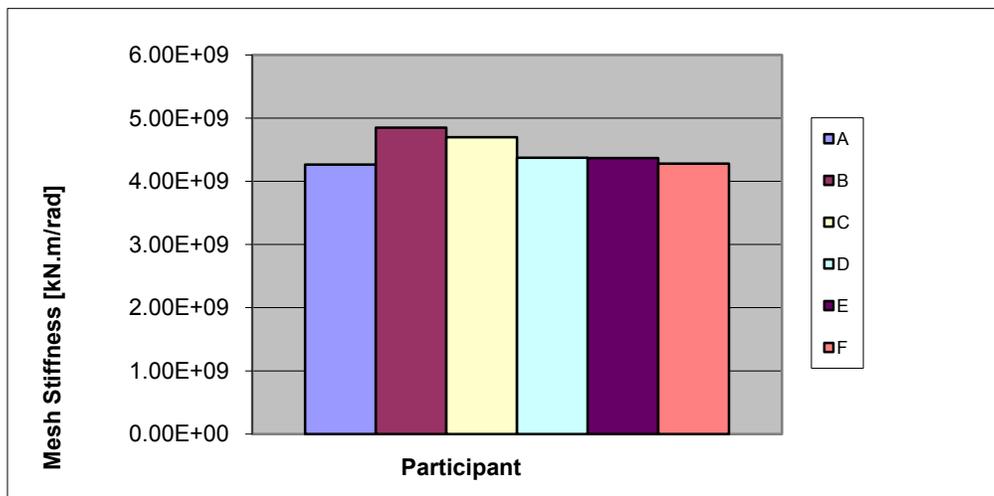
Figure 26. Stiffness of the ring-planet gear mesh

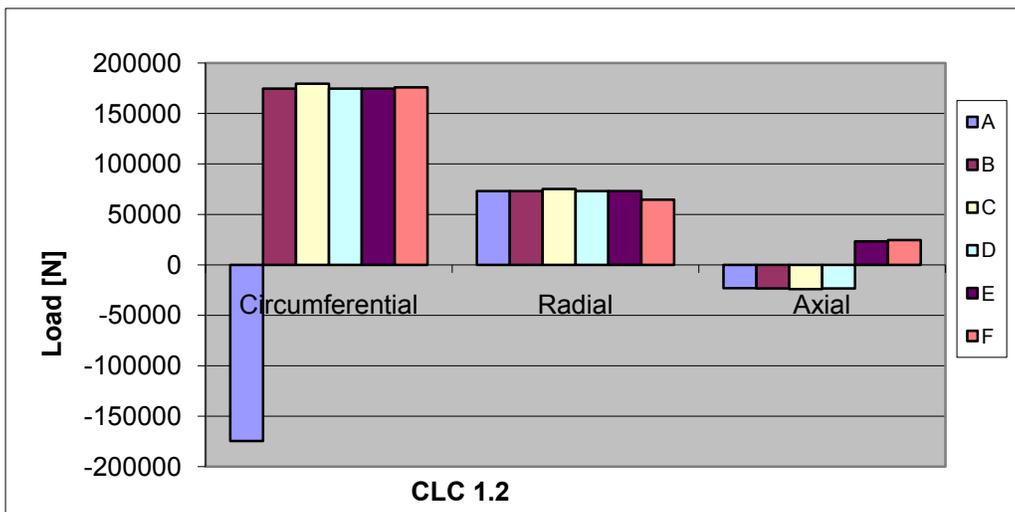
Figure 27. Directional loading of a planet-sun gear contact

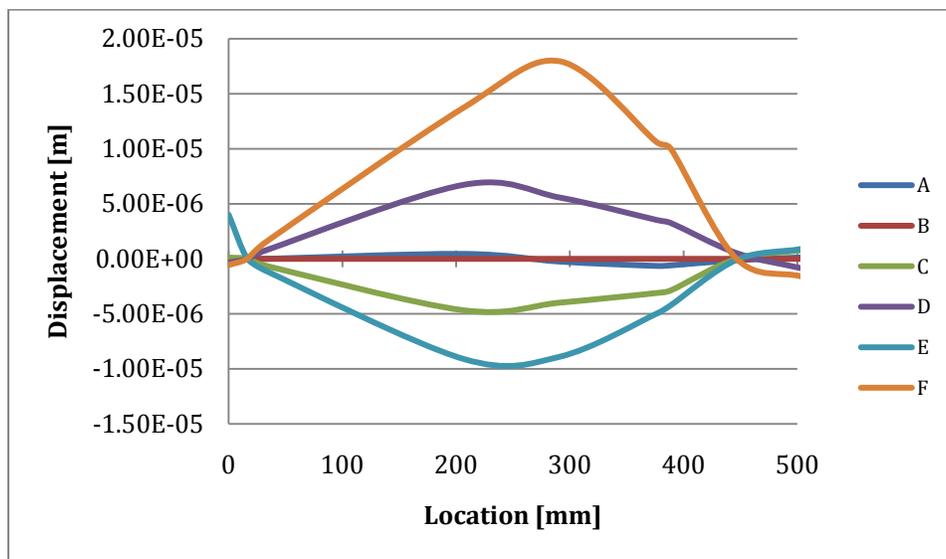
Figure 28. Comparison of model results of main shaft displacement at 100% rated torque relative to drivetrain at rest (A through F represent modeling partners)

The second round robin compared main shaft deflections at a number of nodes located along the shaft (Figure 28) at 100% rated torque relative to the drivetrain at rest. These deflections were compared for both rigid, free rotation bearing models and for compliant bearings using values provided by a bearing manufacturer. The inclusion of 6x6 stiffness matrices to model the bearings caused larger variations in the results. The round required members to implement flexible bodies or appropriate beam simulations for the main shaft and understand and examine the boundary conditions thoroughly. In some multibody codes, for example, the carrier and main shaft needed to be modeled as a single flexible body to avoid the added stiffness created by a 0 DOF joint at the shaft and carrier interface.

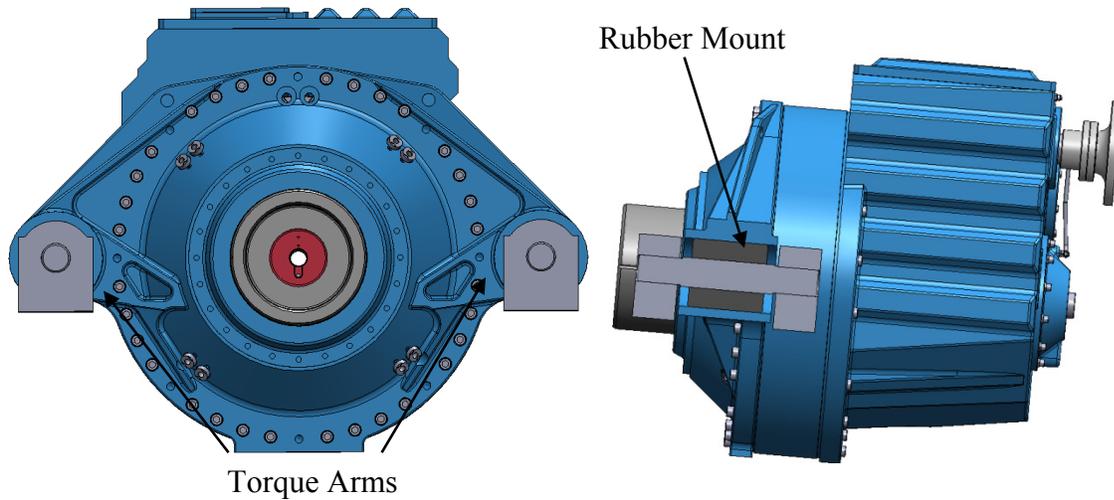
Figure 29. Torque arm trunnion configuration and cutaway showing rubber element

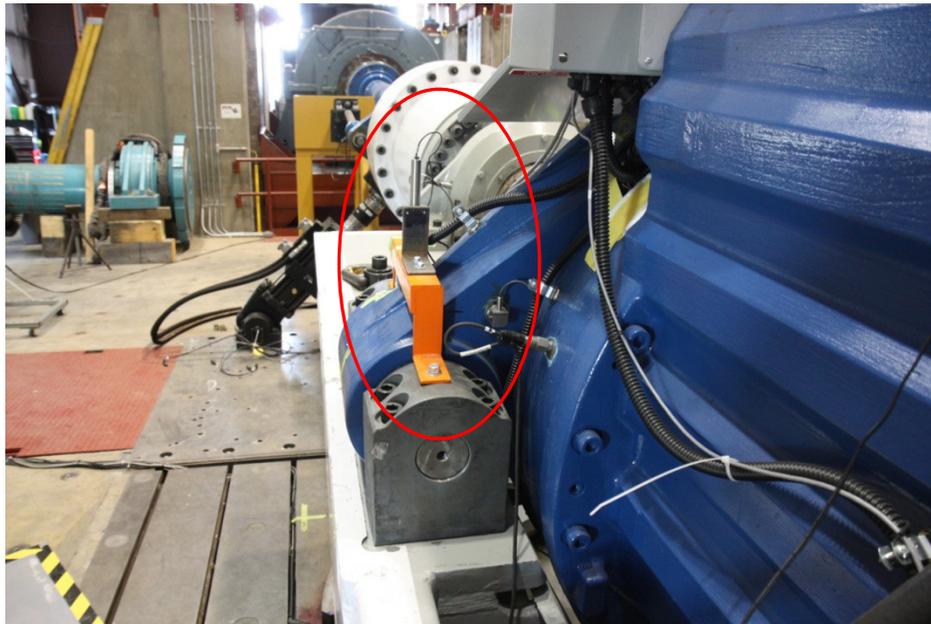
Figure 30. Dynamometer test setup showing trunnion LVDT proximity sensor (NREL PIX/19259)

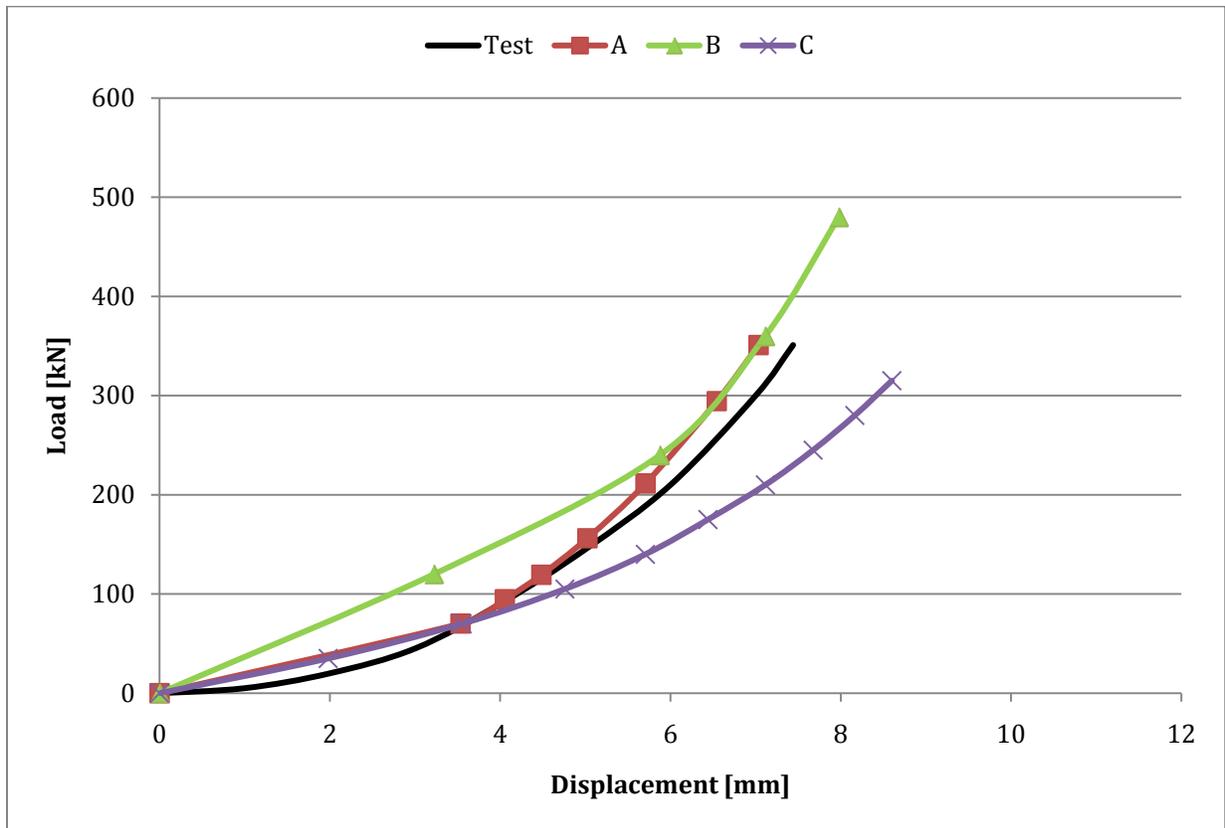
Figure 31. Trunnion radial stiffness model results

Participants developed elastomer material models and tuned them to a benchtop test conducted by Romax (Crowther & Zaidi 2010). Three different stiffness models used are shown in Figure 31 (A, B and C represent different modeling partners). The results of the study revealed that the elastomers were not commonly modeled with a non-linear spring in industry. However, some partners in the study conducted sensitivity studies and found that the gearbox internal responses were not significantly affected by the non-linear stiffness of the elastomer as long as the linear stiffness value used was within a reasonable limit.

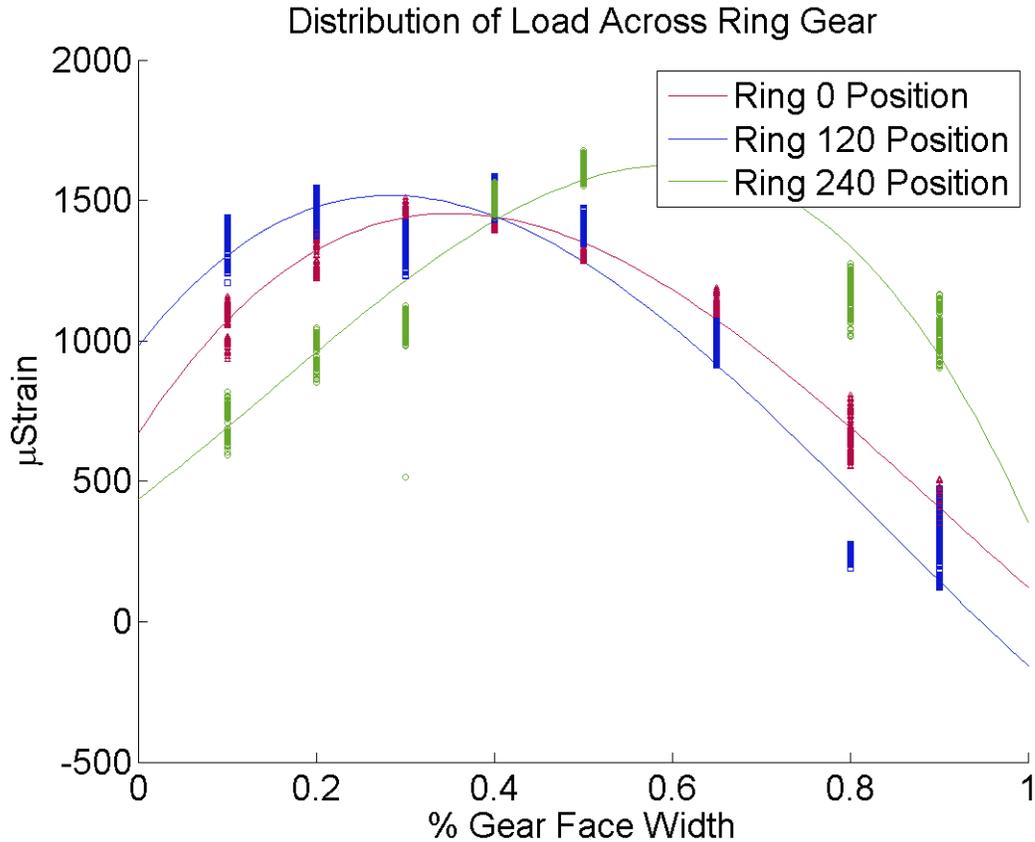
Figure 32. Ring gear load distribution for 100% torque dynamometer testing

The fourth round robin investigated the modeling of the load distribution across the ring gear face width using measured tooth root strain data. It also investigated the ability of models to produce an external load distribution at the measurement location on the test article. The goals were to validate the model load predictions and validate the external measurement of load distribution. Modelers were provided with a 100% steady state load case, which showed variation in the ring gear load distribution at the three measurement locations (see Figure 32).

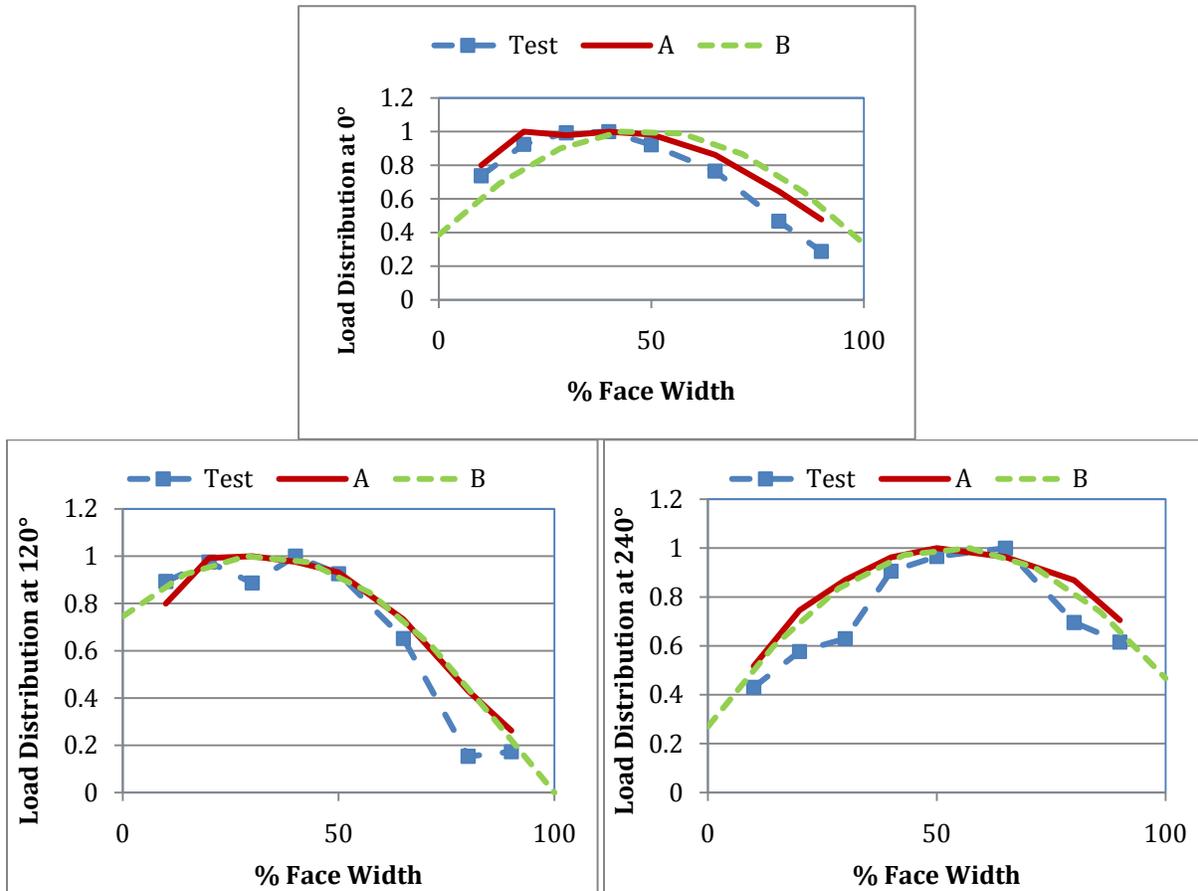
Figure 33. Ring gear load distribution test and modeling results for 0 (top), 120 (left), and 240 (right) (A and B represent the results of two modeling partners).

Modeling results are shown in Figure 33. Due to the limitations of the multibody software approach, these measurements could not be verified using multi body simulation (MBS) codes alone. Full FEA codes and hybrid codes with focus on gear contact analysis worked best for this comparison. Many factors contributed to the shifting ring gear load centroid, but the modelers generally found that flexible body models of the ring gear, carrier, and housing were necessary to predict the changing ring gear load. One modeler was able to capture the shifting effect only after increasing the fidelity of the model to full contact elements for all roller bearings in the gearbox (as opposed to the more common usage of a 6x6 stiffness matrix for bearing modeling). Accurate planet bearing, planet carrier, and ring gear modeling was necessary to capture the shifting load effect. The external strain gauge findings are presented in the Findings section.

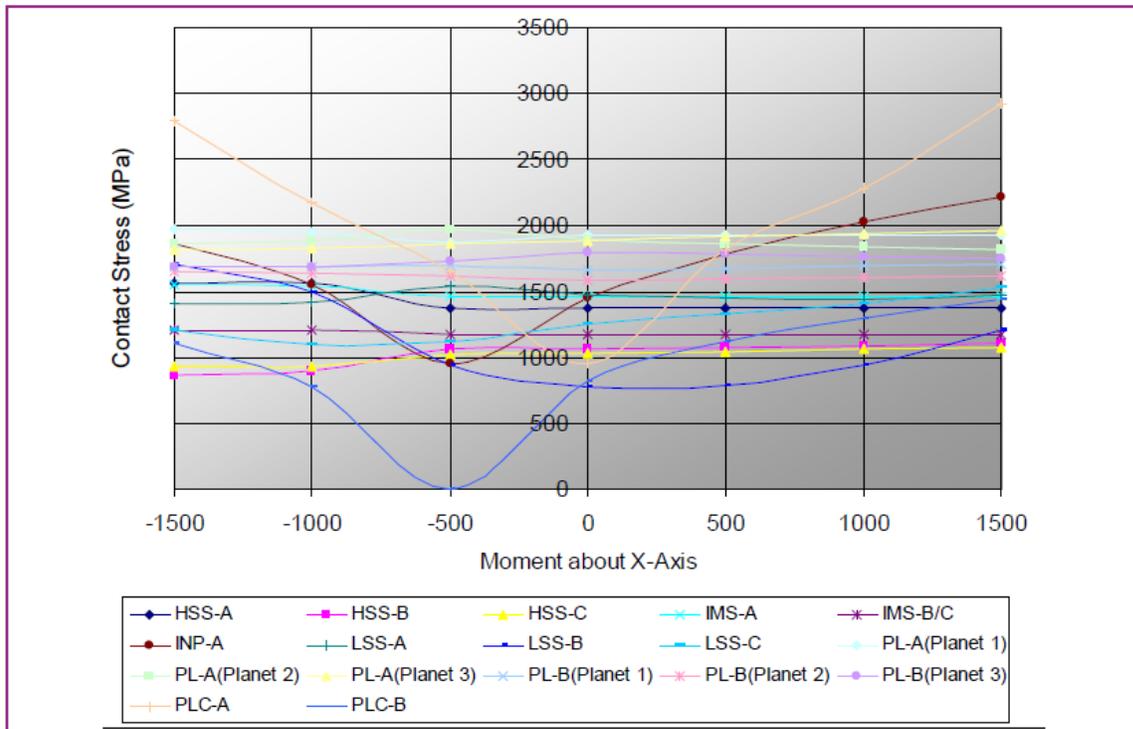
Figure 34. Peak contact stress values for GRC gearbox bearings with varying values of pitch moment. (This Romax figure designates pitch axis as the “X-axis”).

The first study was focused on the effect of non-torque loading on the gearbox bearings. The study shows that the impact of the non-torque loading would be limited to the bearings in the low speed and perhaps the planetary stages but would not impact the intermediate and high-speed stage bearings. See Figure 34.

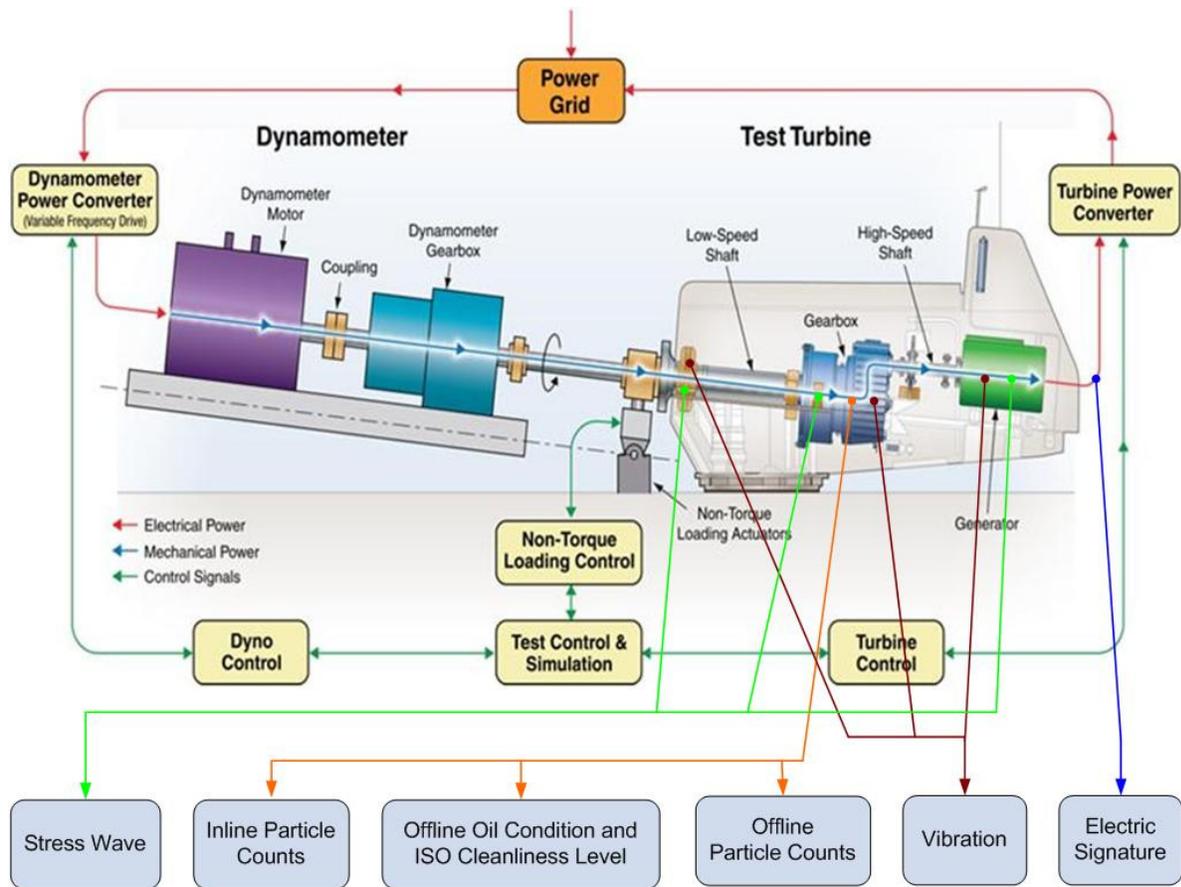
Figure 38. CM system setup in the Phase 2 dynamometer testing of Gearbox 2
