Gearbox Reliability Collaborative Project Report: Findings from Phase 1 and Phase 2 Testing

Technical Report
NREL/TP-5000-51885
June 2011

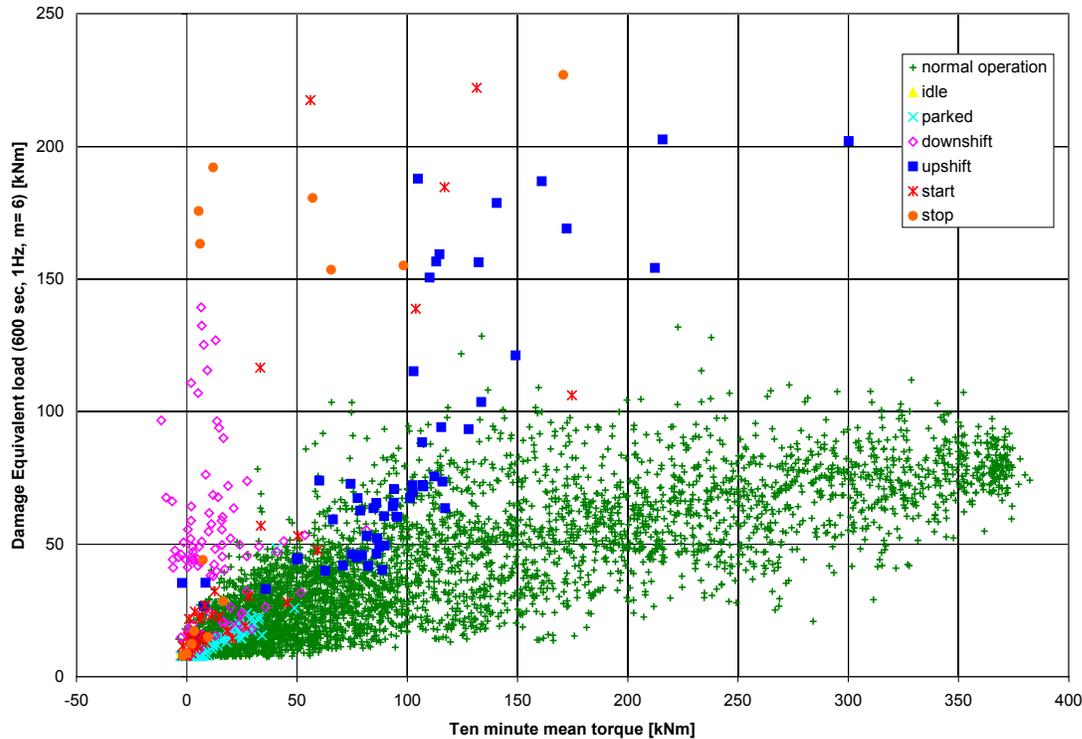
Figure 39. Measured damage equivalent loads per type of event

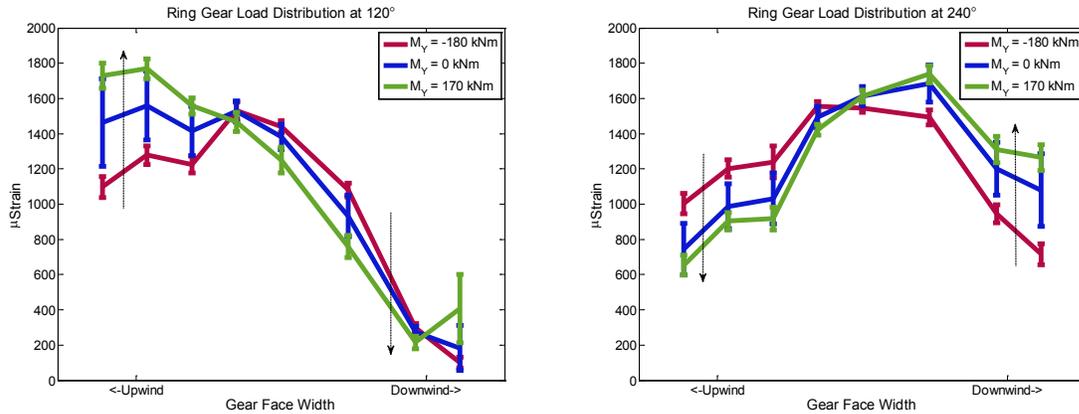
Figure 40. Ring gear edge loading caused by non-torque loading

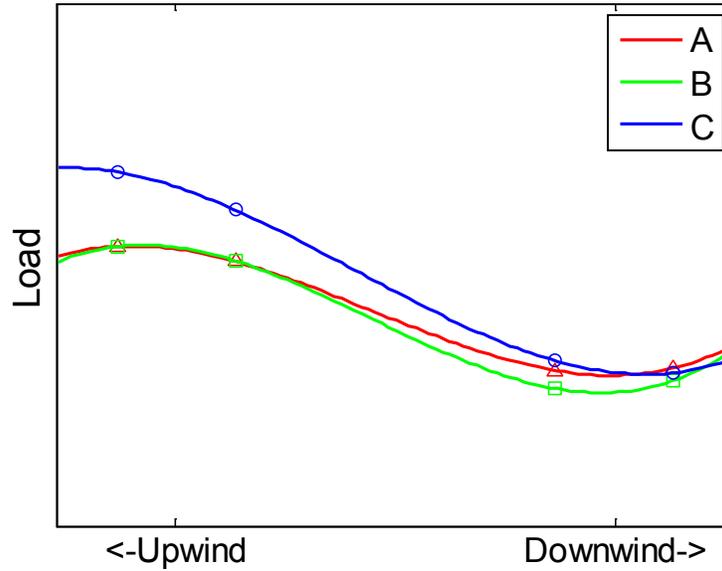
Figure 41. Mean pin load distribution for rated torque field test for three planets pins A, B and C

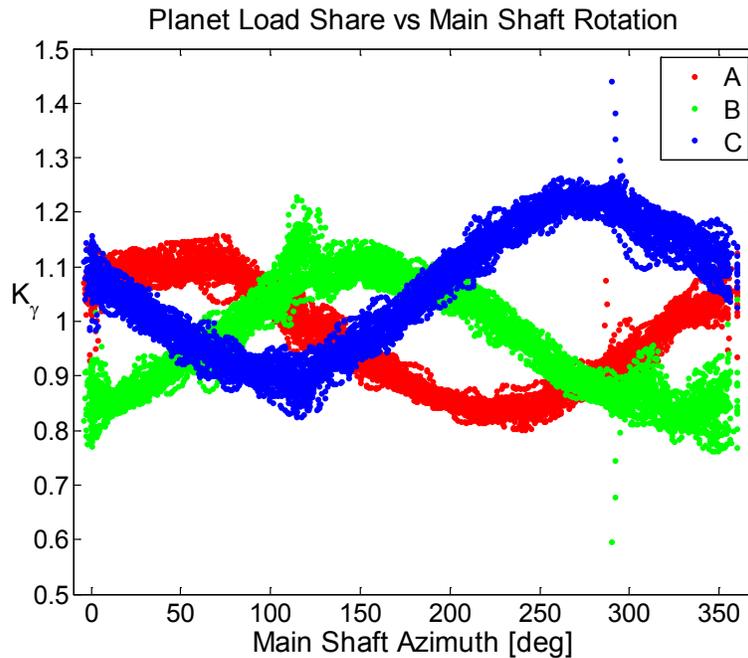
Figure 42. Planet load share versus main shaft rotation for three planets designated A, B and C

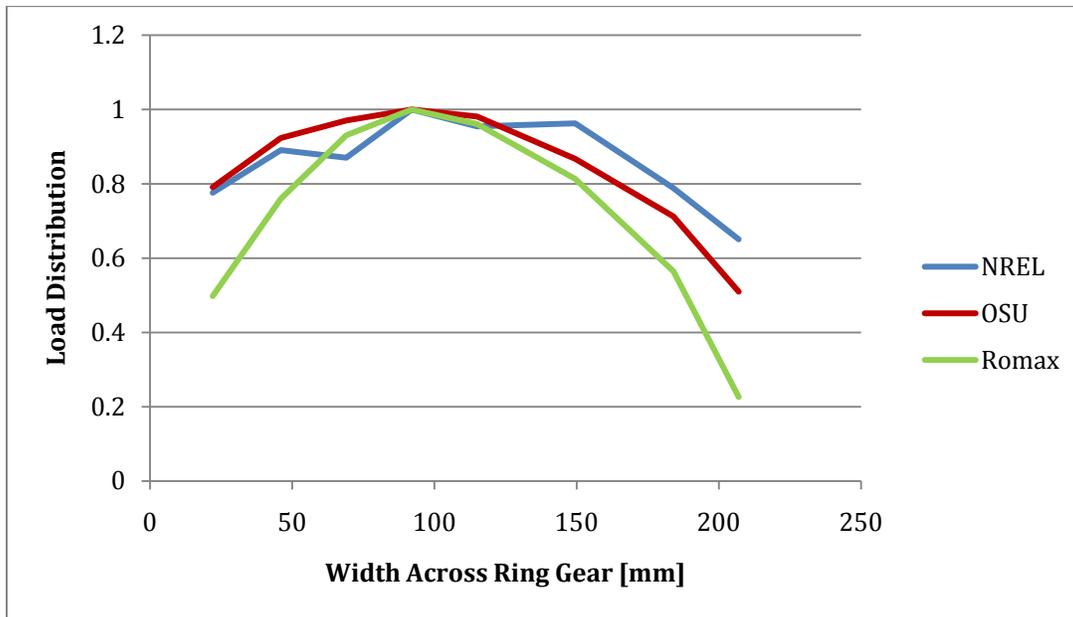
Figure 43. Comparison external ring gear load distribution obtained through modeling and measurement on the outside of the gearbox housing

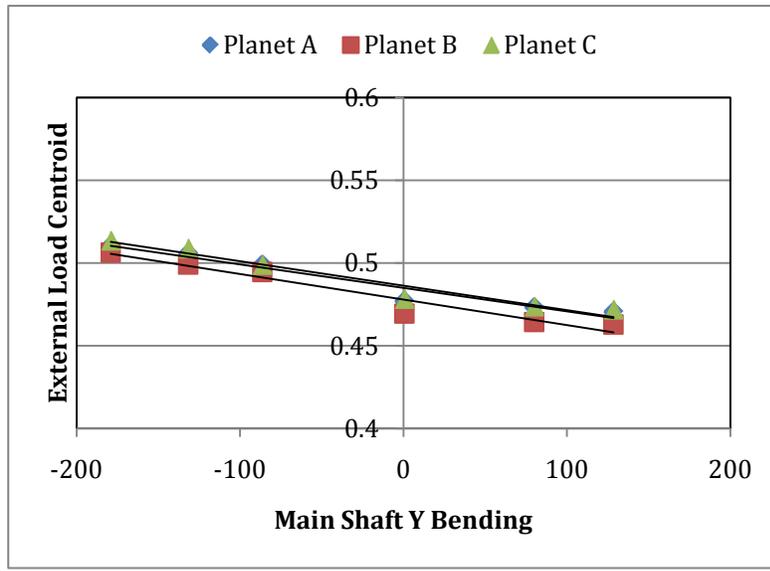
Figure 44. Effect of main shaft bending on the ring gear load centroid can be measured externally

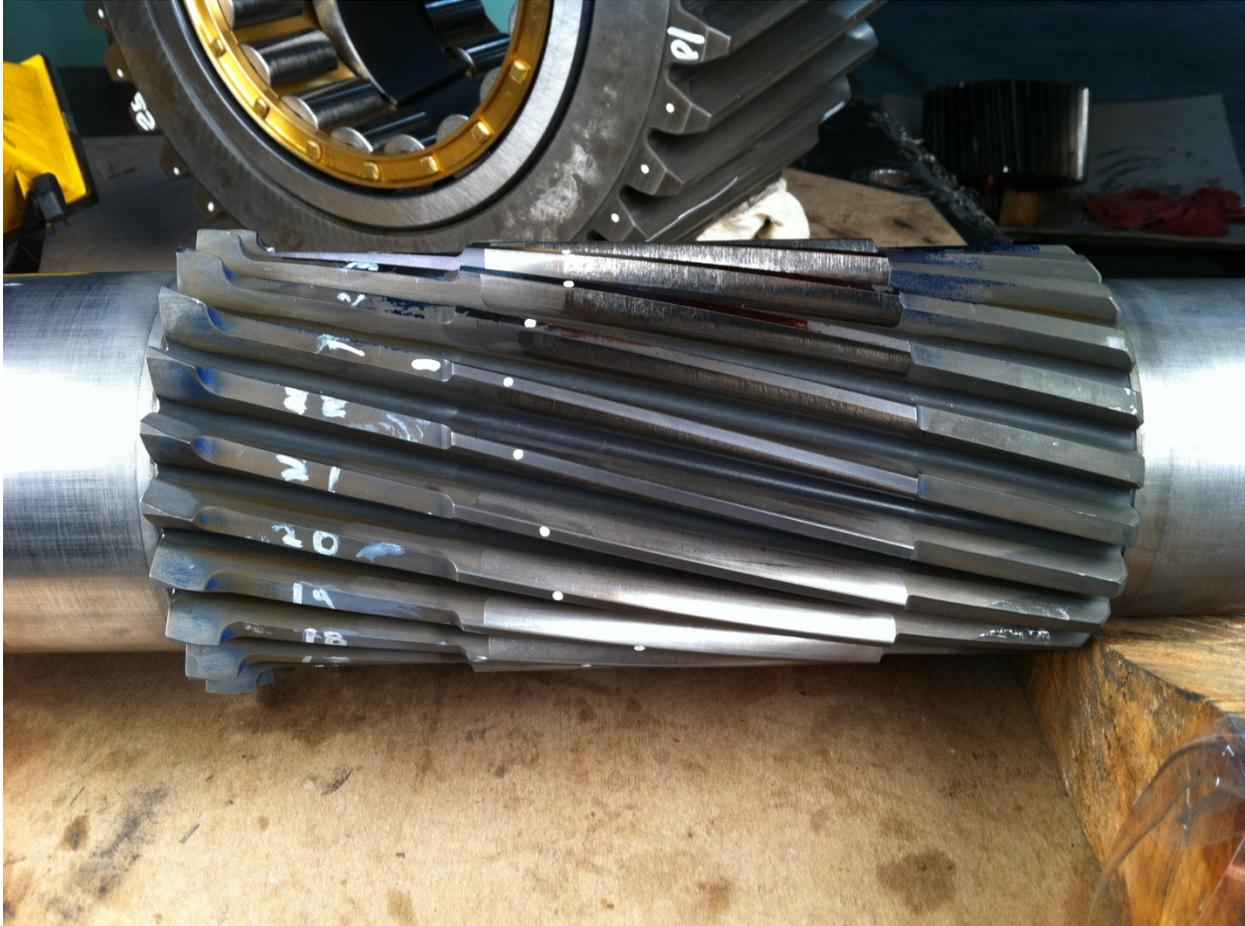
Figure 45. HS pinion scuffing most likely caused by lubricant starvation (Courtesy GEARTECH)

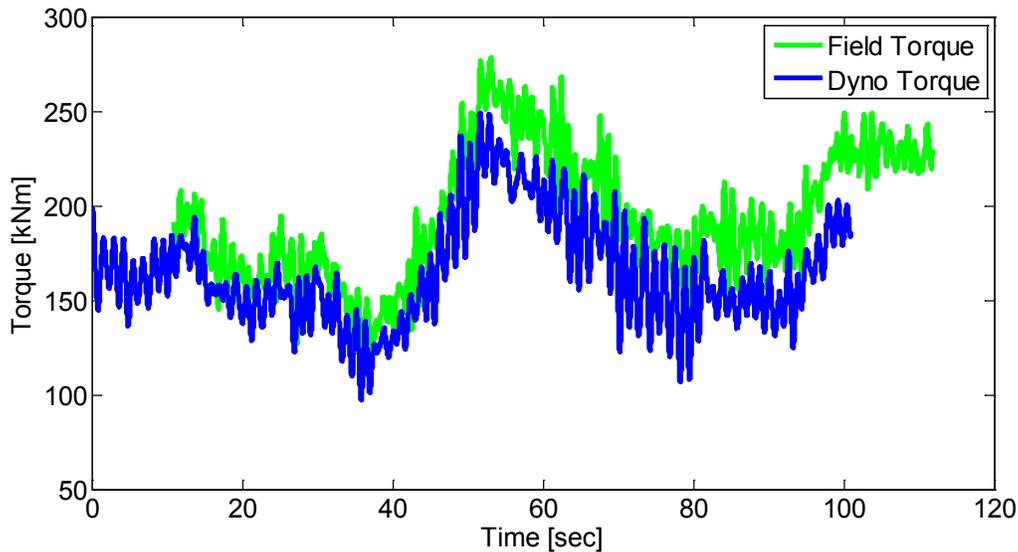
Figure 46. Time series of field torque data reproduced in dynamometer dynamic testing

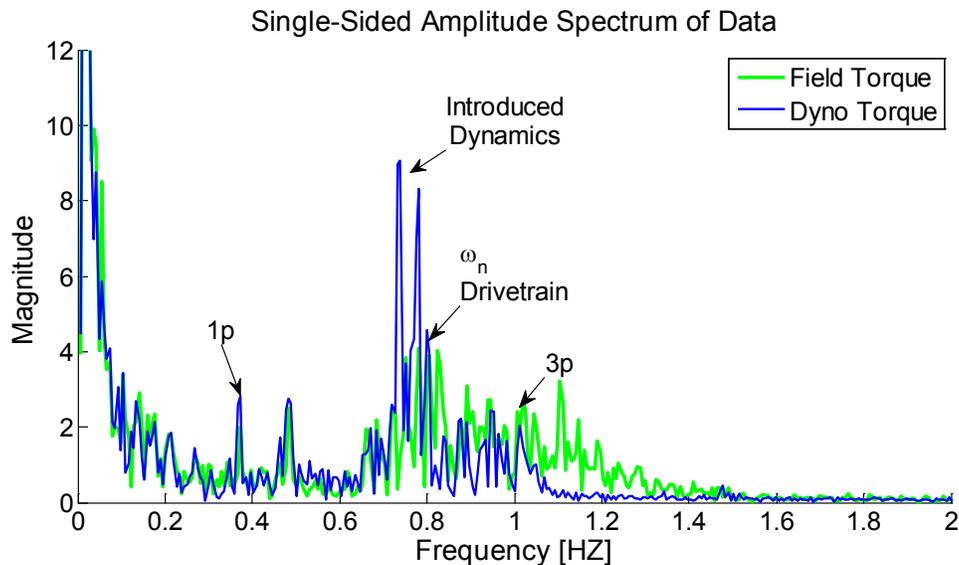
Figure 47. FFT of field torque data reproduced in dynamometer dynamic testing

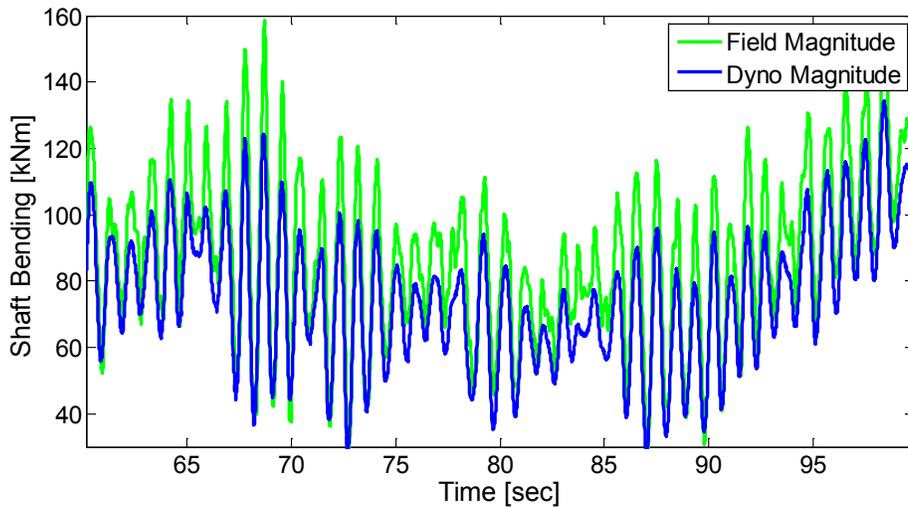
Figure 48. Time series of field shaft bending reproduce

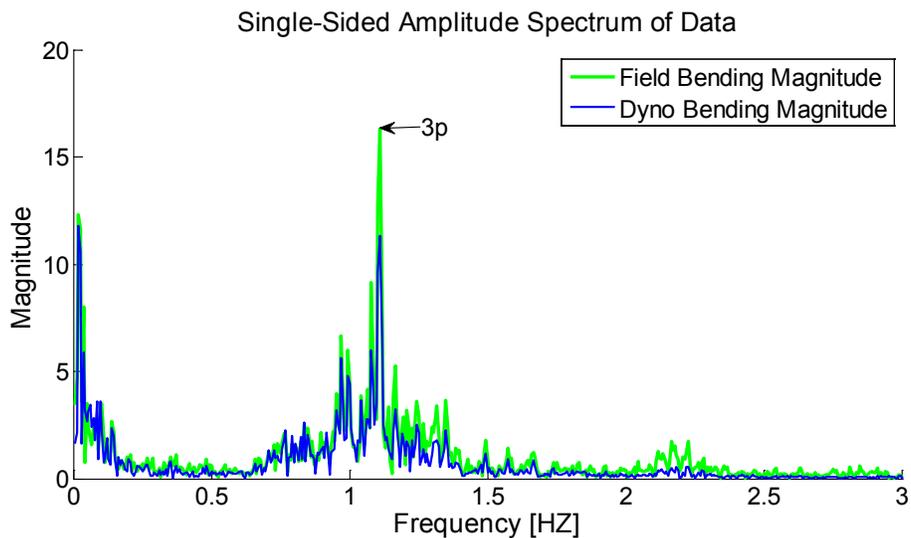
Figure 49. Frequency content of field shaft bending reproduced in dynamic dynamometer testing

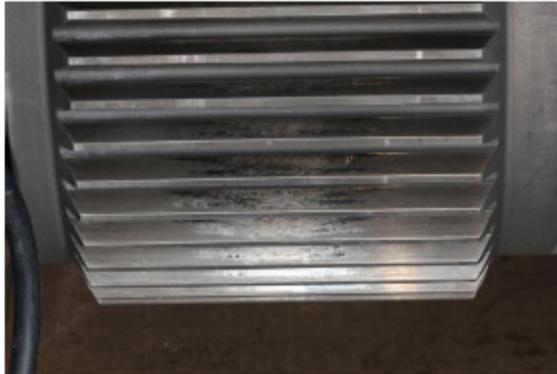
File Name: IMG_5937.JPG
Comments: Fretting on sun spline.

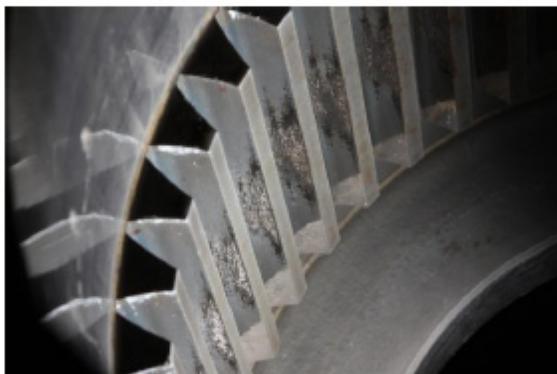
File Name: IMG_6244.JPG
Comments: Hollow shaft spline fretting. Looking toward generator.

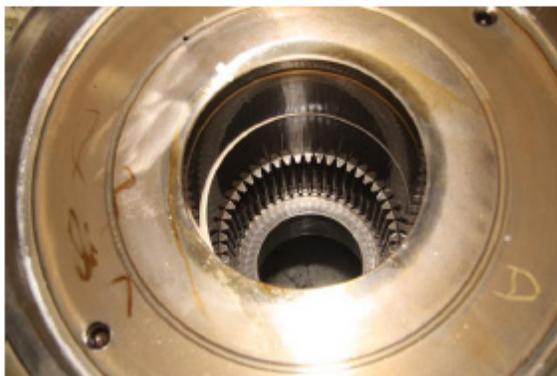
File Name: IMG_6233.JPG
Comments: Hollow shaft spline fretting. Looking toward generator.

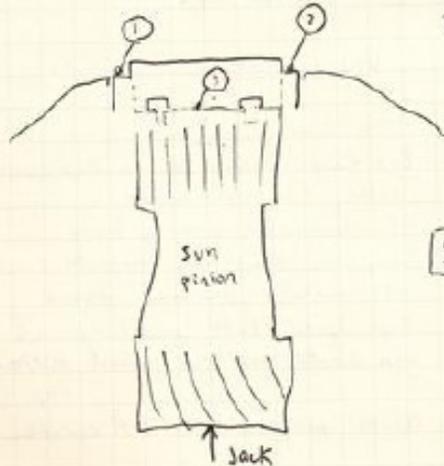
Sun Pinion Axial Play

Test: Measure ③ for axial end play. verify that ① and ② do not move so that axial play of sun is being measured.
