Advancing Replicable Solutions for High-Performance Homes in the Southeast

S.G. Roberts, M.L. Sweet, and A. Francisco
Partnership for Home Innovation

March 2016

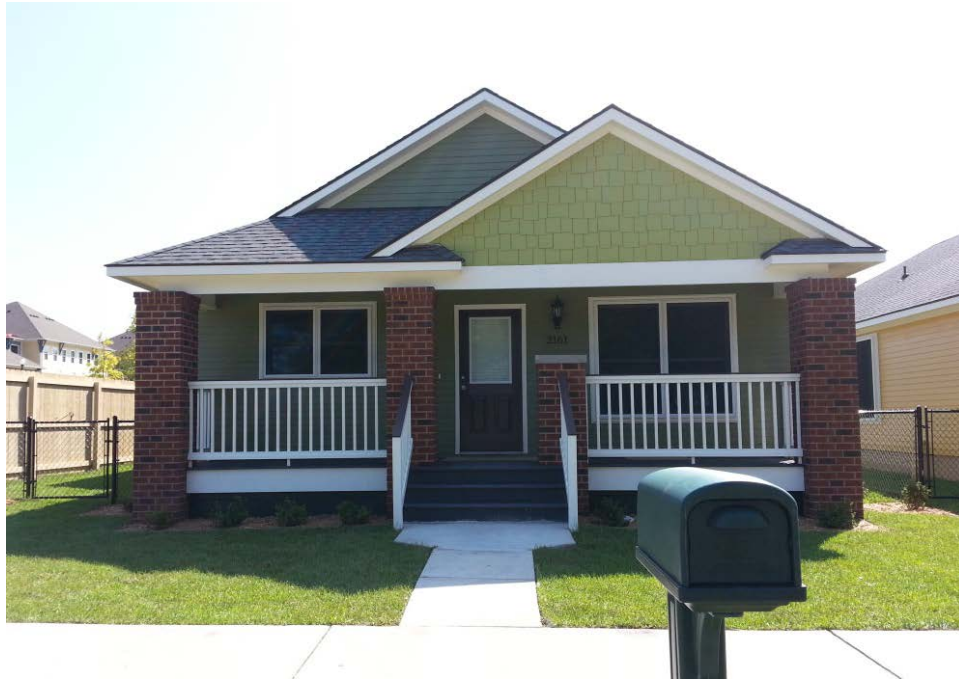
Figure 1. Savannah Gardens Lot 207

Southface partnered with the Savannah Housing Department to specify and construct a single-family, new-construction, test home in Savannah, Georgia (Figure 2). The department’s goal was to redevelop a poverty-stricken community with sustainable homes at affordable prices for income-qualified buyers. The home is in the Savannah Gardens community, a 44-acre site that was redeveloped to meet the standards of the EarthCraft Communities program (Community Housing Services Agency, Inc. 2012).¹ This community is part of a large neighborhood redevelopment effort and will include more than 500 housing units (120 of which are single family) upon completion. The site’s master plan includes 5 acres of green space, and all homes are required to earn EarthCraft certification. The three-bedroom/two-bathroom test home is approximately 1,200 ft² of conditioned floor space on an elevated slab foundation and has a semi-conditioned, encapsulated attic. Like all homes in the community, this home is all electric, and no natural gas service is available. Although Southface partnered with Savannah Housing Department and Chatham Home Builders on the construction of Lot 207, a neighboring home built to standard EarthCraft specifications was also monitored as a control to compare certain measures, namely exterior foam insulation and a heat pump water heater (HPWH). Construction was completed in 2013.

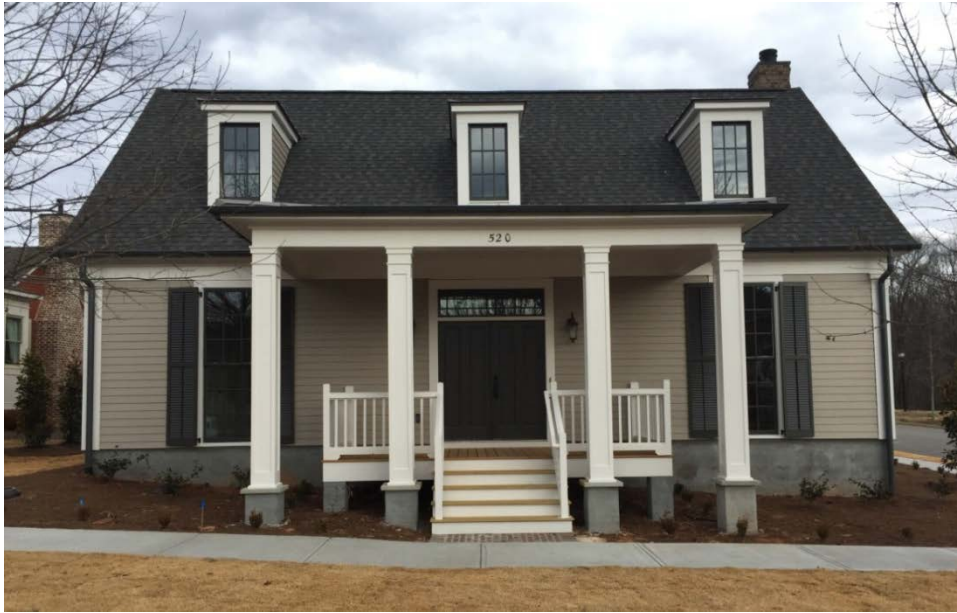
Figure 2. JMC Patrick Square test home

A small-scale production builder partnered with Southface to design and construct a new construction test house in Clemson, South Carolina, in the mixed-humid climate (CZ 3) (Figure 2). As a homebuilder that also participates in Southface’s regional high-performance/green building program, EarthCraft Communities, the builder sought a cost-effective approach to reaching even higher levels of energy savings and home-buyer value. The team also set a goal to achieve DOE Challenge Home/Zero Energy Ready Home certification and the Energy Policy Act of 2005 (EPAAct) tax credit (which expired at the end of 2014). The plan chosen for the prototype home includes a single floor with 1,828 ft² of conditioned living space, three bedrooms, two bathrooms, and an attached two-car garage. The team restricted its options to measures that could be replicated to future construction, including various plan layouts and foundation types. The perceived ability to sell the improvement cost to homebuyers was a key driver in selecting the final measure package. Foundation and attic construction was designed to place the heating, ventilating, and air-conditioning (HVAC) air handling unit and ducts into the conditioned space and achieve cost-effective elevations and storm water control on this lot. The builder chose a semi-conditioned, encapsulated attic and elevated slab foundation. Construction was completed in January 2015.

The JMC Patrick Square project is a single floor with 1,828 ft² of conditioned living space, three bedrooms, two bathrooms, and an attached two-car garage. This small-scale production builder wanted to increase its level of energy efficiency beyond its current green building practices, including bringing ducts into conditioned space. The team met this goal through a combination of upgrade measures and achieved many Zero Energy Ready Home program requirements.

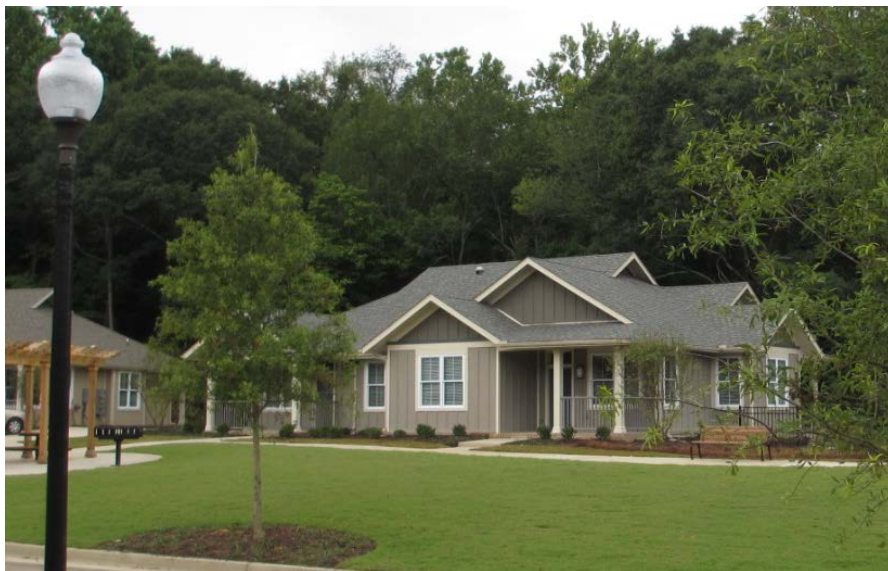
Figure 3. Typical LaFayette two-bedroom/three-bedroom duplex

Southface partnered with the LaFayette Housing Authority (LHA) and architecture firm Lord Aeck Sargent to design, construct, and test 30 sustainable and affordable housing units in 15 duplexes (Figure 4). Each one-story duplex comprises a two-bedroom and a three-bedroom unit. LaFayette, Georgia, is situated in the northwestern corner of the state, approximately 30 miles due south of Chattanooga, Tennessee (CZ 4). Client goals were to minimize occupant utility bills and increase property durability and maintainability. This project, which is seeking Leadership in Energy & Environmental Design for Homes Gold certification, was intended to be a replicable example for rural housing authorities that follow the design-bid-build procurement process that is typical of public housing initiatives.

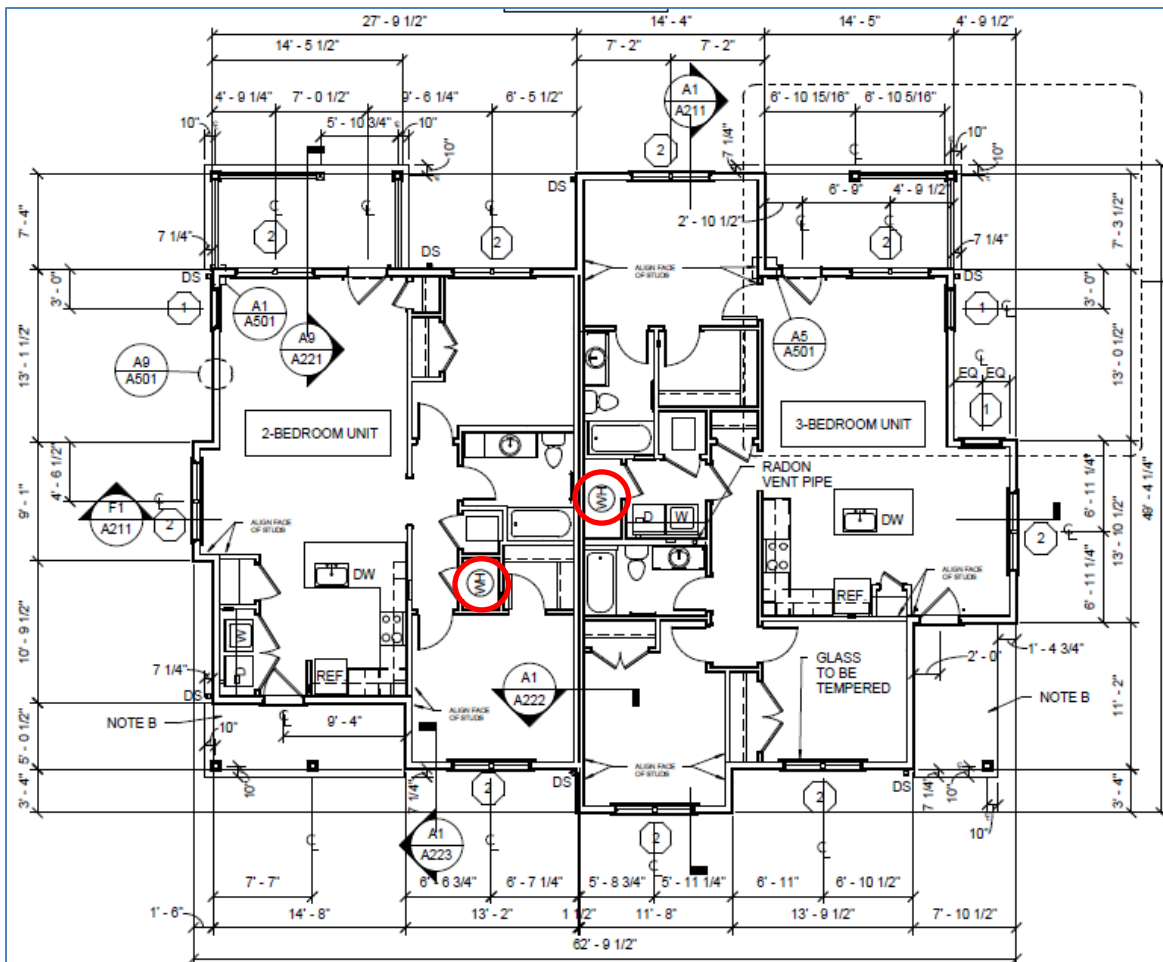
Figure 6. Typical LaFayette two-bedroom/three-bedroom duplex floor plan; red circles indicate HPWH locations.

Lord Aeck Sargent designed 29 identical duplexes and 1 ADA-compliant duplex that were built on two sites (Figure 6). Each duplex consists of a two-bedroom and a three-bedroom unit. Note the location of the ducted HPWH in each unit inside a utility closet with a solid door.

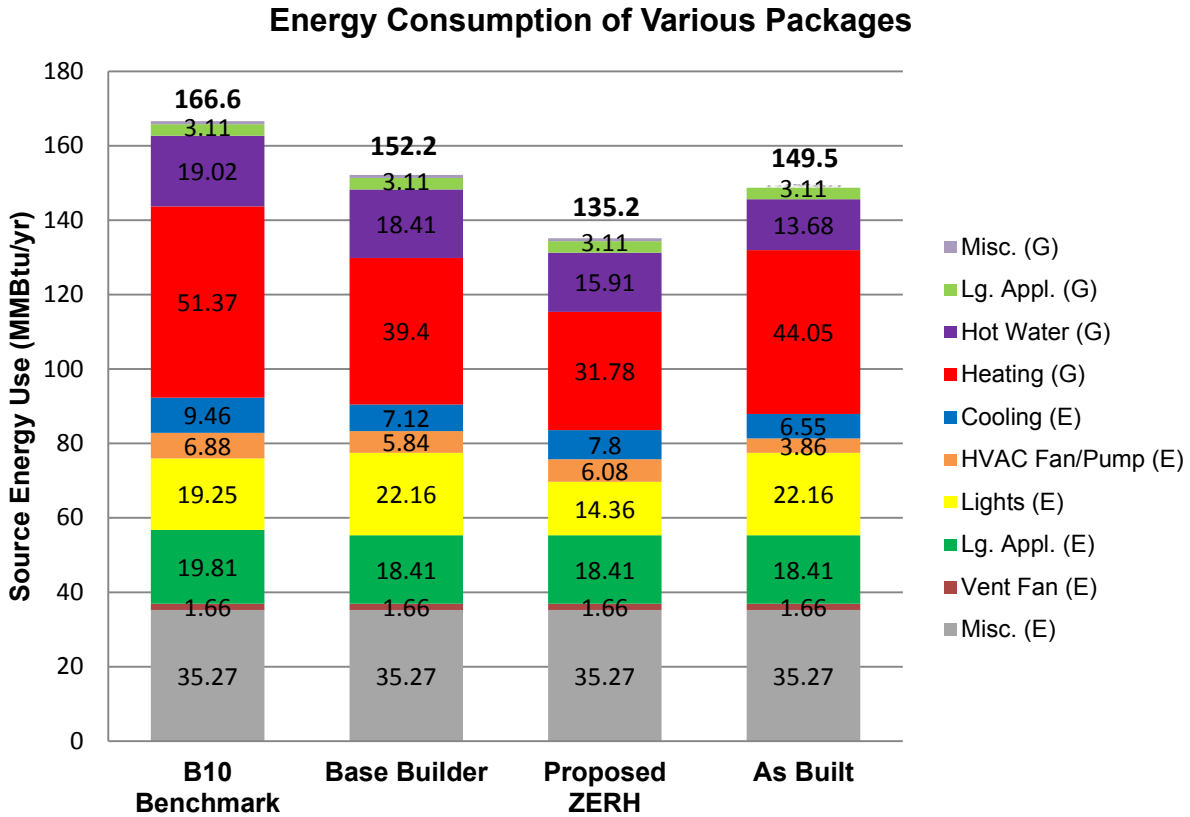
Figure 11. JMC builder package, proposed, and as-built BEopt comparison

The proposed package would meet the project goals of achieving ENERGY STAR certification and result in total source energy consumption savings of 31.4 MBtu/yr (19%) relative to the B10 Benchmark (Figure 11). This would be an 11% improvement over the builder’s base package and save 17 MBtu/yr. The builder did not view the additional costs to meet mandatory requirements for a Zero Energy Ready Home, including further window and plumbing upgrades, as cost-effective. The as-built package was only a modest improvement over base specifications; it saved 2.7 MBtu/yr (2%).

The heating source energy of the as-built home increased from the builder’s base package. Several changes to the building specifications—which have positive impacts on other components of energy consumption, indoor air quality, buyer appeal, and durability—combined to produce this result. For instance, the choice to bring the HVAC system and ducts into conditioned space by encapsulating the roofline with R-20 ocSPF resulted in a significant increase in total U-value times surface area along the insulated top surface of the house. Insulating to R-20 with ocSPF (5.5–6 in. thick) is common practice because that is the perceived point of diminishing returns and thickness for which most ocSPF product manufacturers are approved by the International Code Council Evaluating Service. Even though this strategy reduced duct and enclosure leakage and enclosed the system in a semi-conditioned space, the combined effect of this change alone was a net increase of nearly 4 MBtu/yr.

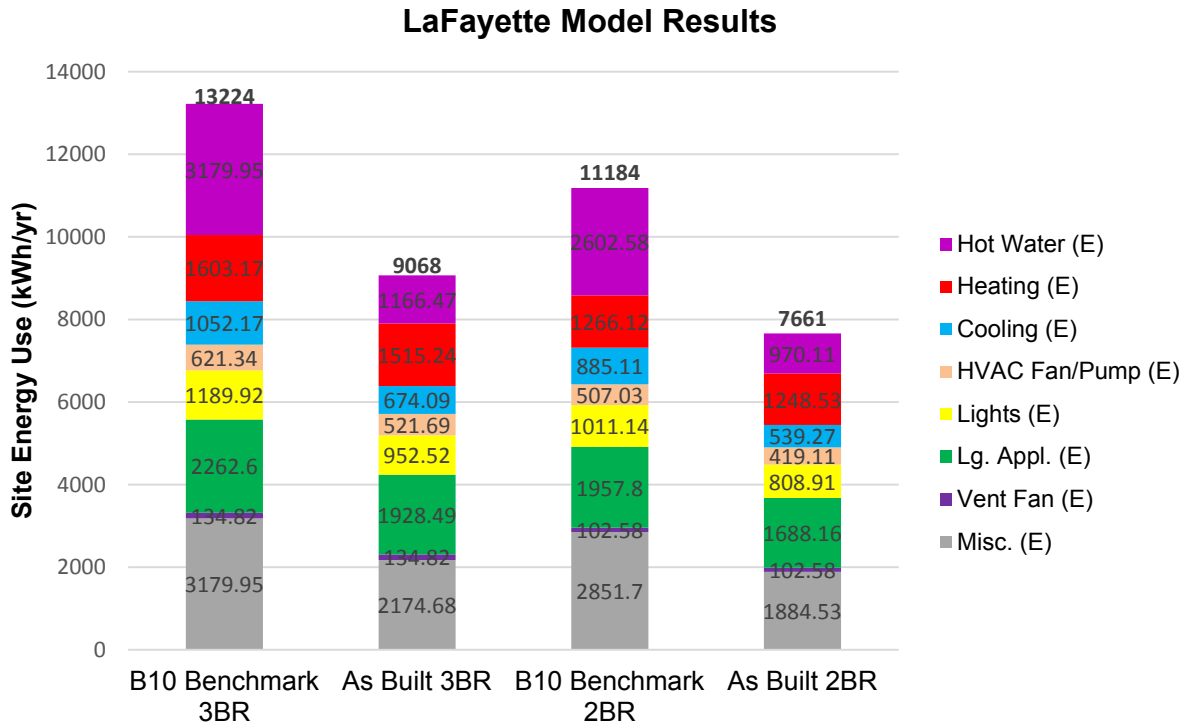
Figure 12. BEoptE+2.3 energy model comparisons of as-built to B10 Benchmark for the two- and three-bedroom LaFayette unit types predicts 31% source energy savings for both.

specifications were entered and compared to the B10 benchmark (Figure 12). The as-built specifications achieved 31% source energy savings over the B10 benchmark for both units.

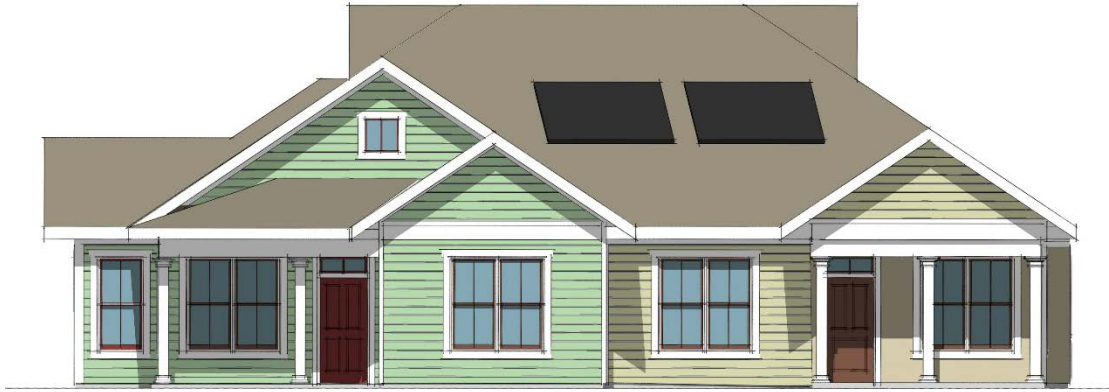
Figure 13. Front elevation of LaFayette duplex with the original plan to include a south-facing solar thermal DHW system

The original design of the duplex was to include solar thermal water heating for each unit, as seen in Figure 13. Southface modeled two different-sized solar thermal arrays (40 ft² and 64 ft²), electric tankless, and an HPWH to analyze the potential savings of various DHW technologies compared to a standard electric resistance storage water heater. Results are in Table 4 and Figure 14. For the three-bedroom unit, the solar thermal water heaters produced the greatest total energy savings (30% for 40 ft² and 36% for 64 ft²) followed by HPWH (27%). The electric tankless water heater produced minimal energy savings (2%). An analysis of simple payback was performed using standard installed costs for all water heater types and an average electricity price of \$0.11/kWh. For the HPWH, the cost included the ducting to connect the utility closet to the attic. Because the installed cost of a solar thermal system is more than three times as expensive as the HPWH, the simple paybacks for the systems were quite different. The simple payback for the HPWH is 10 years, which is within the expected useful life of the appliance. The simple payback for the 64-ft² solar thermal system is 33 years, beyond the age at which the appliance would be expected to require repair or replacement. LHA decided to install a ducted HPWH based on this analysis.

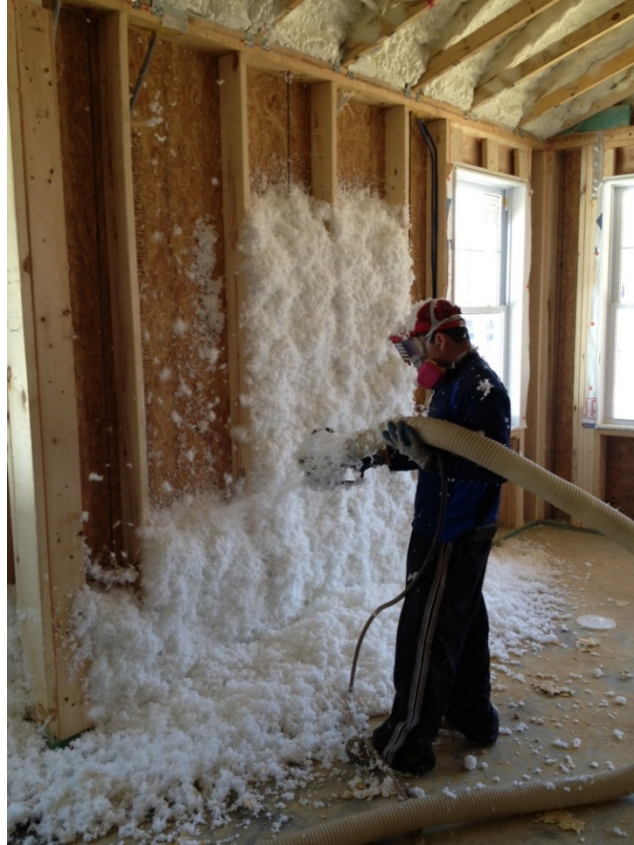
Figure 18. Installation of Johns Manville Spider insulation

Johns Manville Spider spray-in fiberglass insulation was installed in the wall cavities at LaFayette. Spider insulation is installed similarly to wet/damp spray cellulose, except the fiberglass is sprayed with a small amount of acrylic binder (glue) to adhere the insulation to the cavities and perhaps avoid the need to install netting. Spider insulation is installed at a lower density (1.8 lb/ft³) than cellulose (3.5 lb/ft³), using less material and having a slightly better R-value/in of 4.2 versus 3.8 for dense-pack cellulose (Johns Manville 2014; DOE 2015). Johns Manville provided additional technical support by flying two product engineers to the jobsite to witness the first day of Spider installation. This was extremely beneficial to the project, because the engineers discovered that the installation crew was using a hose head and spray nozzles for spray-applied cellulose instead of the specified head and nozzles for Spider. The improper nozzles were delivering a stream of adhesive instead of a mist, and the air pressure on the hose was causing too much fiberglass to be put into the cavity. After replacing the nozzles with Spider nozzles, the insulation still was not cleanly adhering and filling the cavity in a few passes. The cavity filled quickly and overflowed onto the floor and required additional vacuuming. Despite being trained onsite by two Johns Manville Spider technical representatives, installation was tedious and required vacuuming of excess blown fiberglass off the floor (Figure 18).

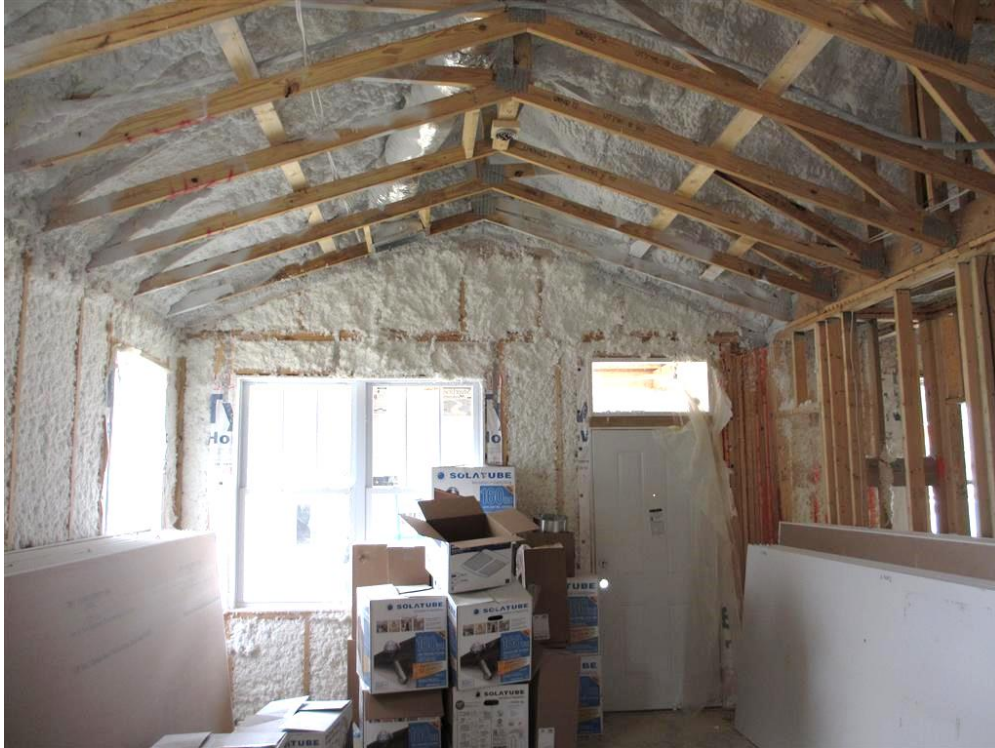
Figure 19. Spray-applied Spider insulation

The spray rig failed while the insulation was being installed on the fifth building at the first site. To stay on schedule, the crew installed netting and dense packed the cavities with dry product (Figure 20). From this, the installer discovered that the time spent installing the netting was much cheaper and faster than applying adhesive, shaving, and vacuuming for the spray-applied application and used this method for the remainder of the project. Unfortunately, the density tester is calibrated for spray-applied product only and could not be used to measure the R-value of netted installations.

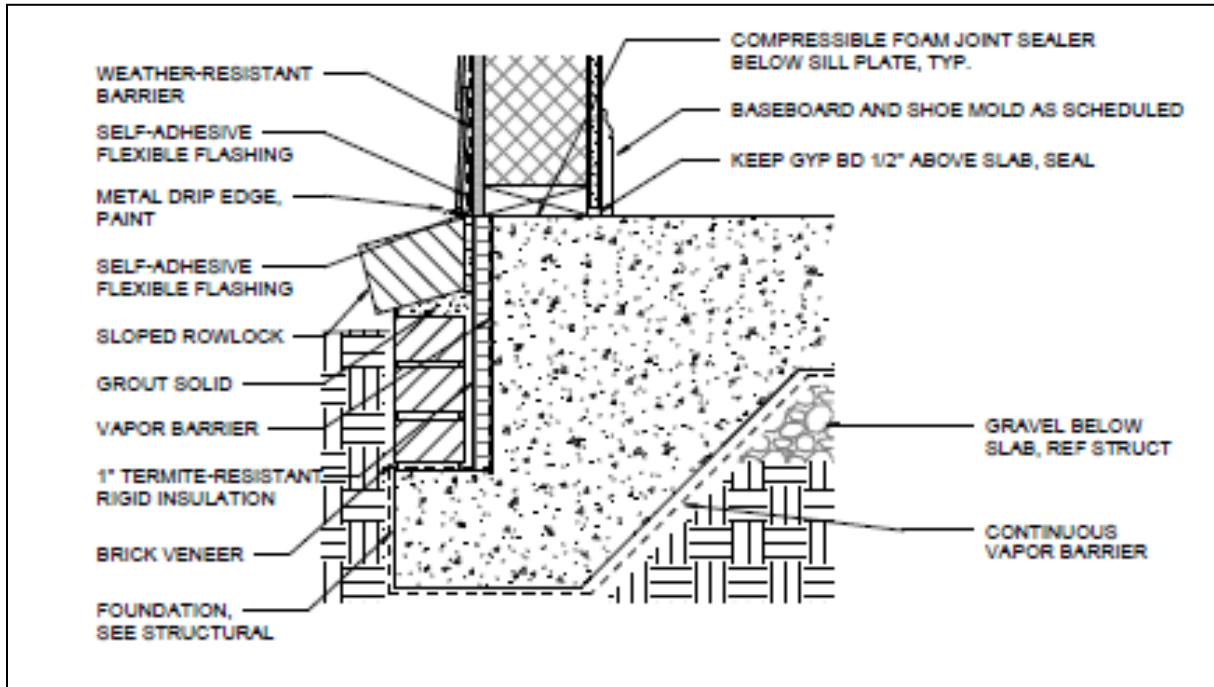
Figure 21. LaFayette slab edge insulation detail

stem walls was constructed. This is a typical construction technique in the Southeast that is used to raise the floor level of the home for storm water management and architectural aesthetics. Instead of constructing a “floating slab” by leaving the concrete masonry units unaltered, the builder notched the concrete masonry units to support the poured slab. Thus, the proposed slab insulation solution was to insulate the slab exterior with 1-in. (R-5) of extruded polystyrene foam board.

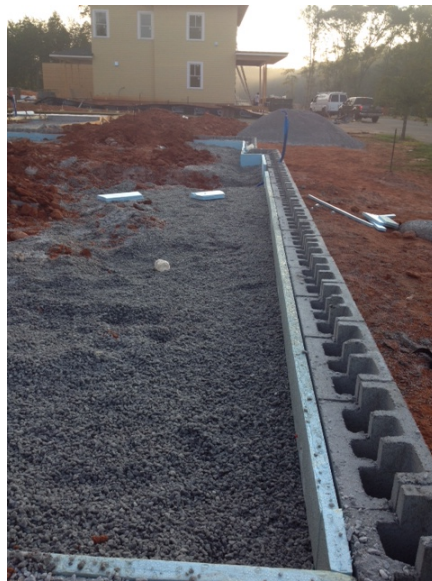
Figure 23. JMC elevated slab construction in progress showing gap insulation and stem wall

The builder chose instead to attempt an interior and gap insulation solution (Figure 23) to eliminate the costs associated with providing a protective covering for the exterior foam. The lower section of the slab is insulated, and the top half of the slab filling in the concrete masonry unit notches is exposed to the stem wall, creating a thermal bridge. The cost of the slab insulation was \$1,645 over initial budget.

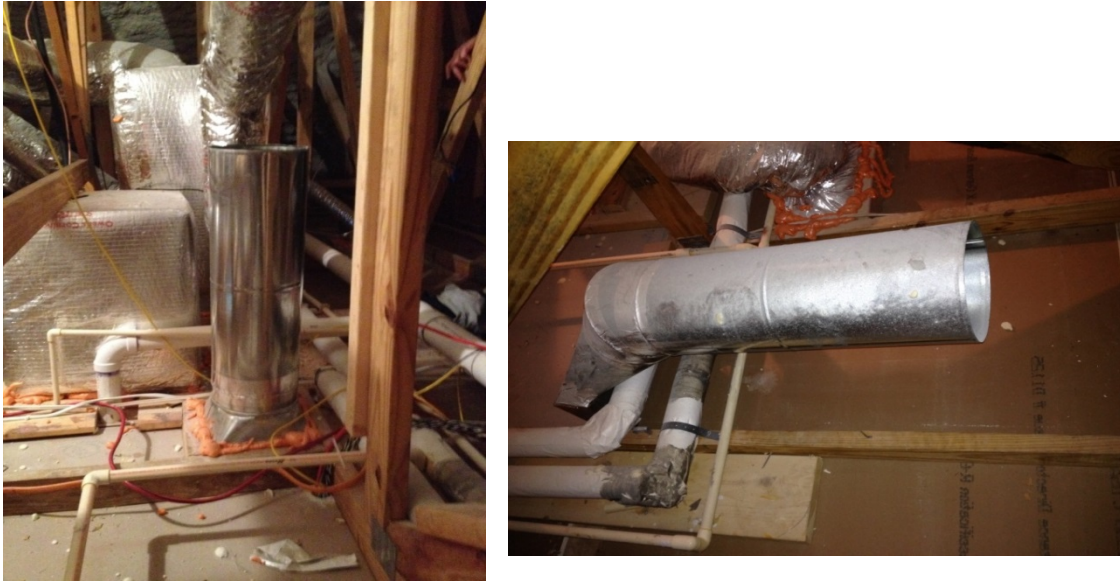
Figure 26. Vertical intake transfer duct connects to a vent in the mechanical closet’s ceiling (left); horizontal exhaust duct connects to 3-in. × 14-in. rectangular duct inside the wall cavity leading to the HPWH in closet (right).

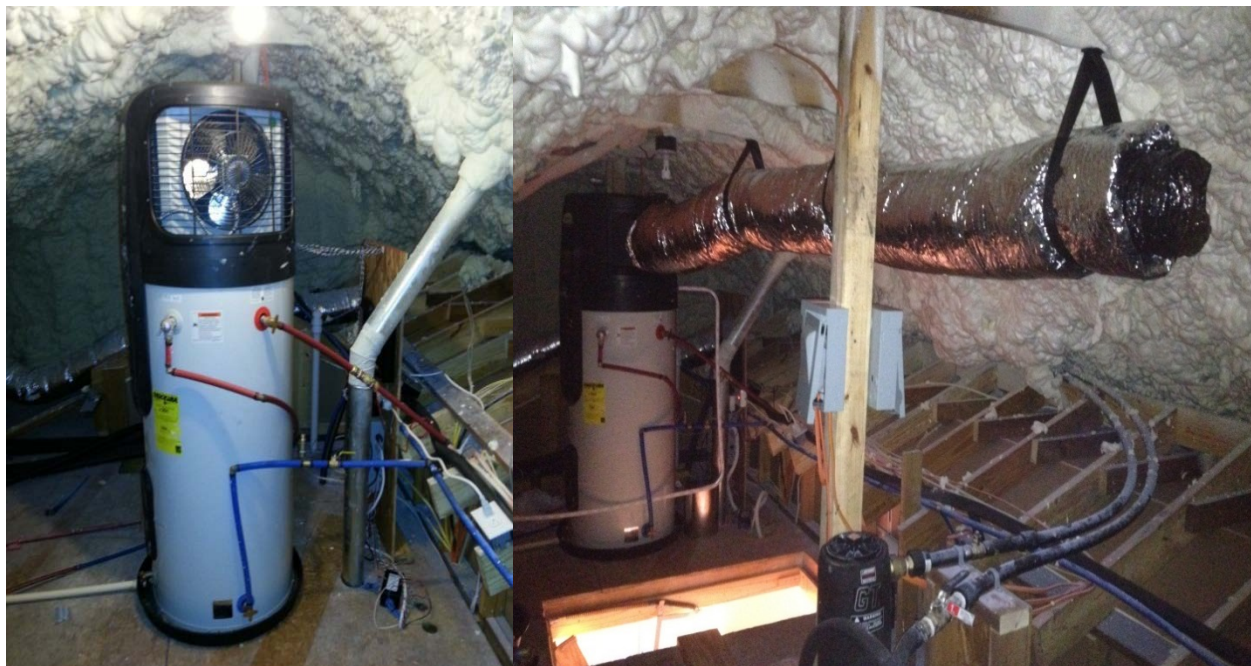
Figure 27. Savannah Gardens Lot 207 HPWH in the encapsulated attic before the exhaust duct was installed (left) and after the exhaust duct was installed (right)

The test home in Savannah Gardens had an HPWH installed directly in the ocSPF encapsulated attic (~1,508 ft³) with a 10-ft duct terminating therein (Figure 27). The house adjacent to the test home is of similar size, dimension, and construction, with an electric 50-gal A.O. Smith water heater (ECRT-52) in its encapsulated attic. The temperature and relative humidity in the attic of the neighboring home were also monitored.

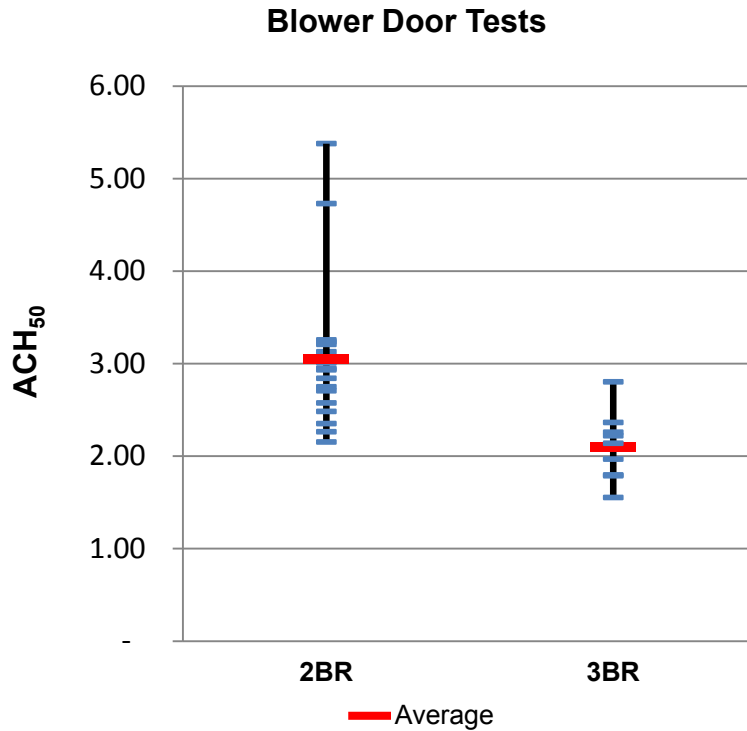
Figure 28. LaFayette airtightness values. Data Courtesy of SKCollaborative.³

The exclusive use of ocSPF for roof and wall cavity insulation was considered at LaFayette to ensure tight envelopes but was not used in wall cavities due to budget constraints. Concerns about the impact on envelope air leakage of using Spider instead of ocSPF in the wall cavities proved unfounded. Blower door testing done as the homes were nearing completion showed that nearly every apartment was lower than the target of 3.3 ACH₅₀; a few units were lower than 2.0 ACH₅₀. Figure 28 shows the variations of envelope leakage in all units by number of bedrooms. The two two-bedroom units in the Uniform Federal Accessibility Standards building are the outliers in the data. All the other buildings' layouts were two- and three-bedroom duplexes. The front-facing bedrooms in the outlying duplex have dormers that were not specifically detailed for air sealing and insulation, and some sort of sealing was clearly omitted from these two two-bedroom units. Although they still easily exceeded 2009 International Energy Conservation Code infiltration rates (7 ACH₅₀), one unit narrowly missed ENERGY STAR Version 3 infiltration levels (5 ACH₅₀). All the three-bedroom units met the 2012 International Energy Conservation Code requirements (3 ACH₅₀). LaFayette also had guarded blower door tests performed on two duplex buildings to distinguish envelope leakage to the outside from that to the adjacent unit. Approximately 35% of the total leakage was to the adjacent unit.

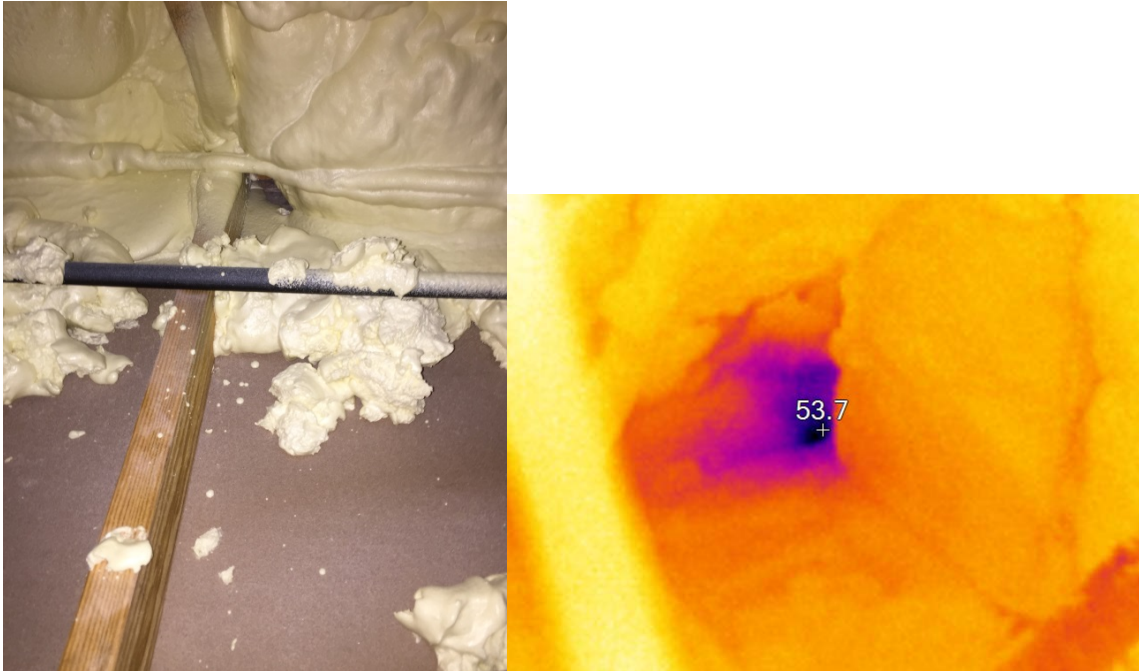
Figure 29. Attic air leakage pathways identified in ocSPF at truss-to-top plate intersection

JMC Patrick Square had the greatest envelope leakage of all three homes, and an infrared camera was used to identify major air leakage pathways. Large sources of air leakage were identified in the attic where the ocSPF did not make an airtight seal between the bases of the trusses and the wall top plates (Figure 29) and behind the bathtub in the master suite (Figure 30).

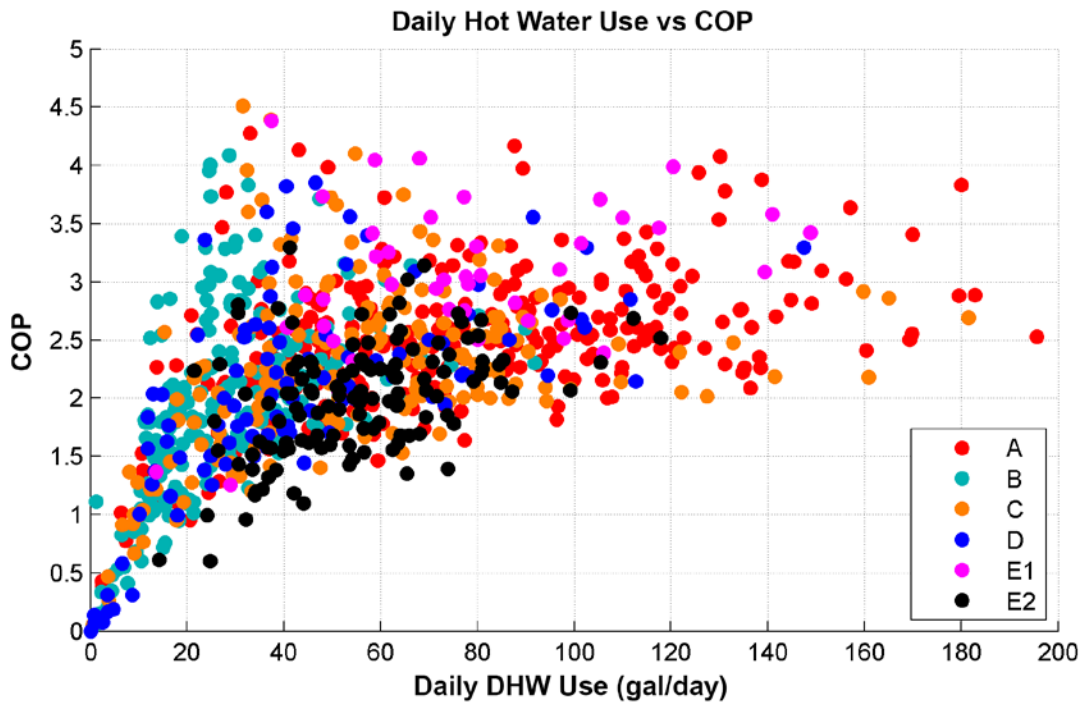
Figure 31. Scatter plot of daily hot water use versus COP for all five units

Figure 31 displays the trend between daily hot water consumption and average daily COP. The COP increases sharply before reaching the knee of the curve between 20 and 40 gal/day before leveling. This trend was reported by Shapiro and Puttagunta (2013). They reported an average COP value of 2.1 for the unducted A.O. Smith Voltex models; the average of daily averages for all units in this study was 2.3 (excluding E2).

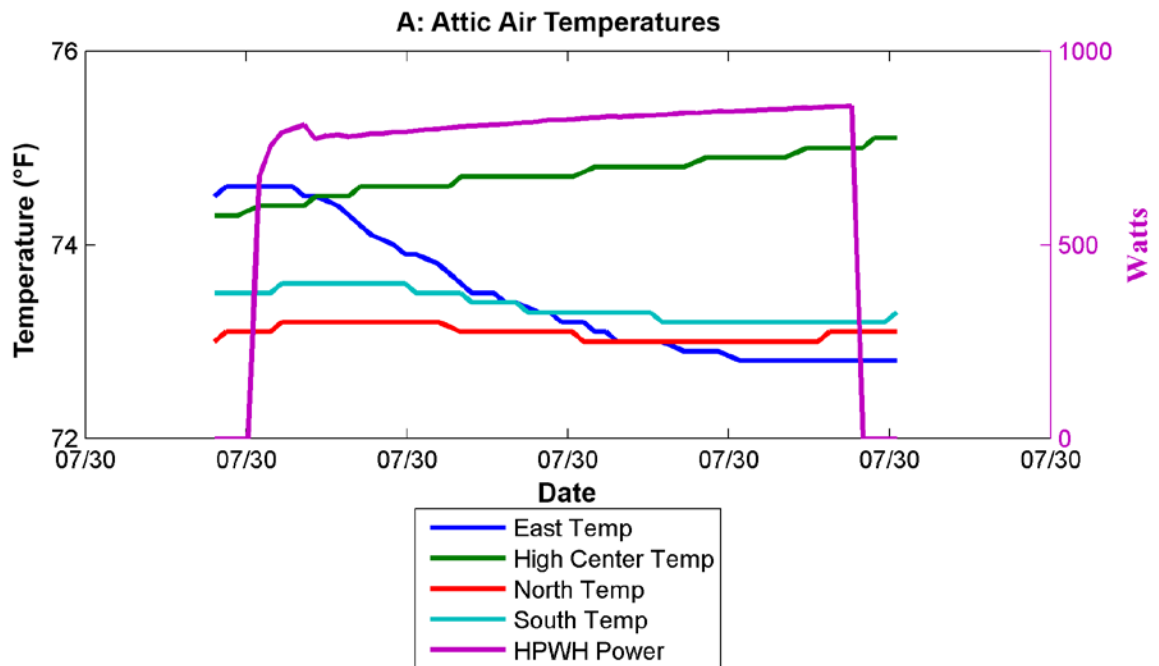
Figure 34. Zoomed section of Figure 33 showing attic temperature changes during HPWH operation

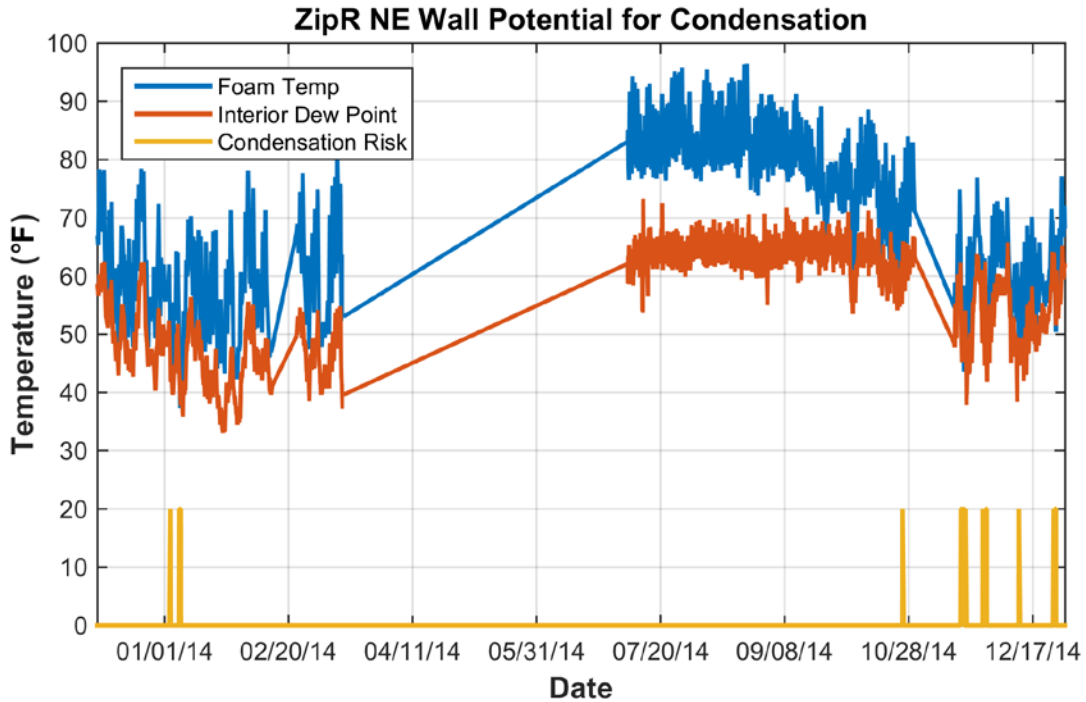
Field data in Savannah were analyzed for each minute to quantify the time either home had a risk of condensation. Figure 41 and Figure 42 show the dew point of the air in the living space and the interior surface temperatures of the sheathing for the NNE walls in the Zip and ZipR homes. The yellow line indicates when the sheathing temperature is lower than the interior air dew point, which indicates a risk for condensation. The ZipR home’s NNE wall had 83% less time at risk for condensation than the Zip home. During an average winter day, the Zip home’s NNE wall was at risk for condensation for 185 minutes. During the same time frame, the ZipR home’s NNE wall was at risk for condensation for 12 minutes.

Figure 42. Periods of potential condensation for ZipR house on northeast wall. A yellow line at 20 indicates a risk of condensation.
