Perspective

Degradation of Insulating Glass Units: Thermal Performance, Measurements and Energy Impacts

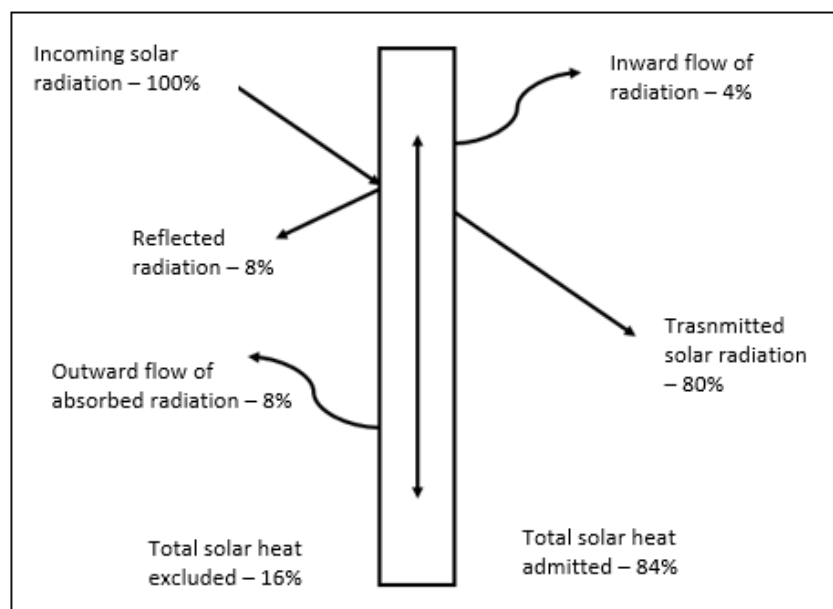
Figure 2. Solar Radiation on a Window; regenerated [8].

The solar radiation and thermal conductivity lead to increased heat gains in the summer which increase cooling loads. In the winter, only the conductivity contributes to the increase in heating required. The conductivity associated with extreme temperature differences and the solar radiation striking windows also drive degradation [9]. Windows are typically broken down into two physical components: the insulating glass unit (IGU) and the frame. The IGU consists of at least two glass lites that are separated by a spacer system, typically containing a desiccant material with the edges of the units sealed using various polymeric materials. The interior of the sealed unit is typically filled with an inert, low thermal conductivity gas, and the glass lites may have low emissivity (Low-e) coatings for mitigating solar heat gains. Degradation of IGUs is most often associated with edge seal failure, inter-pane gas loss, and breakdown of the low-e coating. These modes of failure occur within the IGU of a window system and can typically be decoupled from thermal bridging and other frame effects. Commercial windows have a life span of 20–30 years compared to the overall 50–60 year life span of a commercial building [10]. Their shorter lifespan, multiple modes of degradation, and large contribution to energy

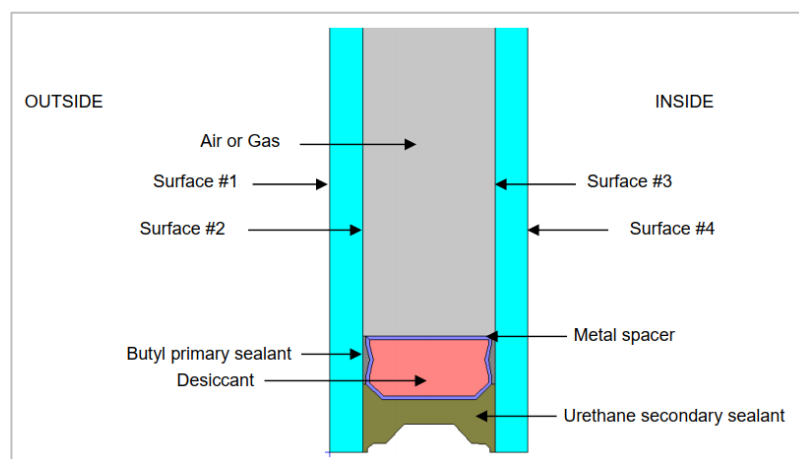
Figure 3. NFRC diagram.

Figure 3 shows an IGU with a dual edge seal system, which became popular in the 1990s due to the demand for longer service life [9]. A dual seal system consists of a “primary” sealant, typically polyisobutylene (PIB), which provides gas retention properties, and a secondary seal of varied polymeric materials that provides structural integrity for the unit. Commonly used secondary sealants include polyurethane, polysulphides, and polysilicones. The spacer, which holds the two glass lites apart, is filled with a desiccant material that is intended to absorb any moisture that enters the edge seal and prevent ingress to the inter-lite gas gap. The dual seal system of an IGU is of great importance to product durability as it has a notable influence on the gas leakage rate and vapor permeability, which both can reduce the thermal performance of a window [13]. In addition

The durability of a window is its ability to remain functional and perform as designed. Window durability is dependent on the frame and sash, insulating glass seals, and weatherstripping, though there is no simple rating of durability [12]. Figure 3, from NFRC 100, shows the arrangement of a dual-paned IGU.

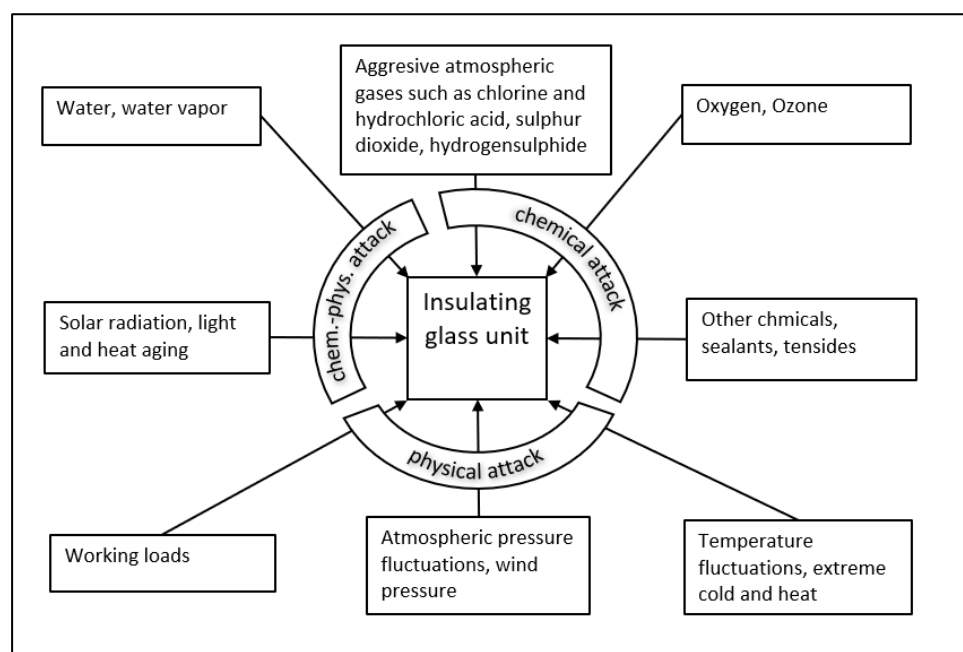
Figure 4. Environmental Influences on Aging Process of Insulating Glass [13].

In the 1990s, Wolf and Waters found that the secondary seal of IGUs played the most important role in IGU life expectancy and durability [14]. The main environmental aging and weathering effects on an IGU and seal are temperature, pressure, sunlight, and oxygen/ozone, as shown in Figure 4 [13].

Both temperature and pressure fluctuations lead to mechanical stress on the edge seal which can affect elasticity and accelerate physical deterioration. Oxygen/ozone exposure can result in the oxidation of the glass sealants and make them more brittle. Sunlight is regarded as the most important aging factor on IGUs due to its thermal and photochemical effects on the edge seal. These aging factors work in tandem during the entire lifecycle of IGUs and can result in seal and glass material degradation. Additionally, low elastic recovery of the secondary seal at high temperatures shortens the service life of IGUs. Wolf and Waters evaluated the effects of temperature on vapor diffusion of 15 insulating glass sealants following DIN 53122. They assessed the permeability at 20 °C, 40 °C, 60 °C, and 80 °C, and found that the sealants exhibit six to eight times more permeability at 60 °C than 20 °C. This indicates that the sealant will degrade more rapidly in summer months than winter months, even when exposed to high temperatures for a shorter duration. Wolf and Waters also observed that silicone sealant permeability varies less as a function of temperature than those with a polysulphide base, as shown by Figures 5 and 6, indicating that polysilicones may extend the lifespan of sealants and prevent moisture penetration. Note that for Figure 5, sealants labeled with b had no meaningful data obtained.

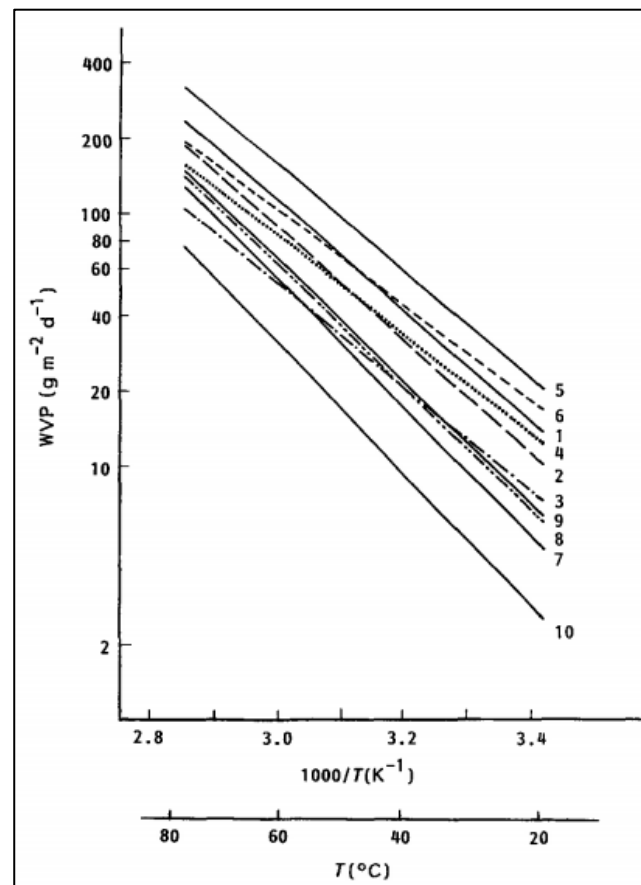
Figure 6. Arrhenius Plot for the Water-vapor Permeabilities of Insulating Glass Sealants [14].

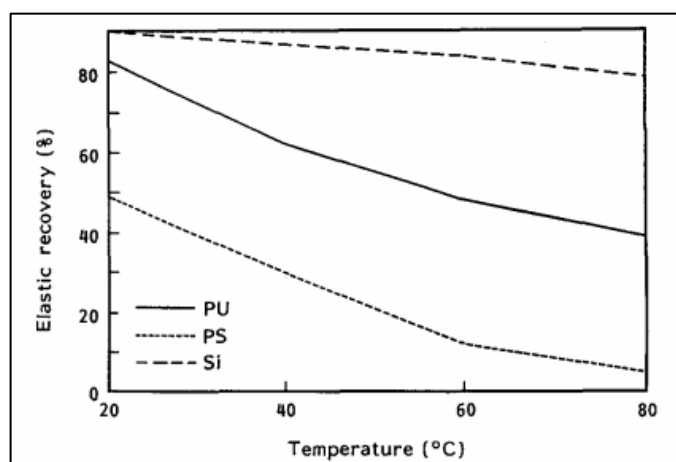
Figure 7. Influence of Elastic Recovery of the Secondary Sealant [14].

Wolf and Waters also analyzed eight sealants on premature failure due to adhesion loss following ASTM G-53. All sealants were allowed to cure for six weeks under standard climate conditions before being subjected to accelerated weathering. The accelerated weathering of the sealants consisted of UV light exposure over 1000, 2000, 5000, 10,000, and 20,000 h followed by a weathering cycle of four of UV exposure at 65 °C, then by four hours of condensation at 50 °C. Finally, specimens were elongated by 25% for 24 h and considered “failed” if they lost more than 10% of adhesion. Results of this test revealed that polysulphide sealants exhibited the poorest resistance to UV exposure and lowest elastic recovery, as shown in Figure 7.

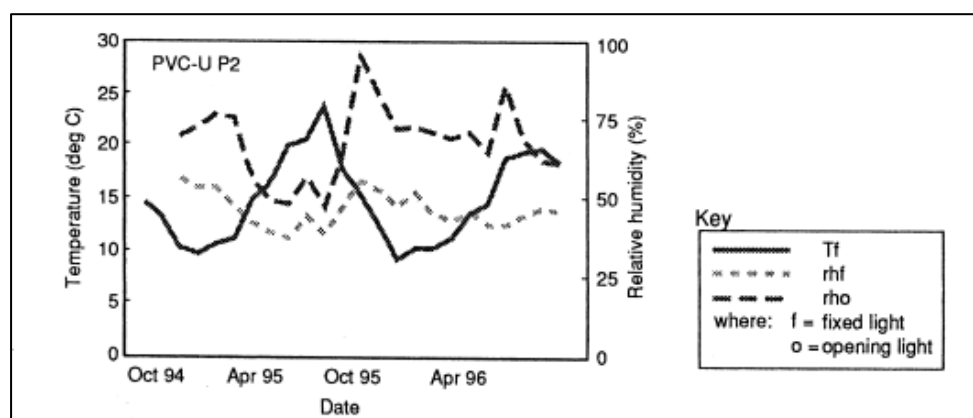
Figure 8. Mean Temperature and Relative Humidity for PVC-U P2 Type Window [15].

Unlike most durability literature that is typically completed in a lab, Garvin and Wilson used in-field measurements to acquire quantitative data on durability parameters [15]. The main goal of this research was to analyze the potential service life of windows under real conditions given the lack of long-term durability studies. The experiment was set up in a test home in Scotland and took place over two years. Windows of various orientations and constructions were monitored every 30 min on relative humidity of the cavity, temperature of the cavity, and liquid moisture in the edge seal. The interior room temperature was controlled via heaters while the exterior was exposed to ambient conditions. Humidity results showed that the mean relative humidity in the cavities was highest during winter months and for timber frames, likely due to direct penetration of rain. Temperature readings revealed that the cavity temperatures were a direct reflection of external conditions. Liquid moisture in the edge seal was found to be higher in fully bedded windows than the drained and ventilated frames. A sample of the results for a PVC-U frame is shown in Figure 8.

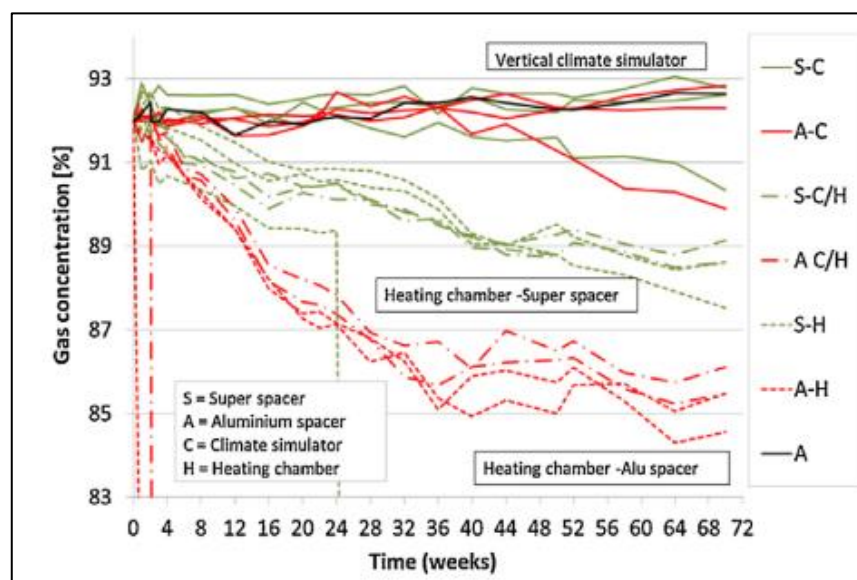
Figure 9. Gas Concentration Versus Time of the Windowpanes Subjected to Accelerated Aging [5].

Asphaug et al. found that aging and degradation of windowpanes can lead to a loss of noble gas concentration within the inter-pane space [5]. Like Wolf and Waters, Asphaug et al. found that the durability of IGUs is primarily characterized by spacer type. Seal failure leads to the loss of insulating gas, such as argon, krypton, xenon, and air, which can increase the U-factor of an IGU up to 32%. Their experiment included 18 IGUs filled with argon gas, nine with super spacers and nine with aluminum spacers. The IGUs were split into three groups with various weathering methods including a climate simulator, a heating chamber, and a combination of the two. The gas concentration of each IGU was measured regularly over a span of 70 weeks and plotted versus time. Results indicated more gas leakage for aluminum spacers and significantly more leakage for all IGUs put in the heating chamber, as shown in Figure 9.

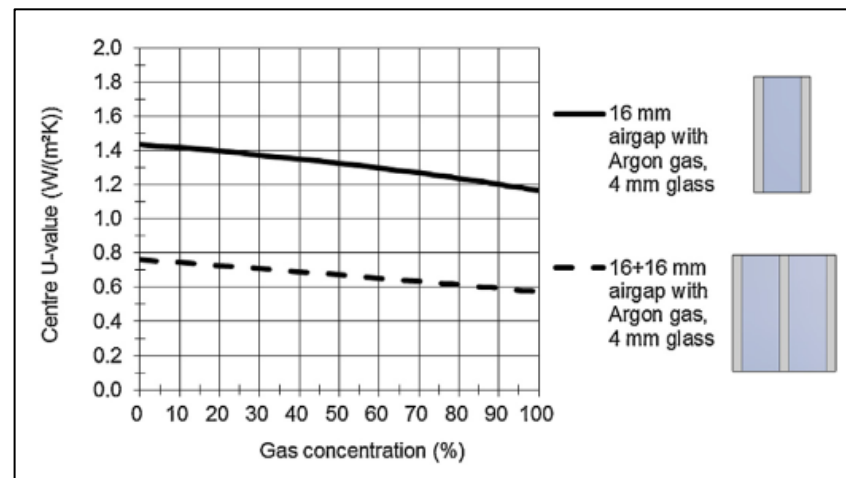
Figure 10. Increasing Center U-value with Decreasing Gas Concentration [5].

Results also indicated a decrease in U-factor as a function of gas leakage, as provided in Figure 10, but little information is given on how U-factor is evaluated in this study.

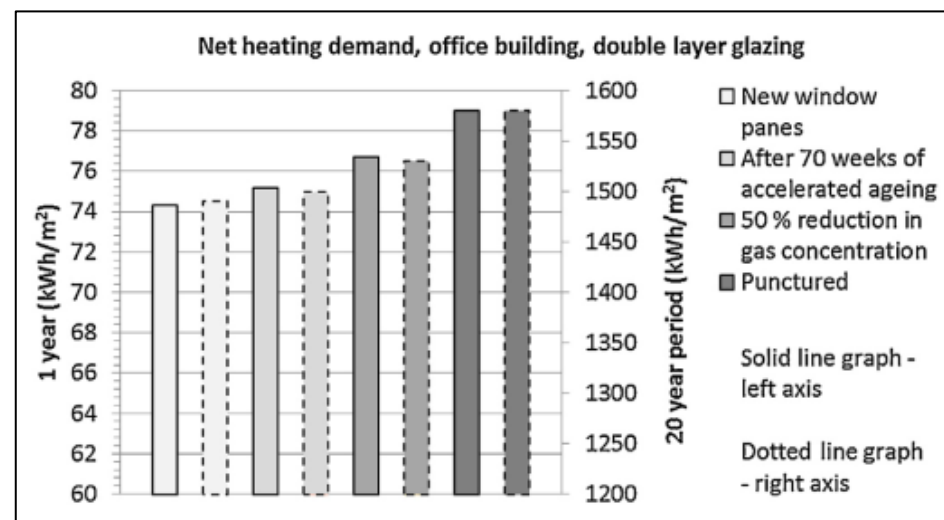
Figure 11. Net Heating Demand, Office Building, Double Layer Glazing [5].

Similar to the gas concentration, little information is given on the overall U-factor of the windows used in each of the simulations. Results of the simulation showed that an increase in heating demand over 20 years due to gas concentration loss would be up to 65 MWh for a typical office building and up to 1.3 MWh for a single-family home. A sample of the results is provided in Figure 11.

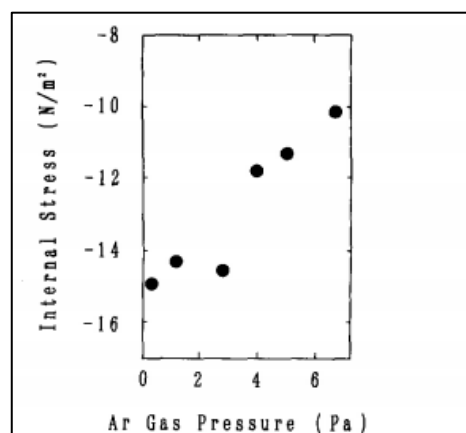
Figure 13. Dependence of the Internal Stresses in ZnO Layers on the Sputtering Gas Pressure [26].

Miyazaki and Ando [26] discuss improving the durability of silver-based low-e coatings. In their study, they investigated the degradation of a silver layer sandwiched between two layers of zinc oxide. The degradation process was comprised of a humidity test at $50\text{ }^{\circ}\text{C}$, 95% relative humidity for 144 h. After this test, Miyazaki and Ando used electron microscopy, energy dispersive X-ray spectroscopy, and X-ray diffraction to compare to the new sample. They found that the zinc films had a large internal stress under higher gas pressure that was reduced by adding aluminum, as shown in Figure 13.

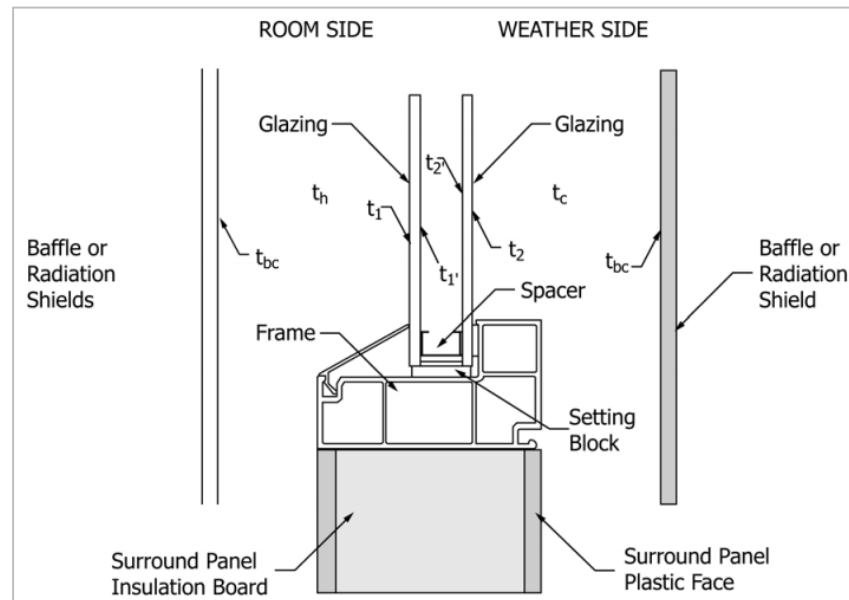
Figure 14. ASTM C1199 testing setup.

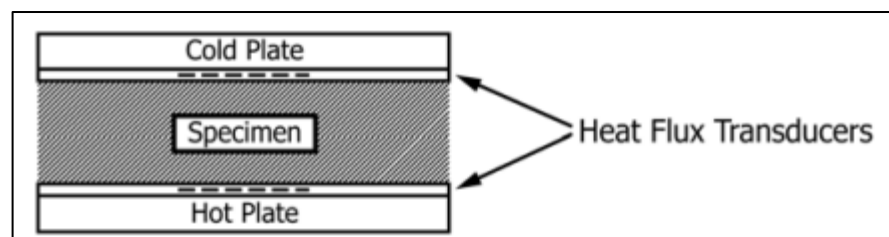
Figure 15. Apparatus with Two Heat Flux Transducers and One Specimen.

ASTM C518-21 is a standard test method for steady-state thermal transmission through flat slab specimens using a heat flow meter apparatus. This standard can be applied to any material, including glass samples. Steady-state one-dimensional heat flux through a specimen is generated through two parallel plates. Fourier’s law of heat conduction is used to calculate thermal conductivity based on the heat flux and plate temperature measurements. This method offers a quick and easy way to measure thermal properties of window samples using a heat flow meter; however, the testing apparatus is typically large and cannot be used in the field. Figure 15 shows a typical assembly using two heat flux transducers and one specimen.

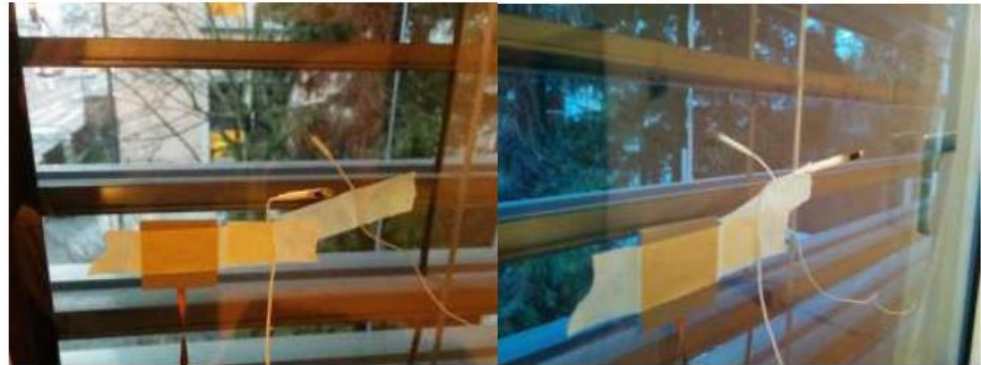
Figure 16. gSKIN Measurement Setup [31].

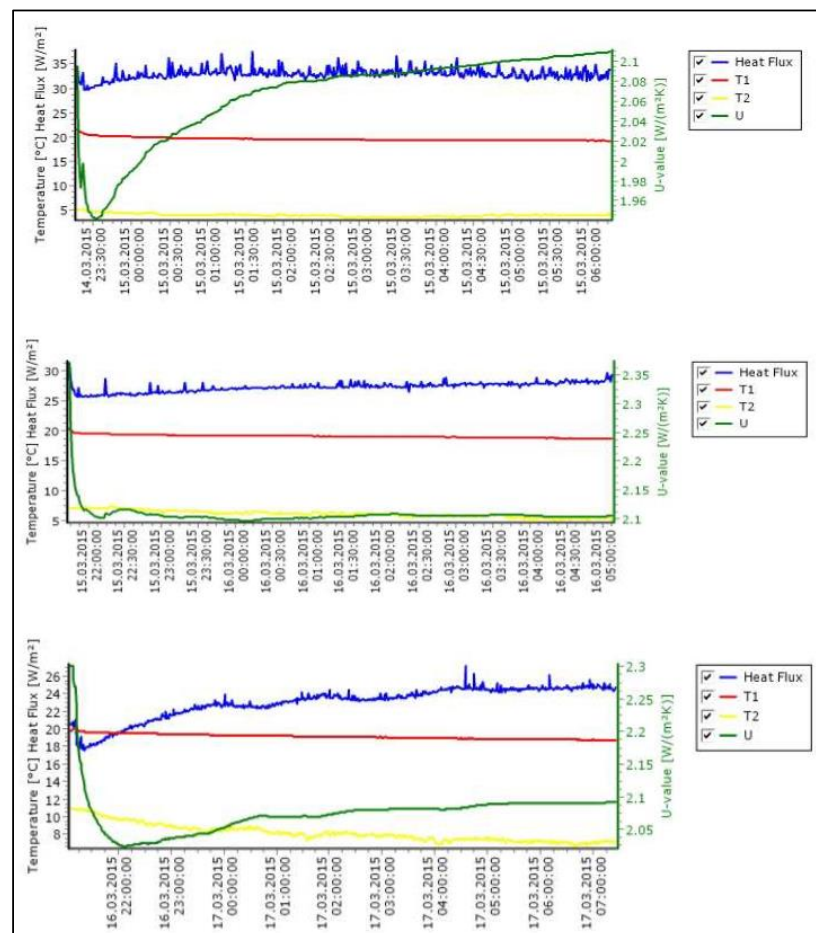
Figure 17. Results of Three Nighttime Measurements [31].

Three night-time measurements were taken over several hours with stable weather conditions to negate the effects of wind and solar radiation and evaluated using greenTEG software. Graphs of these measurements are provided in Figure 17.

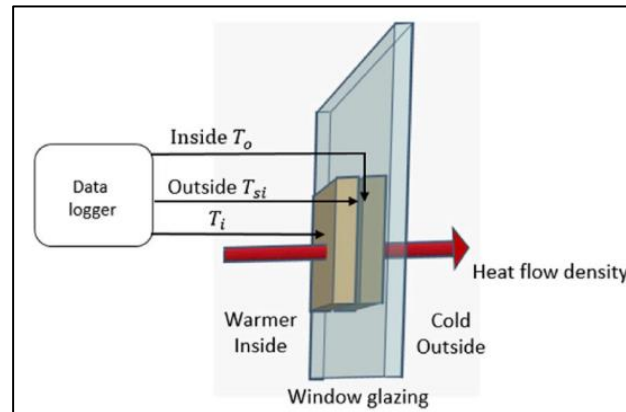
Figure 18. Typical Measurement Setup [32].

The thermocouples in Figure 18 measure inside air temperature, outside air temperature, and inside surface temperature. They assumed steady-state so that the heat flux through the 3D-printed object and window could be equal, and the equations simplified. By doing so, they were able to estimate the center-of-glass U-factor of the window based on three temperatures and the R-value of the 3D object. The three temperatures were processed every second by a micro-controller and plotted versus time over several hours in the evening to avoid solar radiation effects. Three measurements with various outdoor conditions were taken on a double-pane window with a manufacturer U-factor rating of $2.97 \text{ W/m}^2\text{K}$. The first measurement took place with an indoor temperature of $24.1 \text{ }^\circ\text{C}$ and outdoor temperature of $6.3 \text{ }^\circ\text{C}$. It took 35 min to reach steady-state and the measured U-factor was $3.15 \text{ W/m}^2\text{K}$, a 6.1% error compared to the known value. The second measurement took place with an indoor temperature of $23.7 \text{ }^\circ\text{C}$ and outdoor temperature of $8.4 \text{ }^\circ\text{C}$. It took 35 min to reach steady-state and the measured U-factor was $3.26 \text{ W/m}^2\text{K}$, a 9.8% error compared to the known value. The third measurement took place with an indoor temperature of $23.8 \text{ }^\circ\text{C}$ and outdoor temperature of $18.2 \text{ }^\circ\text{C}$. It took 40 min to reach steady-state and the measured U-factor was $2.32 \text{ W/m}^2\text{K}$, a 21.6% error compared to the known value. Figures 19–21 show the results from each measurement.

used two 3D-printed objects made of acrylonitrile butadiene styrene with known thermal properties, three temperature sensors, and a data logger as their measurement setup, as shown in Figure 18.

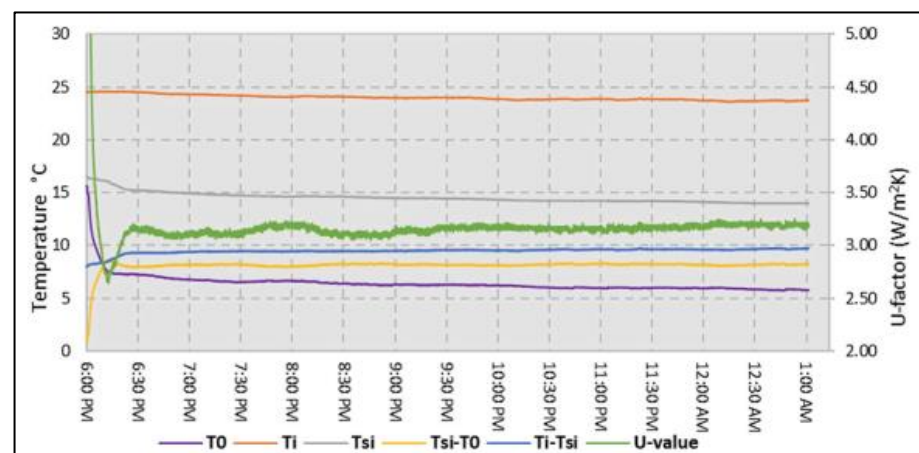
Figure 19. First Measurement [32].

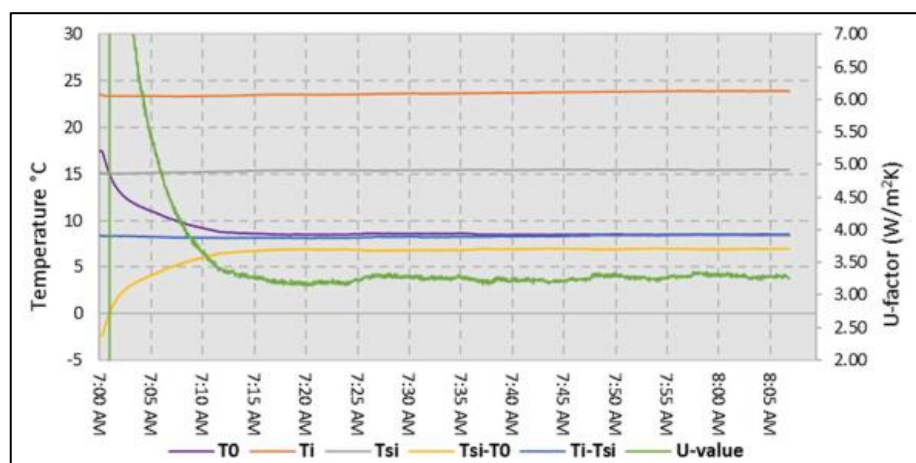
Figure 20. Second Measurement [32].

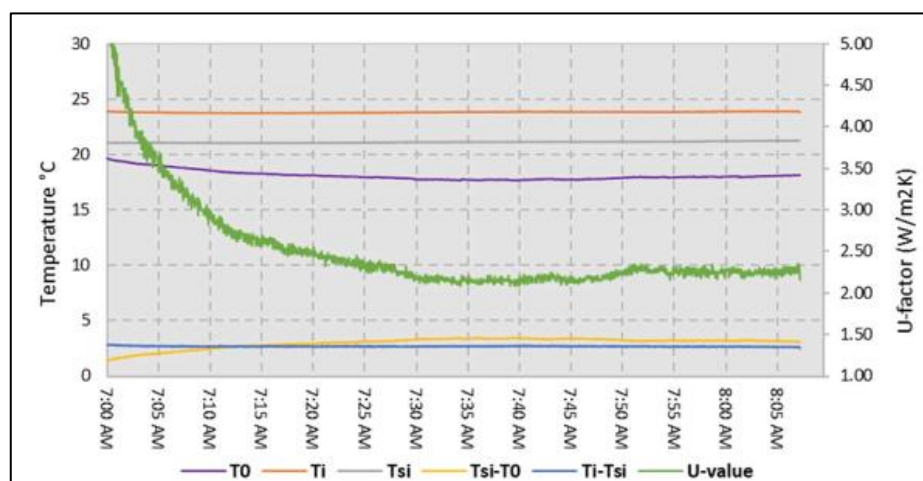
Figure 21. Third Measurement [32].

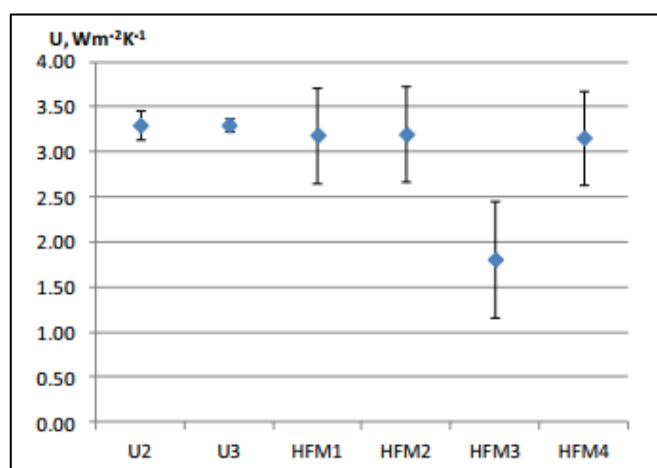
Figure 22. Comparison between in situ U-values [33].

The authors found method one to be unreliable and thus scrapped it from their results. Their results for the window sample show a range of accuracy for each test and each heat flux meter. They averaged the results for each sample duration and found the U-factors to be 3.19 W/m²K, 3.2 W/m²K, 1.81 W/m²K, and 3.16 W/m²K for four different HFM measurement techniques. These are compared to the known U-factor of 3.3 W/m²K. A box-and-whisker plot of these in situ values, along with U2 and U3 values measured in-lab and their uncertainties, is provided in Figure 22.

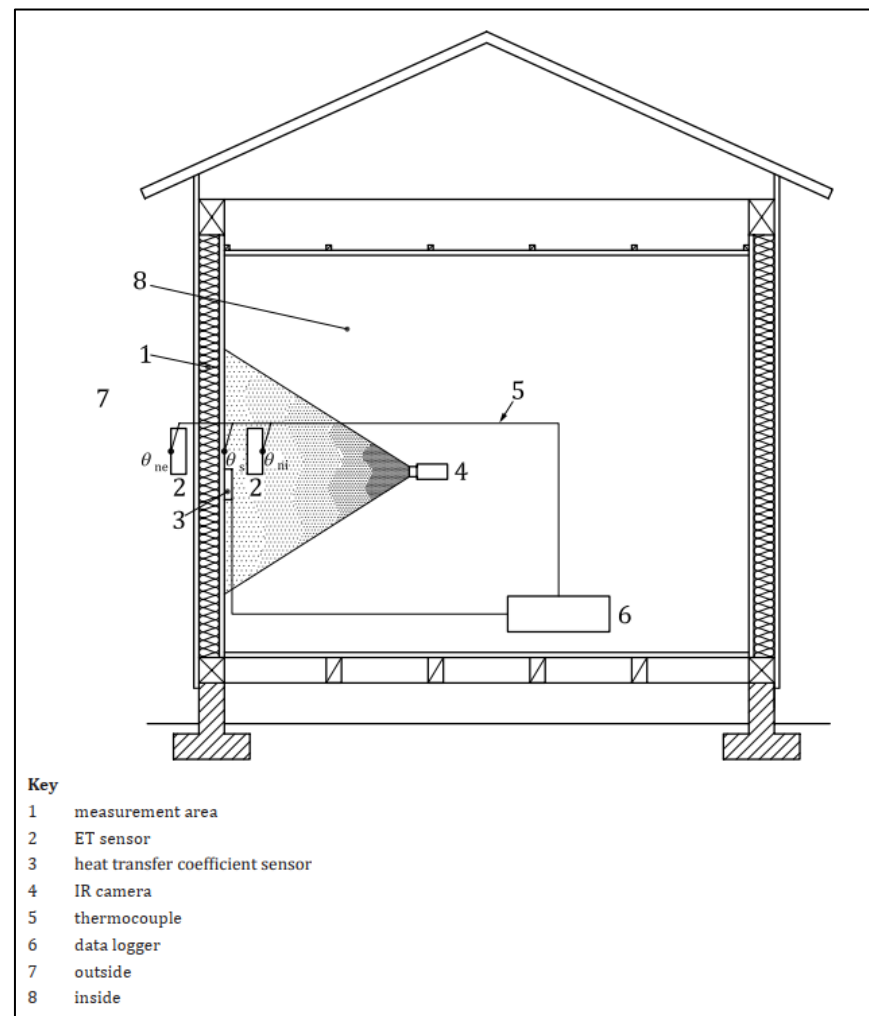
Figure 23. IRT Measurement Setup.

Another promising method for measuring window U-factor in situ is the infrared method. The apparatus consists of an infrared camera, heat transfer coefficient sensor, ET sensor, and thermocouples. This method measures the amount of irradiance of regions in contact with outside air from the surface temperature, total heat transfer coefficient, and ambient temperatures. Compared to the heat flow method, infrared offers shorter testing time, more flexibility of measurement area/location, and less interference with building constructions. The infrared method is outlined in ISO 9869-2 for opaque envelope constructions and results on accuracy for transparent constructions is mixed. An example of the testing apparatus is provided in Figure 23. ET sensors are used to measure environmental temperature of the regions of the object to be measured, and the heat transfer coefficient sensor is used to estimate the total heat transfer coefficient of the surface to be measured. Thermocouples are arranged to measure inside air temperature, outside air temperature, and at least one surface temperature. The main component of the setup is the infrared camera which captures a thermal image of the surface.

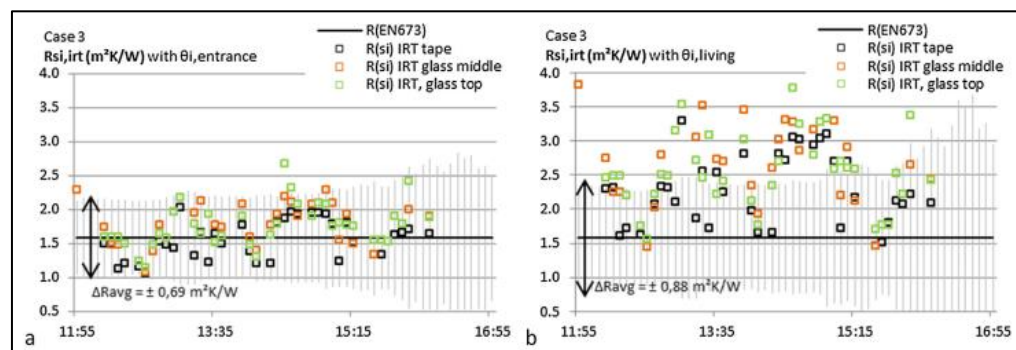
Figure 24. (a) Resistance Calculation for location 1 and (b) Resistance Calculation for location 2 for Case 3 Sample [34].

indicate high sensitivity to the internal and external heat transfer coefficients and outdoor air temperatures. Figure 24 shows the results of resistance values for Case 3 (triple glazing with argon). This figure shows the high variation of measured R-values (shown as black, orange, and green squares) compared to a known value (black line).

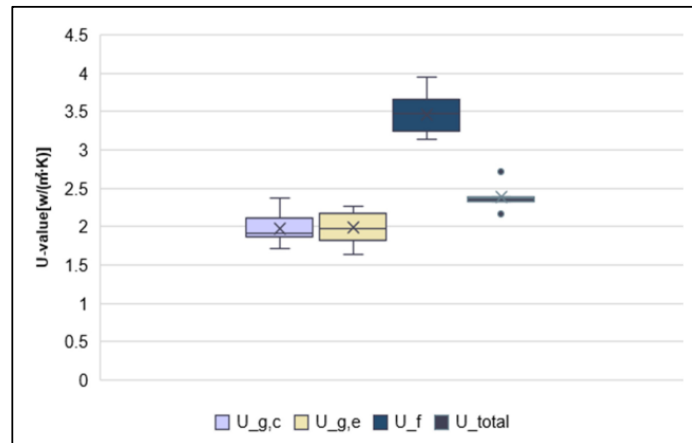
Figure 25. Boxplot of U-value Results Using HFM Method [36].

flux and temperature after the sample reached steady-state. For the IR method, a black body was created to correct for emissivity and reflectance, then the surface temperature of the actual window sample was taken. The U-factor was evaluated based on the measured surface temperature and surface coefficient using either case one or case two mentioned above. Results showed that the relative errors for the HFM, IR case one, and IR case two are 5.9%, 3.05%, and 11.81%, respectively. Boxplots of these results are given in Figures 25–27.

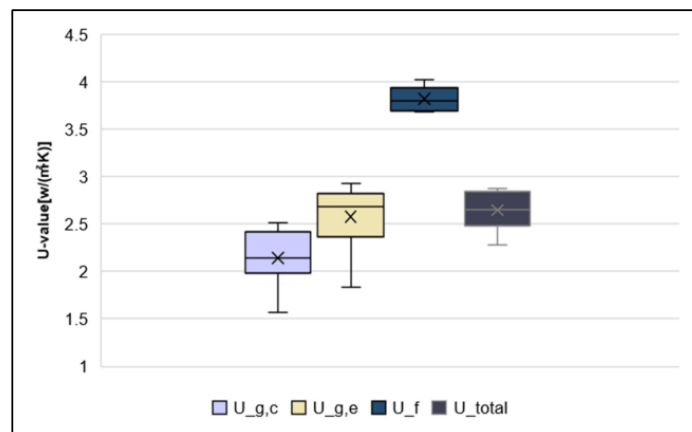
Figure 26. Boxplot of U-value Results Using IR Case 1 [36].

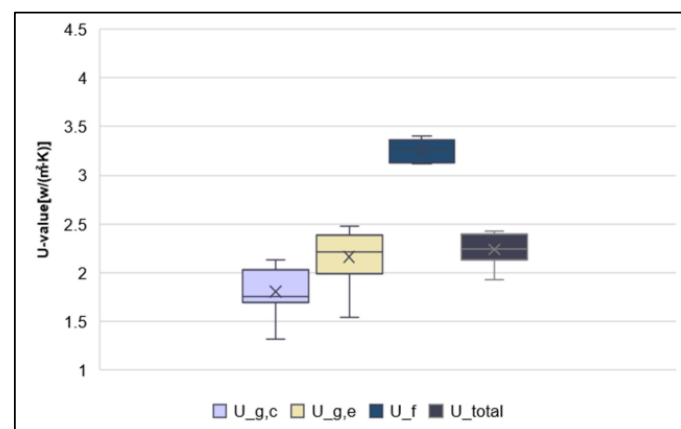
Figure 27. Boxplot of U-value Results Using IR Case 2 [36].

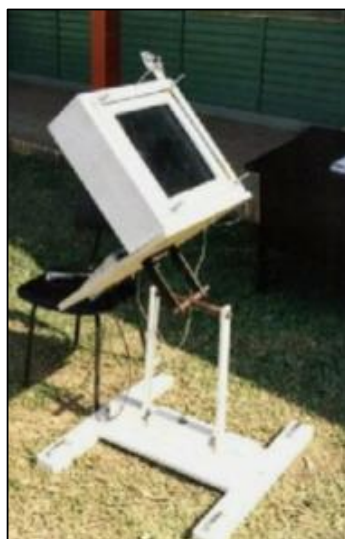
Figure 28. Front View of Fenestration Radiometer Prototype [38].

Marinoski et al. [38] presented a study on an improved system for measuring the solar heat gain through fenestrations. Their test setup consisted of clear glass measuring 21 cm by 21 cm within a fenestration radiometer prototype consisting of cooling fans, heat flux meters, and a support system as shown. A photo of the actual setup is shown in Figure 28.

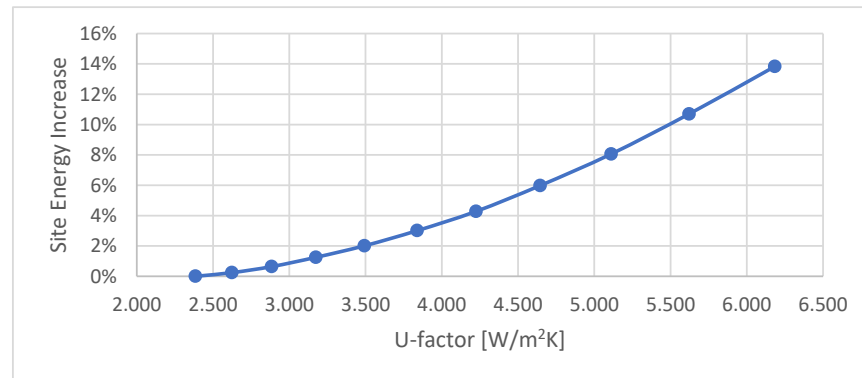
Figure 29. Site Energy Increase as a Function of Window U-factor.

Ratings and simulations do not account for window durability or aging effects, leading to an underestimation of annual building energy consumption of up to 14% per building based on a black-box model of a typical office building located in Denver, as shown in Figure 29.

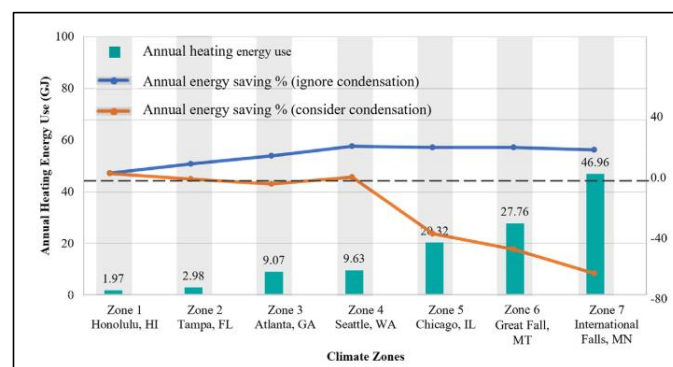
Figure 30. Annual Heating Energy Use and Associated Energy Savings Trends [39].

Duan et al. [39] consider the effects of condensation in low-e windows on overall building energy use. Duan et al. point out that inner glazing surfaces with added low-e coatings are colder than those without and may increase the risk of condensation. Condensation within the panes of an IGU leads to reduced energy performance and cascades down to all equipment in the building. The authors of this paper chose to focus on condensation because no prior study considered whole-building impacts. The authors extended the Nusselt film-wise condensation model to validate their own analytic model. They then created a series of building energy use comparisons within EnergyPlus. The authors found that low-e films on single pane windows are not suitable for colder climates due to condensation effects. Figure 30 shows the difference in annual heating energy savings with and without considering condensation effects applied to retrofitted windows. It reveals that there can be a loss of savings in climate zones 5–7 when condensation is considered.
