Observed field failures and reported degradation rates

Thin Film PV Workshop,

**Dirk Jordan, Michael Kempe, David Miller, Corinne
Packard, John Wohlgemuth, Sarah Kurtz**

2/28/2013

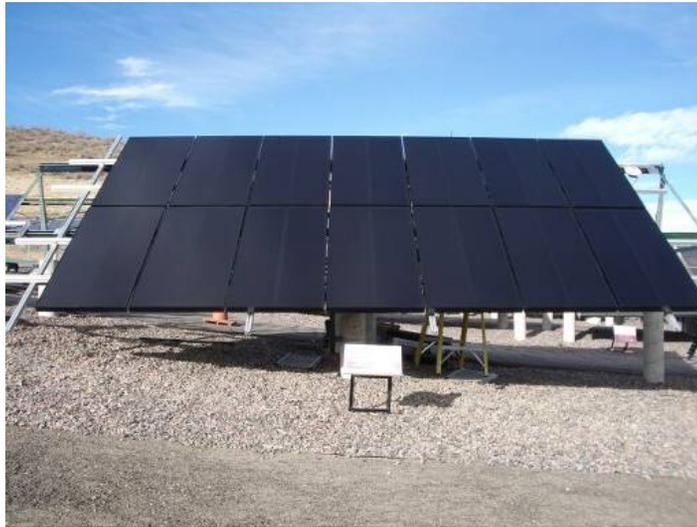
Shell Solar E80-C modules deployed at NREL.
Photo credit: Harin Ullal, NREL PIX 14725

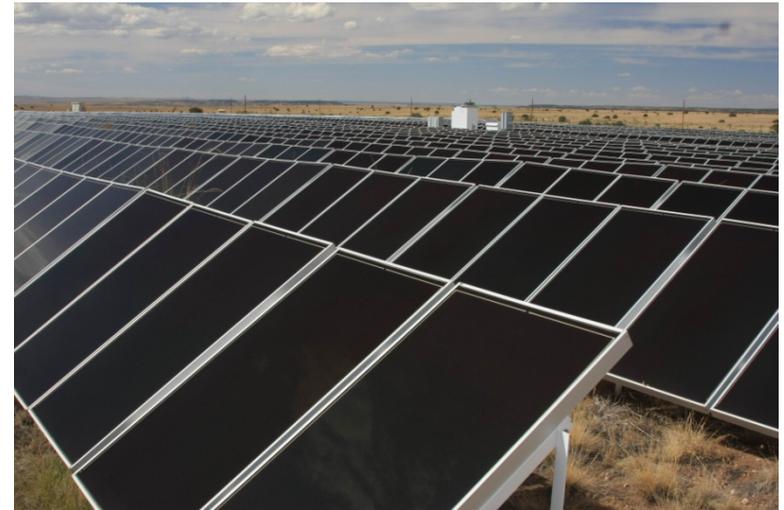
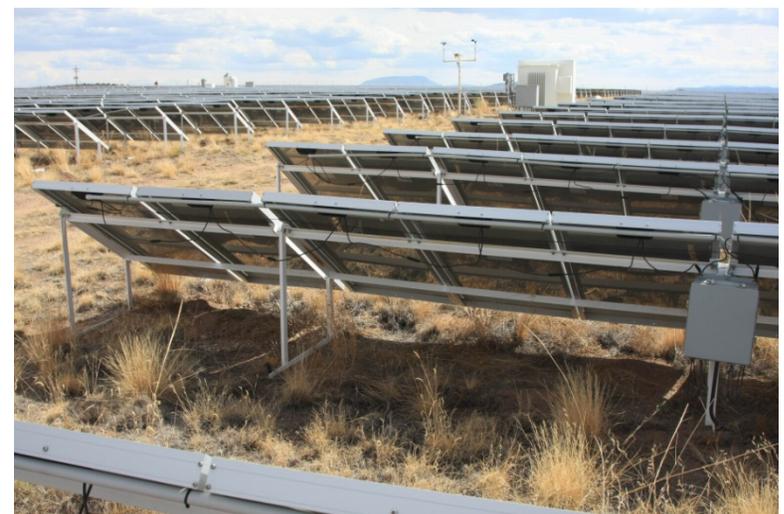
**BP Solar array, facing north (top)
and facing south (bottom)**

a-Si

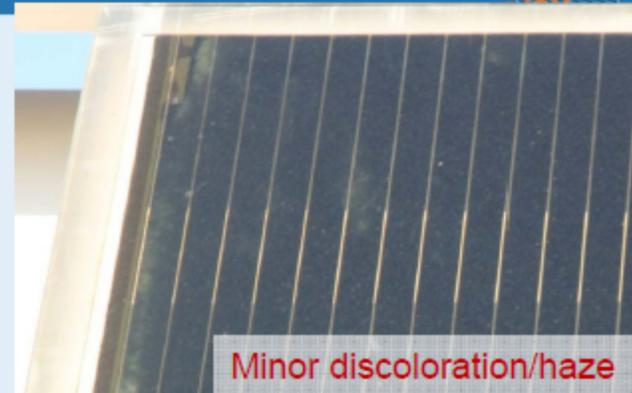
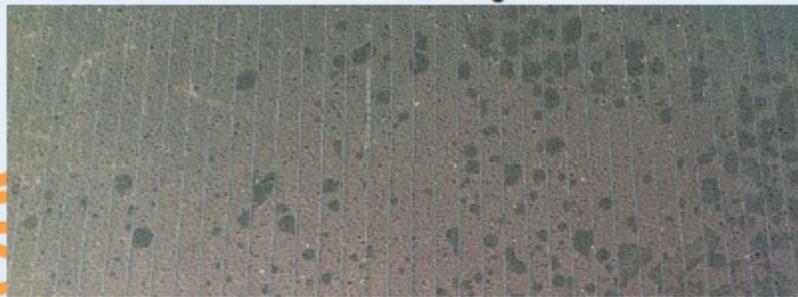
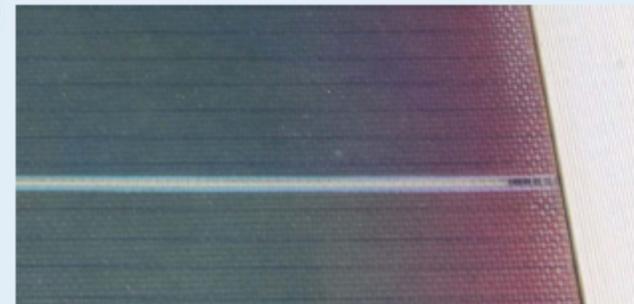
spotted degradation haze (encapsulant browning) other

overall/no location pattern module center module edge(s)

cell center cell edges near crack(s)
